SUBJECT: Notice of Appeal, DNS decision dated May 14, 2024
8229 – Talbot Road, Edmonds, WA
Continued Maintenance of Fish-Killing Flow Splitter
File No.: PLN2024-0020

Dithering = Disaster

Perrinville Creek
Failed Culverts and Flow
Splitter threaten BNSF Rail
Tracks,
Puget Sound
Edmonds, WA

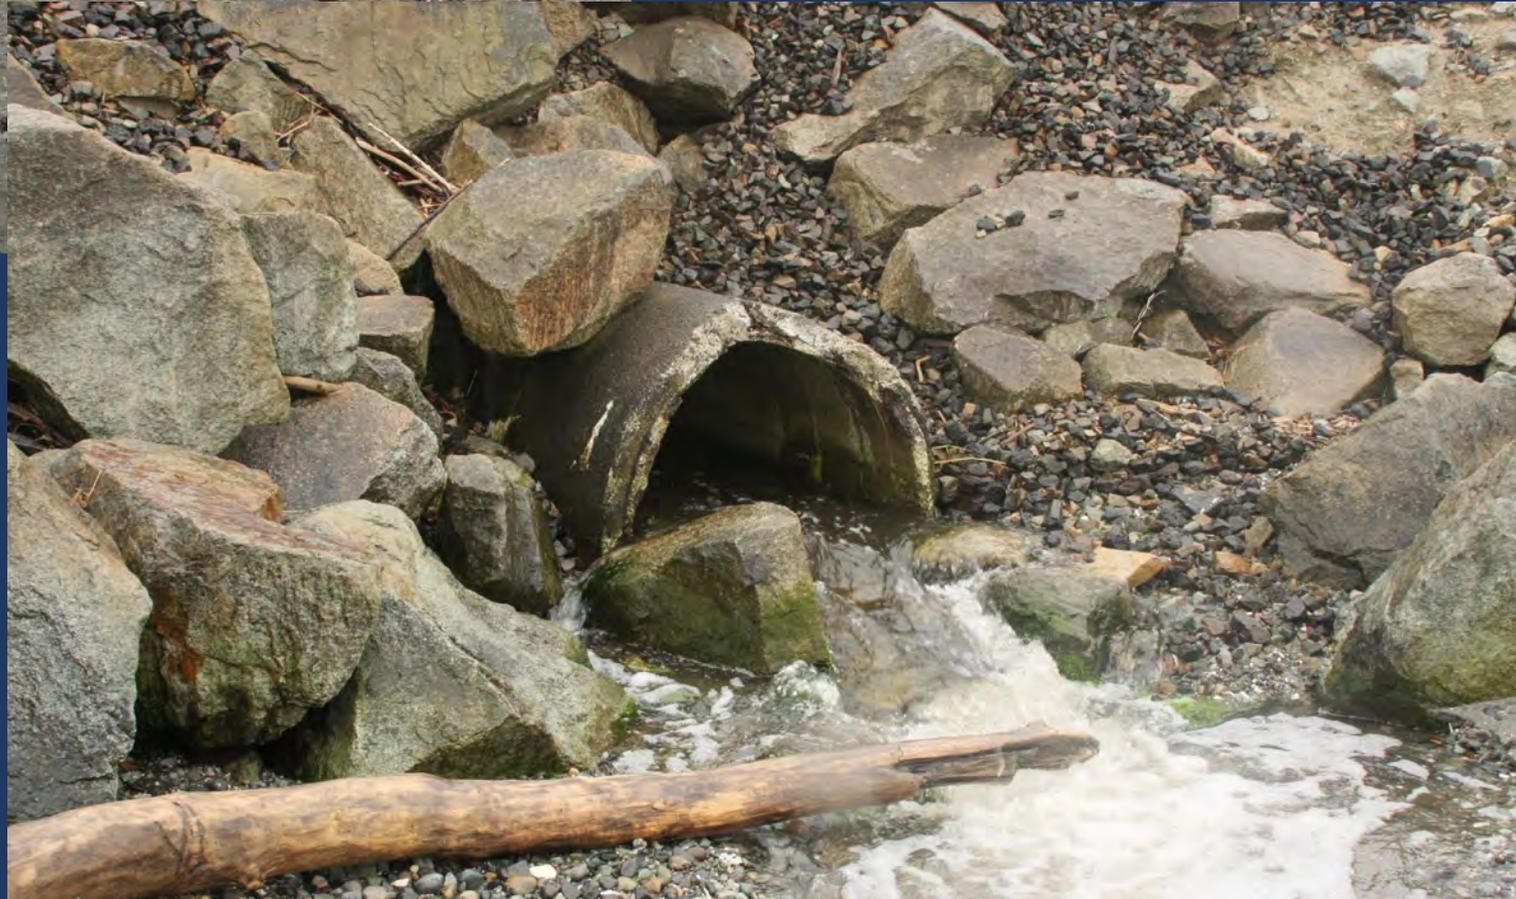
30" BNSF Culvert outfall
to Puget Sound over a
decade ago.

Culvert flowing half-full
in June is not a good
sign!

Current BNSF
design standards
require a minimum
36-inch culvert.

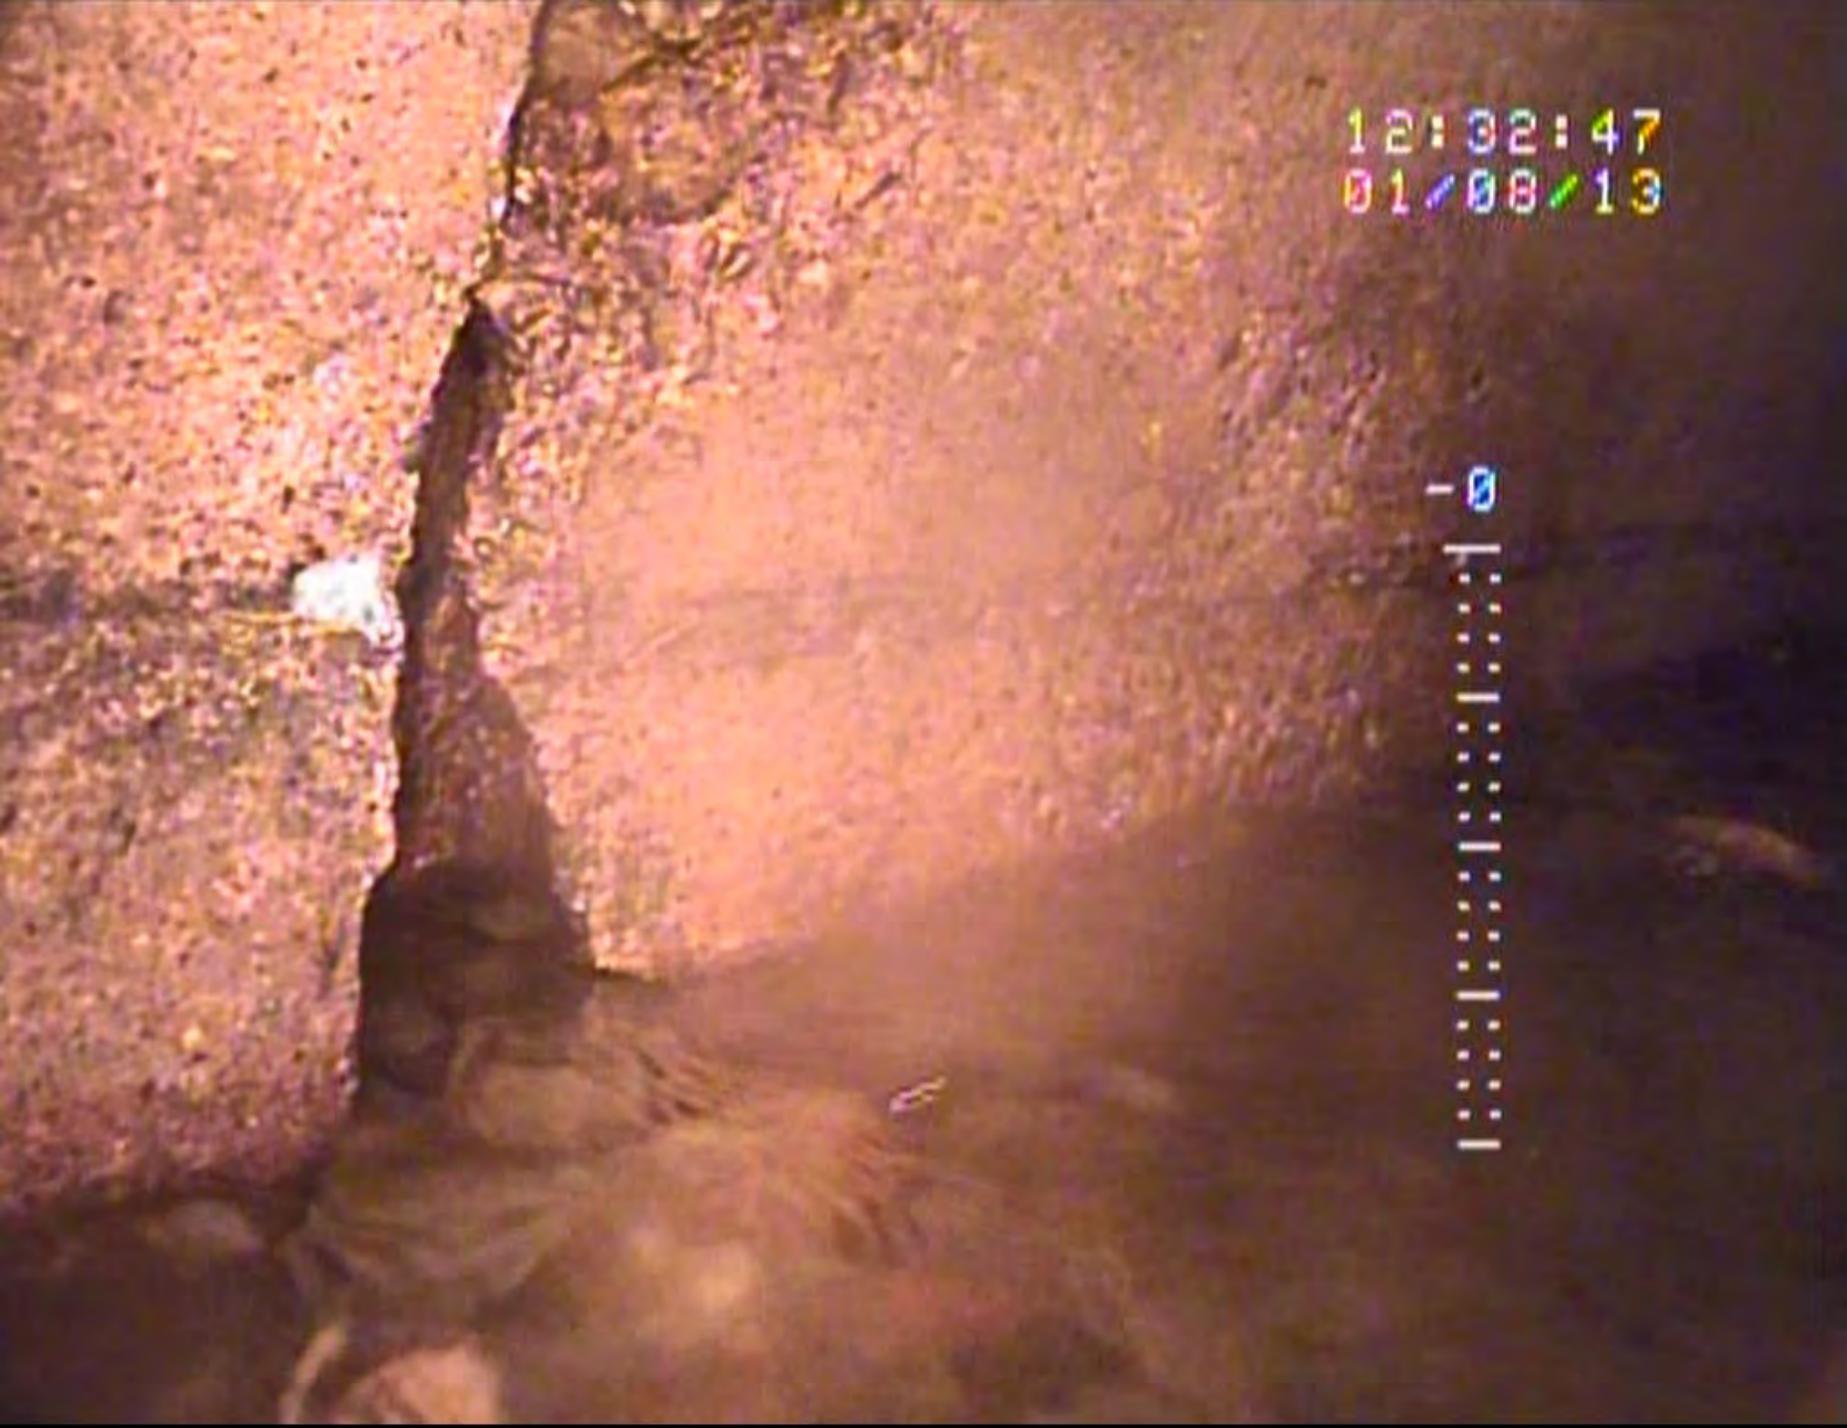
Video of reinforced concrete 30" culvert. Video was made after 2012 Lider Engineering report:

Broken pipe joint in 30" conc pipe will wash out pipe bedding.

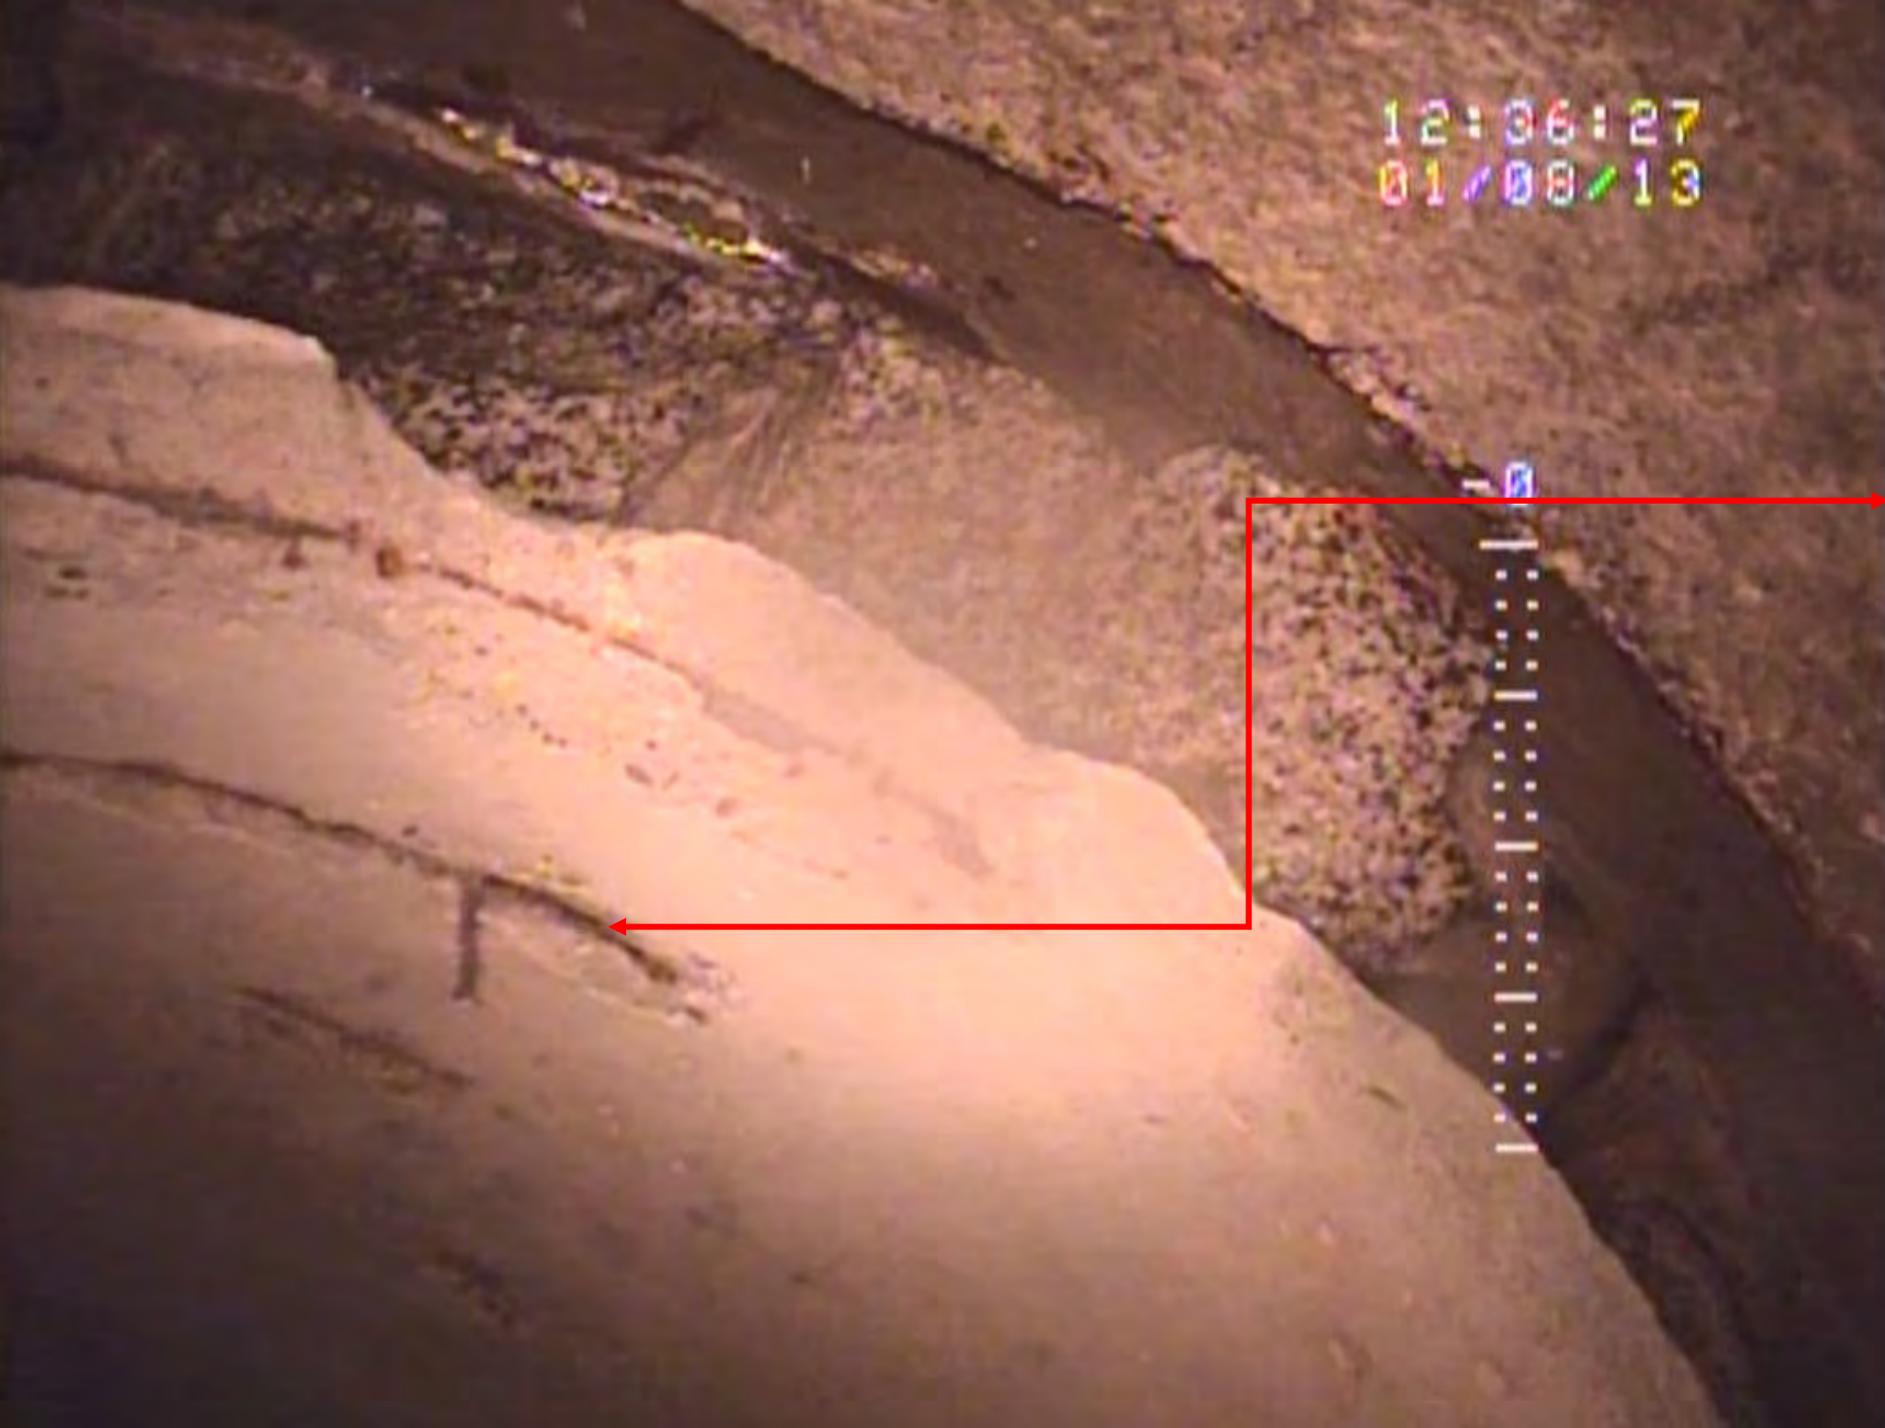
Pipe has settled 6"-12" and railroad ballast rock is visible at the crown of the pipe per the City's inspection report.

Large diameter pipe is allowed a 2.5° joint deflection. 12" is > than a 7° deflection.

Note rebar is exposed to saltwater corrosion corrosion/chloride ion attack.

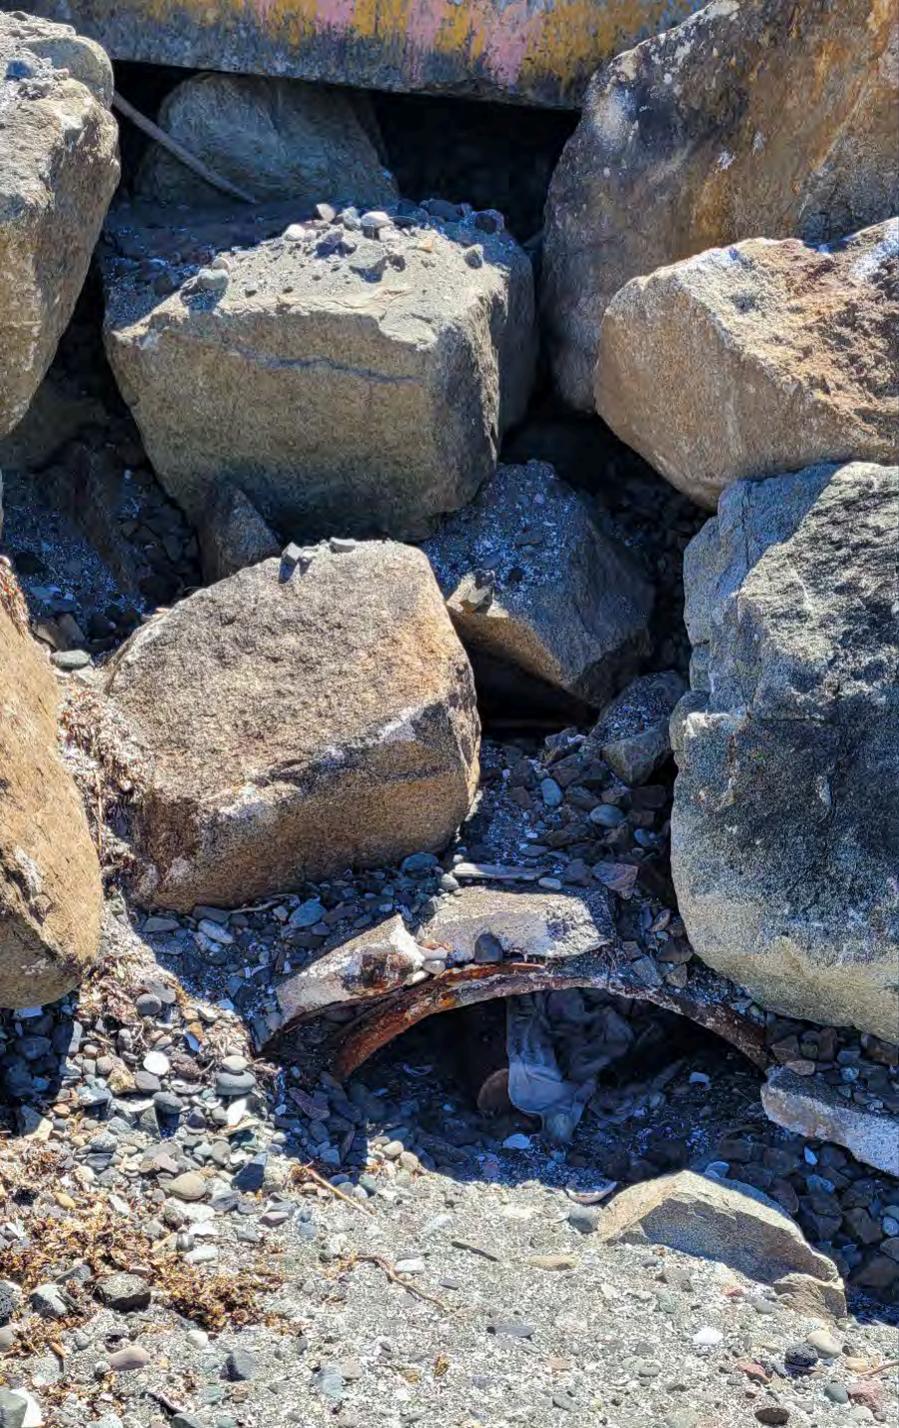
There is no flow whatsoever out of the 30-inch concrete culvert since the Dec. 2020 storm. The pipe is entirely clogged with unconsolidated material.

The pipe needs to be cleaned and filled with engineered controlled density fill (CDF) to safely convey rail loads.

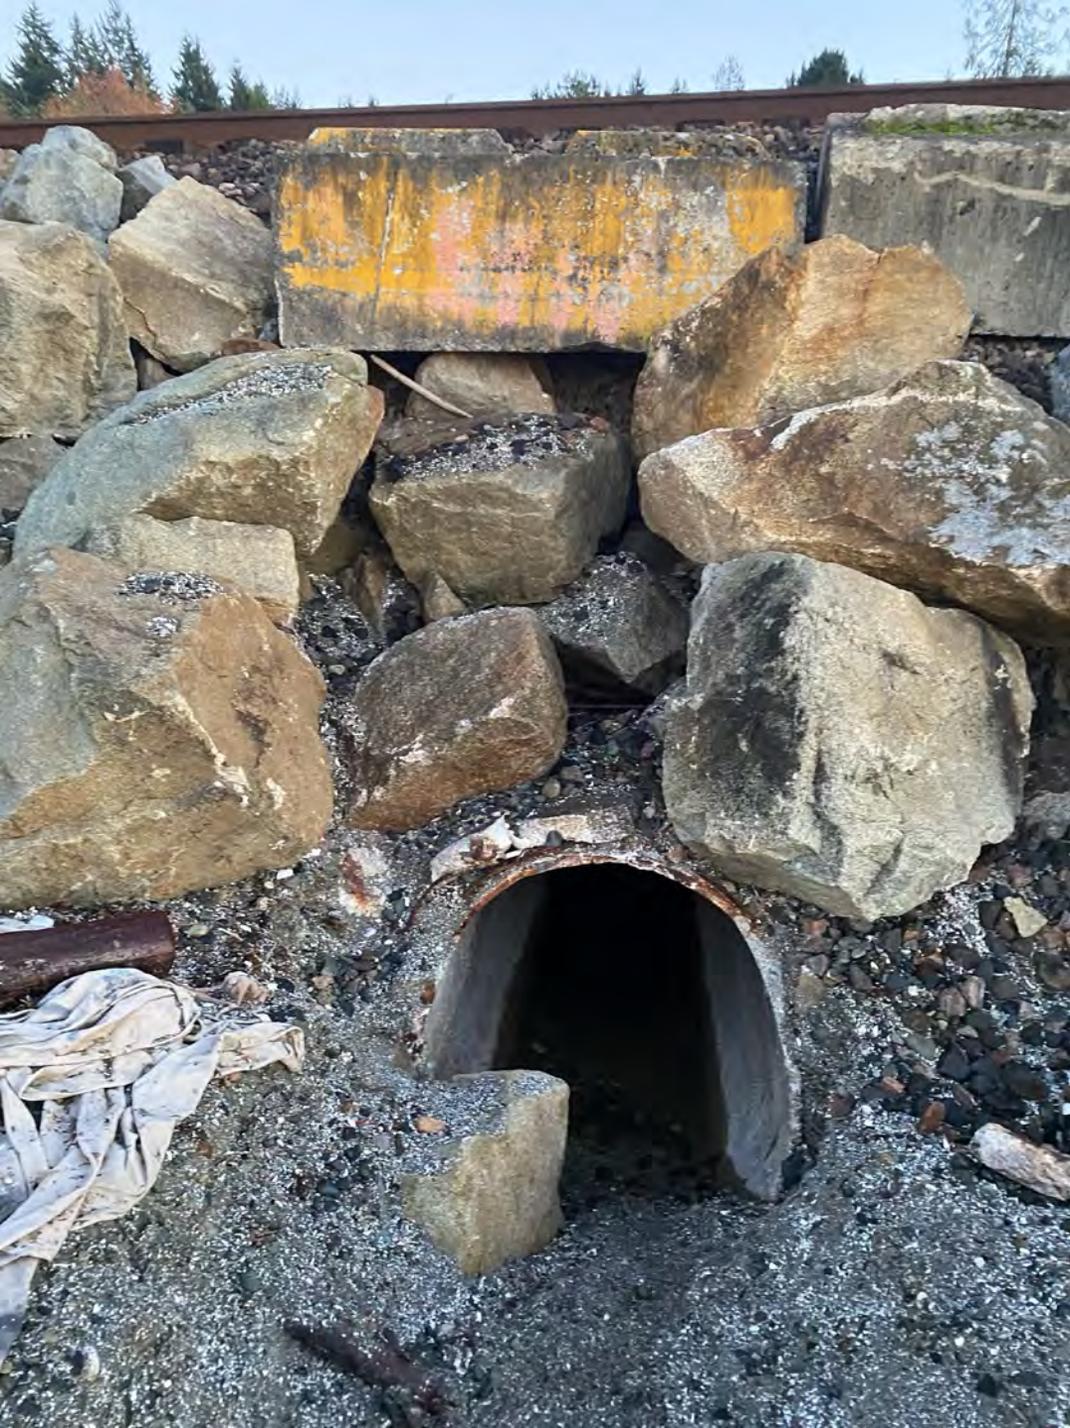
BNSF 30" CULVERT OUTLET

November 2023 jetted out 30-inch BNSF reinforced concrete culvert outfall to Browns Bay. Note, there is no stream flow is currently reaching this culvert. Only a small amount of tidal groundwater flow is visible in the pipe.

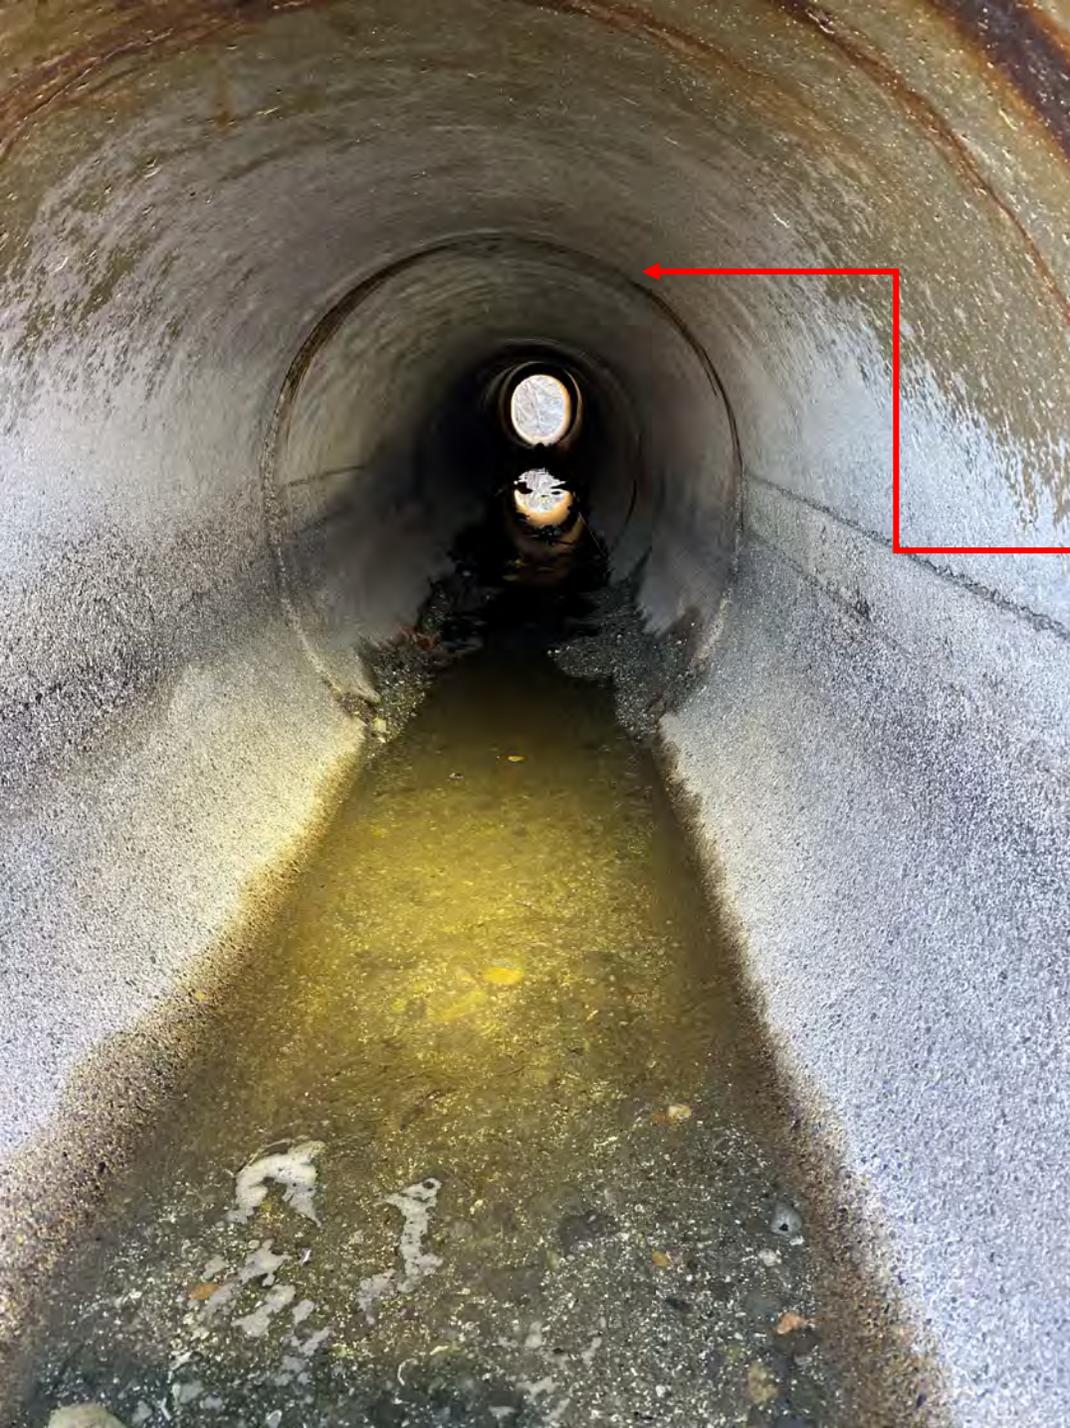
BNSF 30" CULVERT INLET

Culvert cleaned Nov. 2023, but not video inspected. Currently there is no flow through this culvert as all Perrinville Creek flow is via the City owned 42-inch DIP culvert.

Separated pipe joint. Note rust staining from corroded rebar

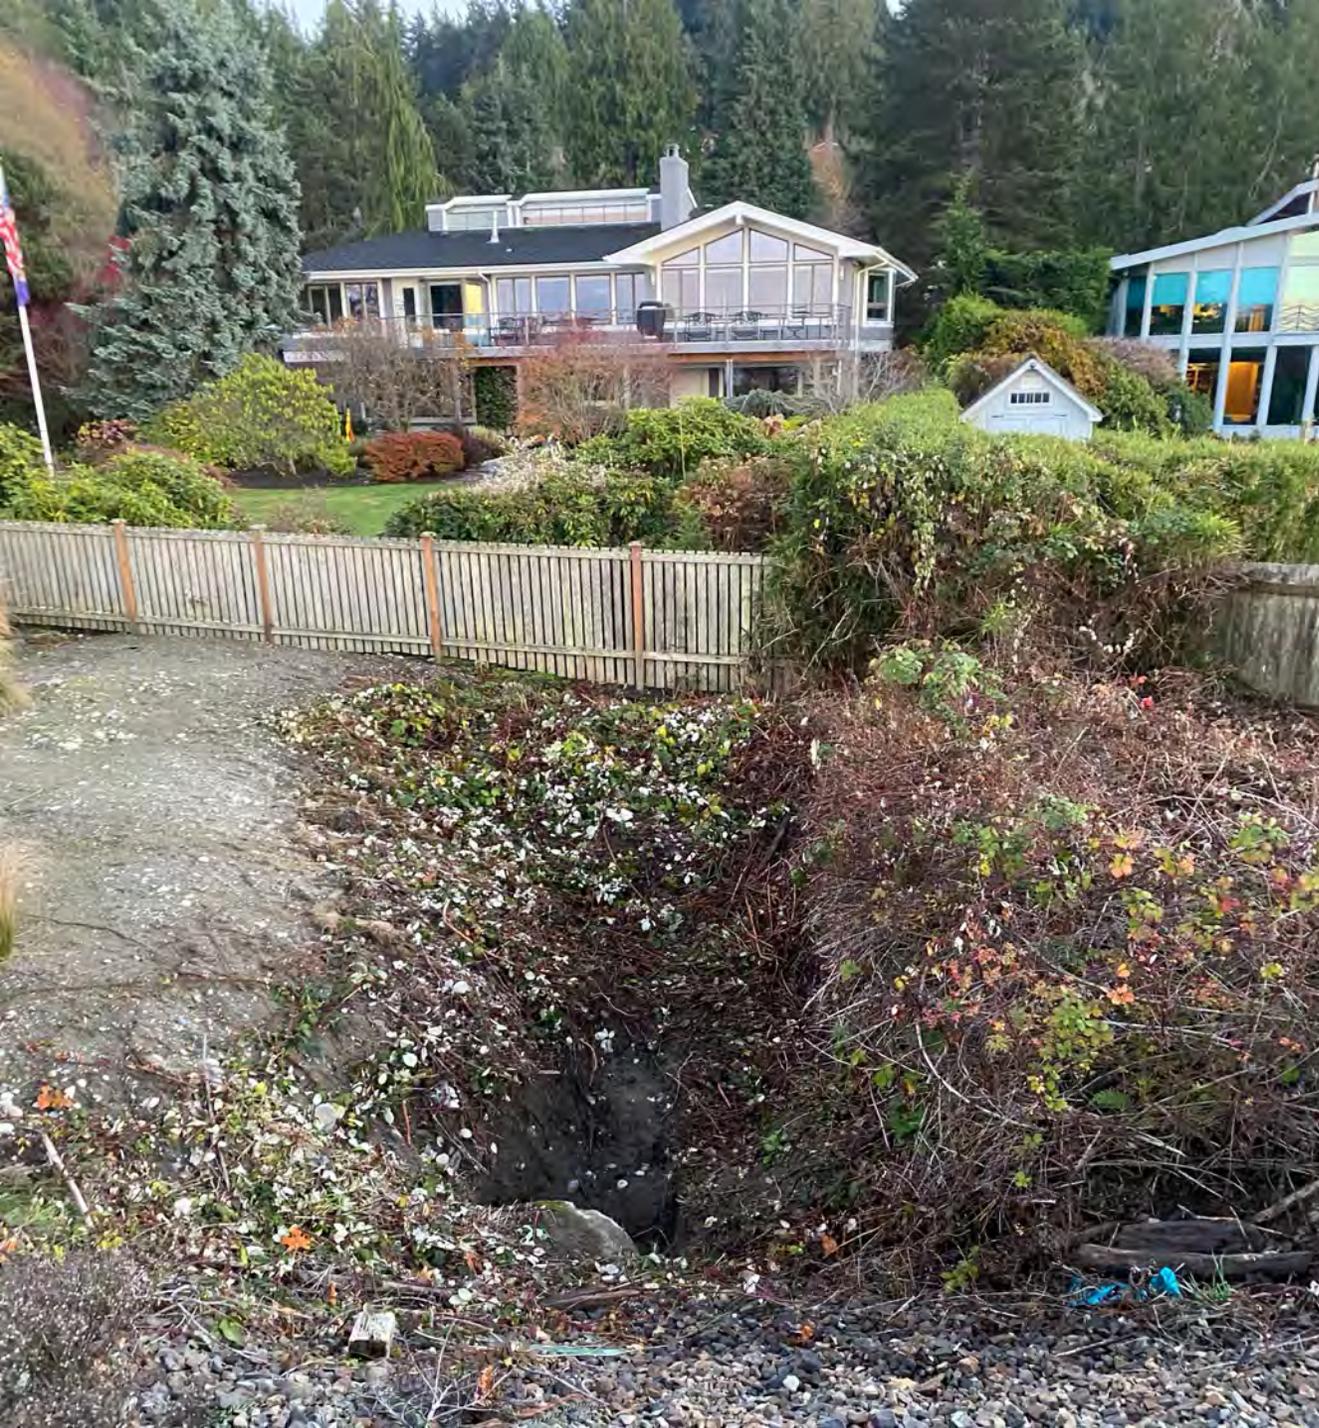
View looking east at the inlet to the BNSF 30-inch concrete culvert. The Perrinville Creek stream channel has been obliterated and currently there is no stream flow entering the BNSF 30-inch concrete pipe.

The gardens of properties at 8235 and 8307 Talbot Road are shown in the background. These properties will be flooded during the next major storm event because the City of Edmonds ductile iron pipe is undersized by a factor of 10 to convey the Perrinville Creek, 100-year storm flow.

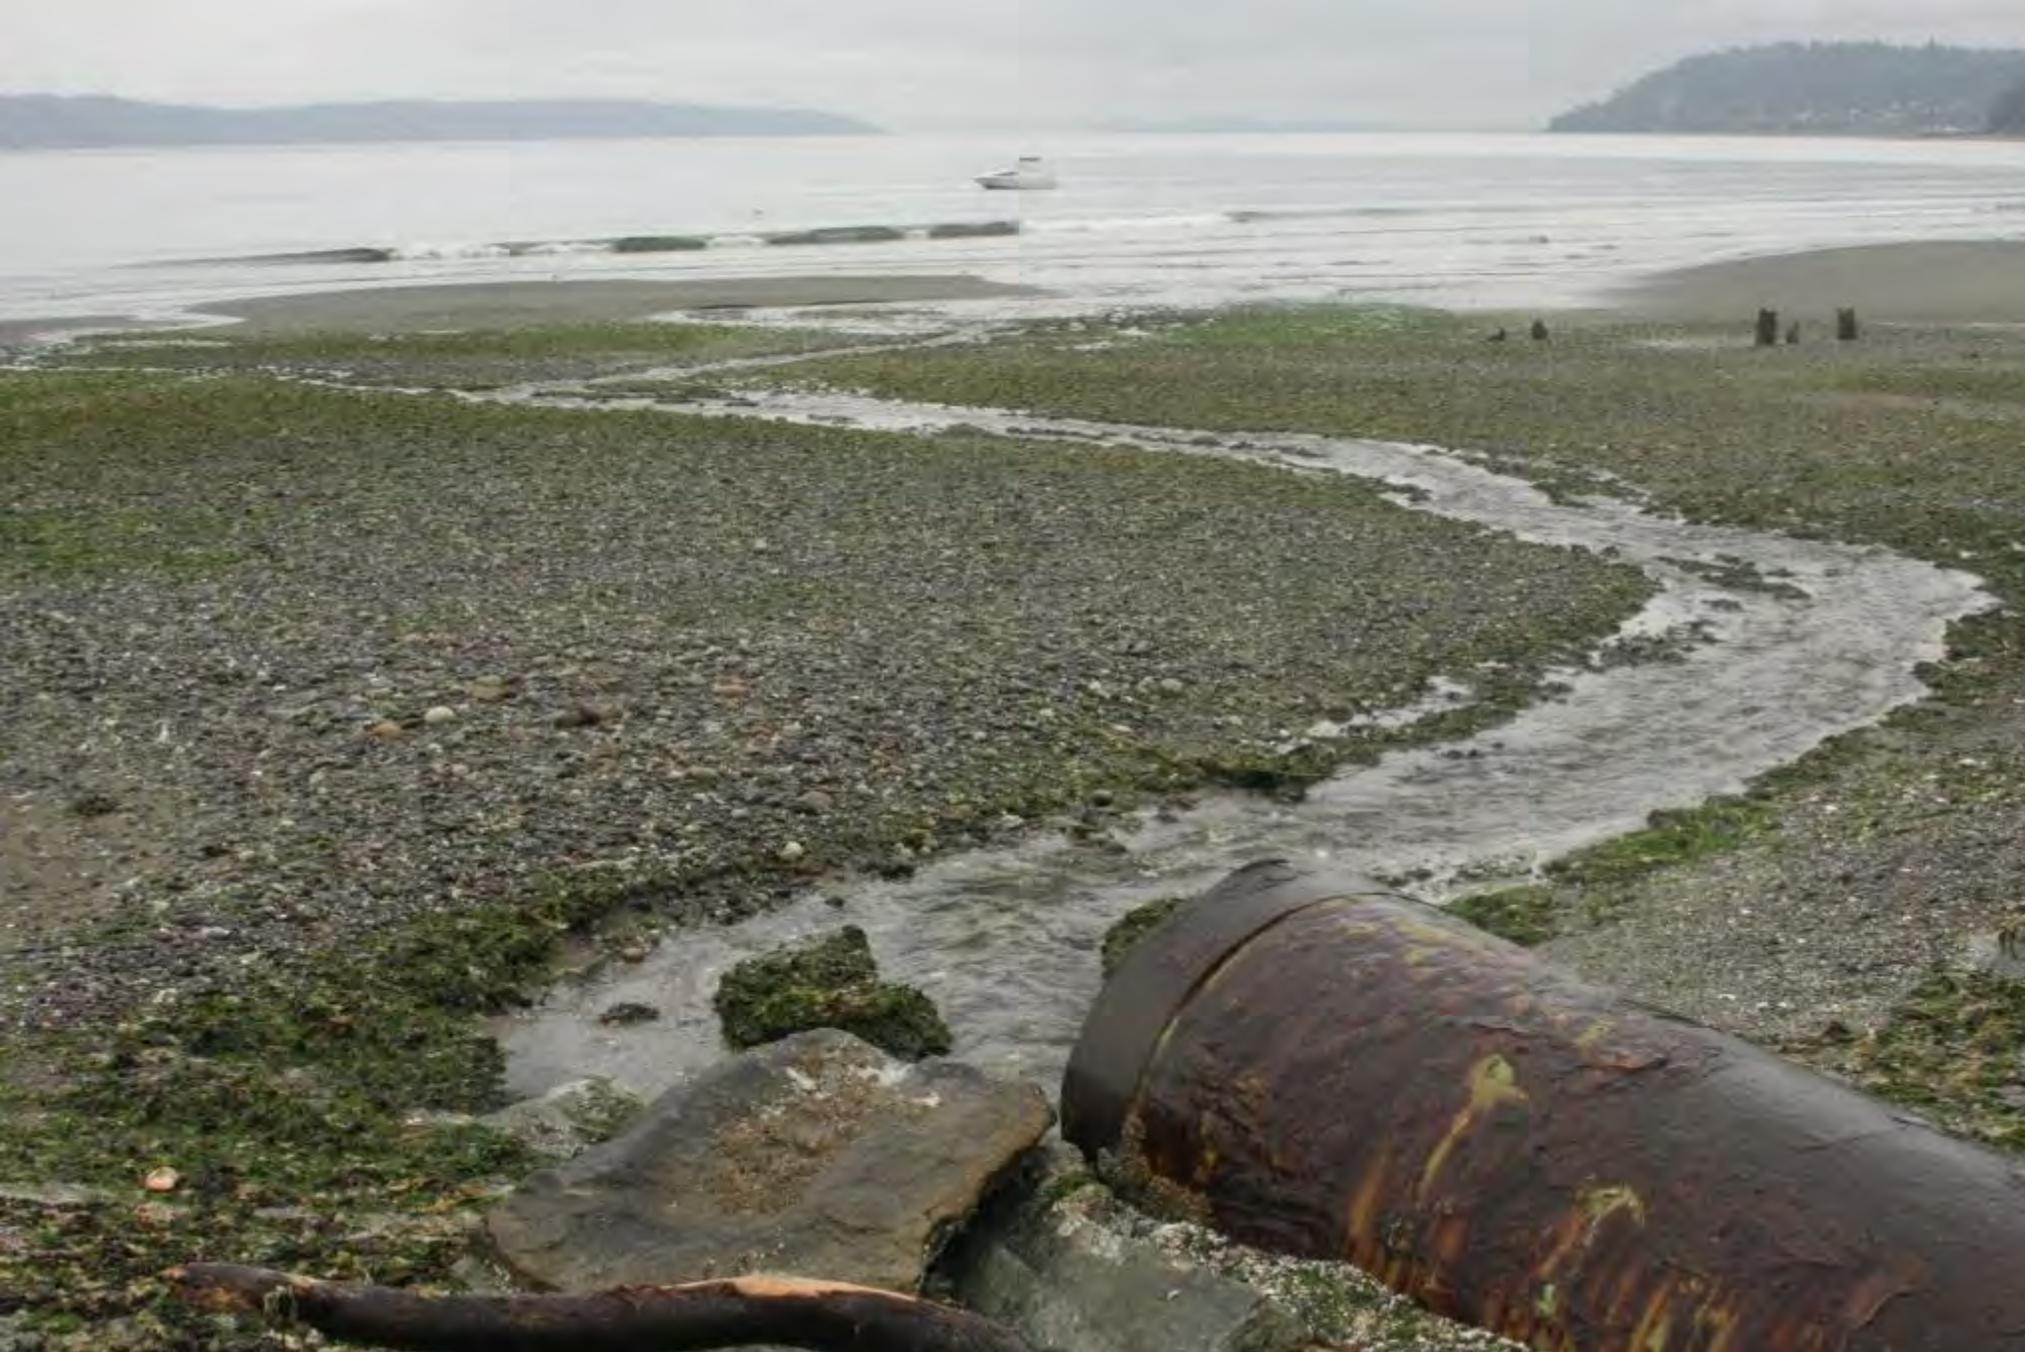
42" DIP high flow
bypass overflow pipe
into Browns Bay.

This pipe is owned and
maintained by the City
of Edmonds.

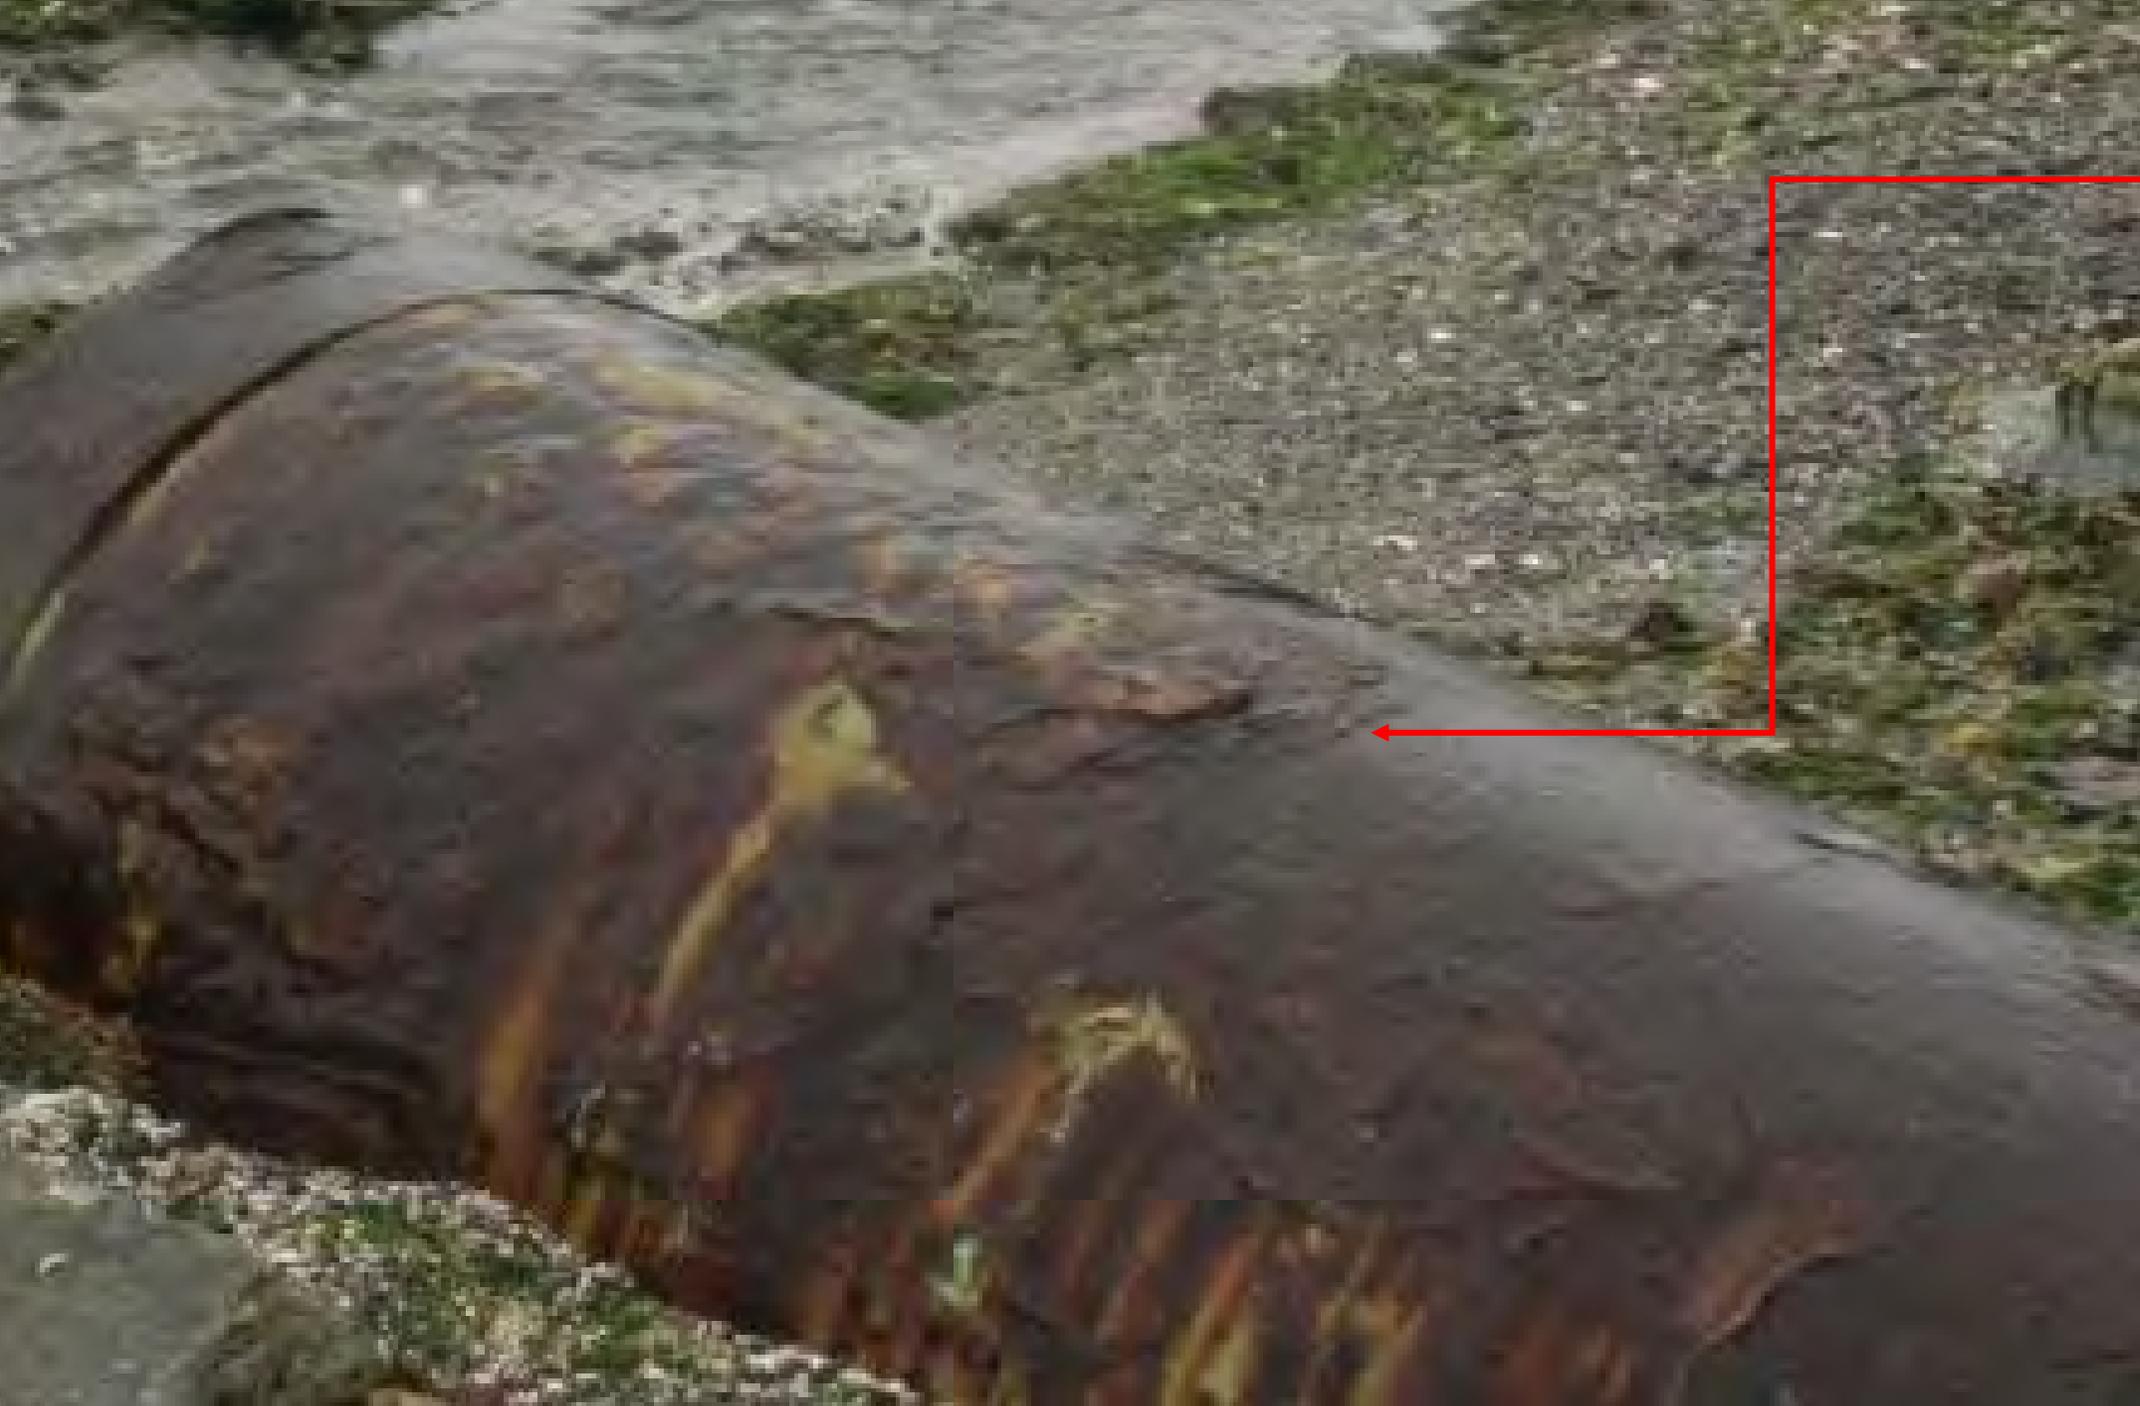
Saltwater corrosion has delaminated the DIP, reducing its thickness and strength.

Lider Engr. recommends replacement.

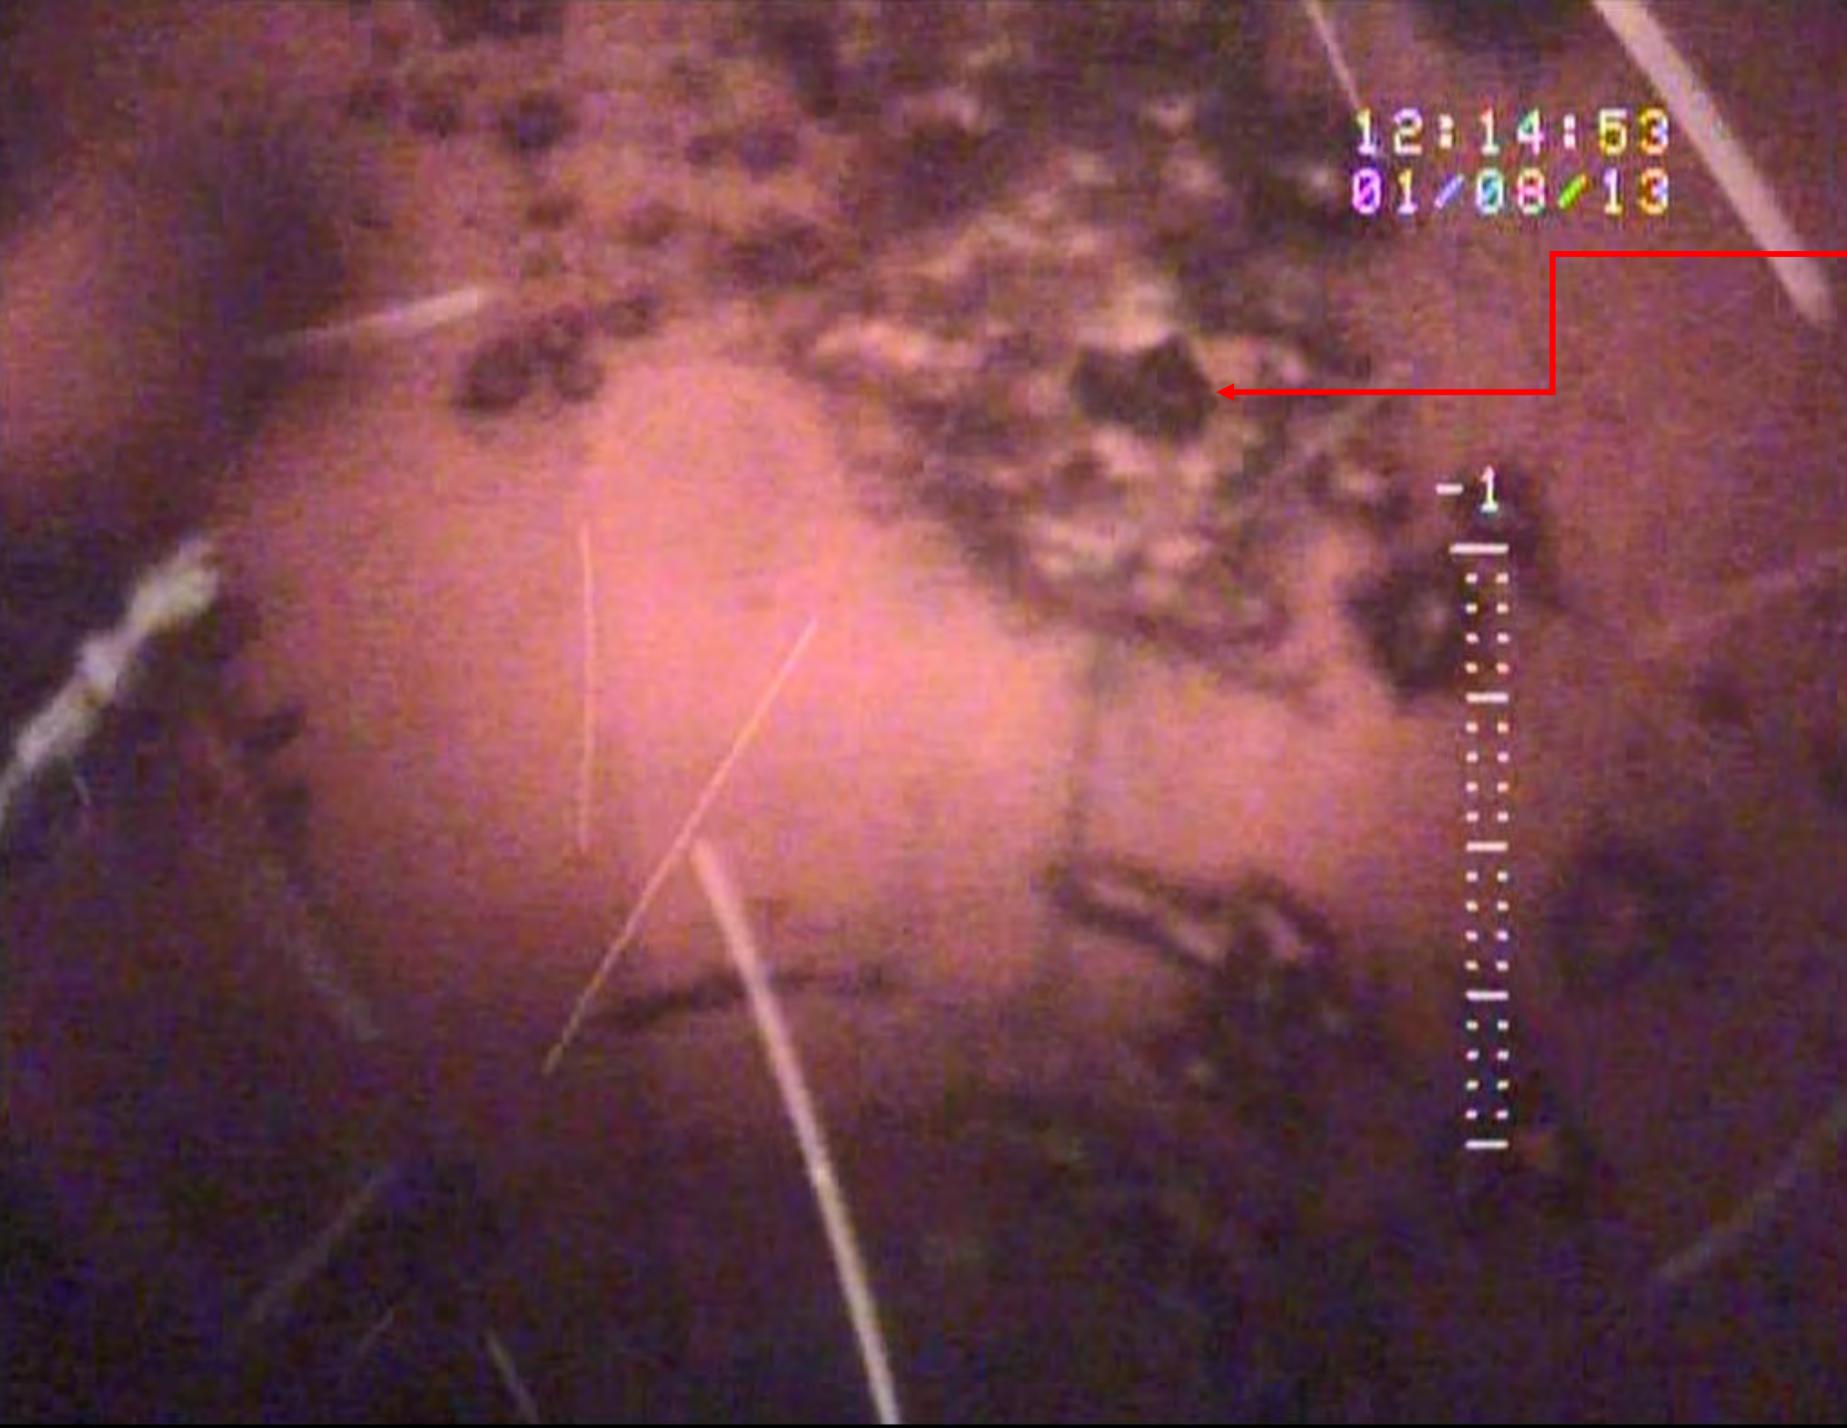
This video of the interior of the DIP was made after the 2012 Lider Engineering report filed with the City of Edmonds.

42" DIP video showing rust boils and incipient opening in the pipe. Much of the video was out of focus or under water.

While the City's consultant recommended annual reinspection, no inspection has occurred to this date.
