SUBJECT: Notice of Appeal, DNS decision dated May 14, 2024
8229 – Talbot Road, Edmonds, WA
Continued Maintenance of Fish-Killing Flow Splitter
File No.: PLN2024-0020

Dithering = Disaster

Perrinville Creek
Failed Culverts and Flow
Splitter threaten BNSF Rail
Tracks,
Puget Sound
Edmonds, WA

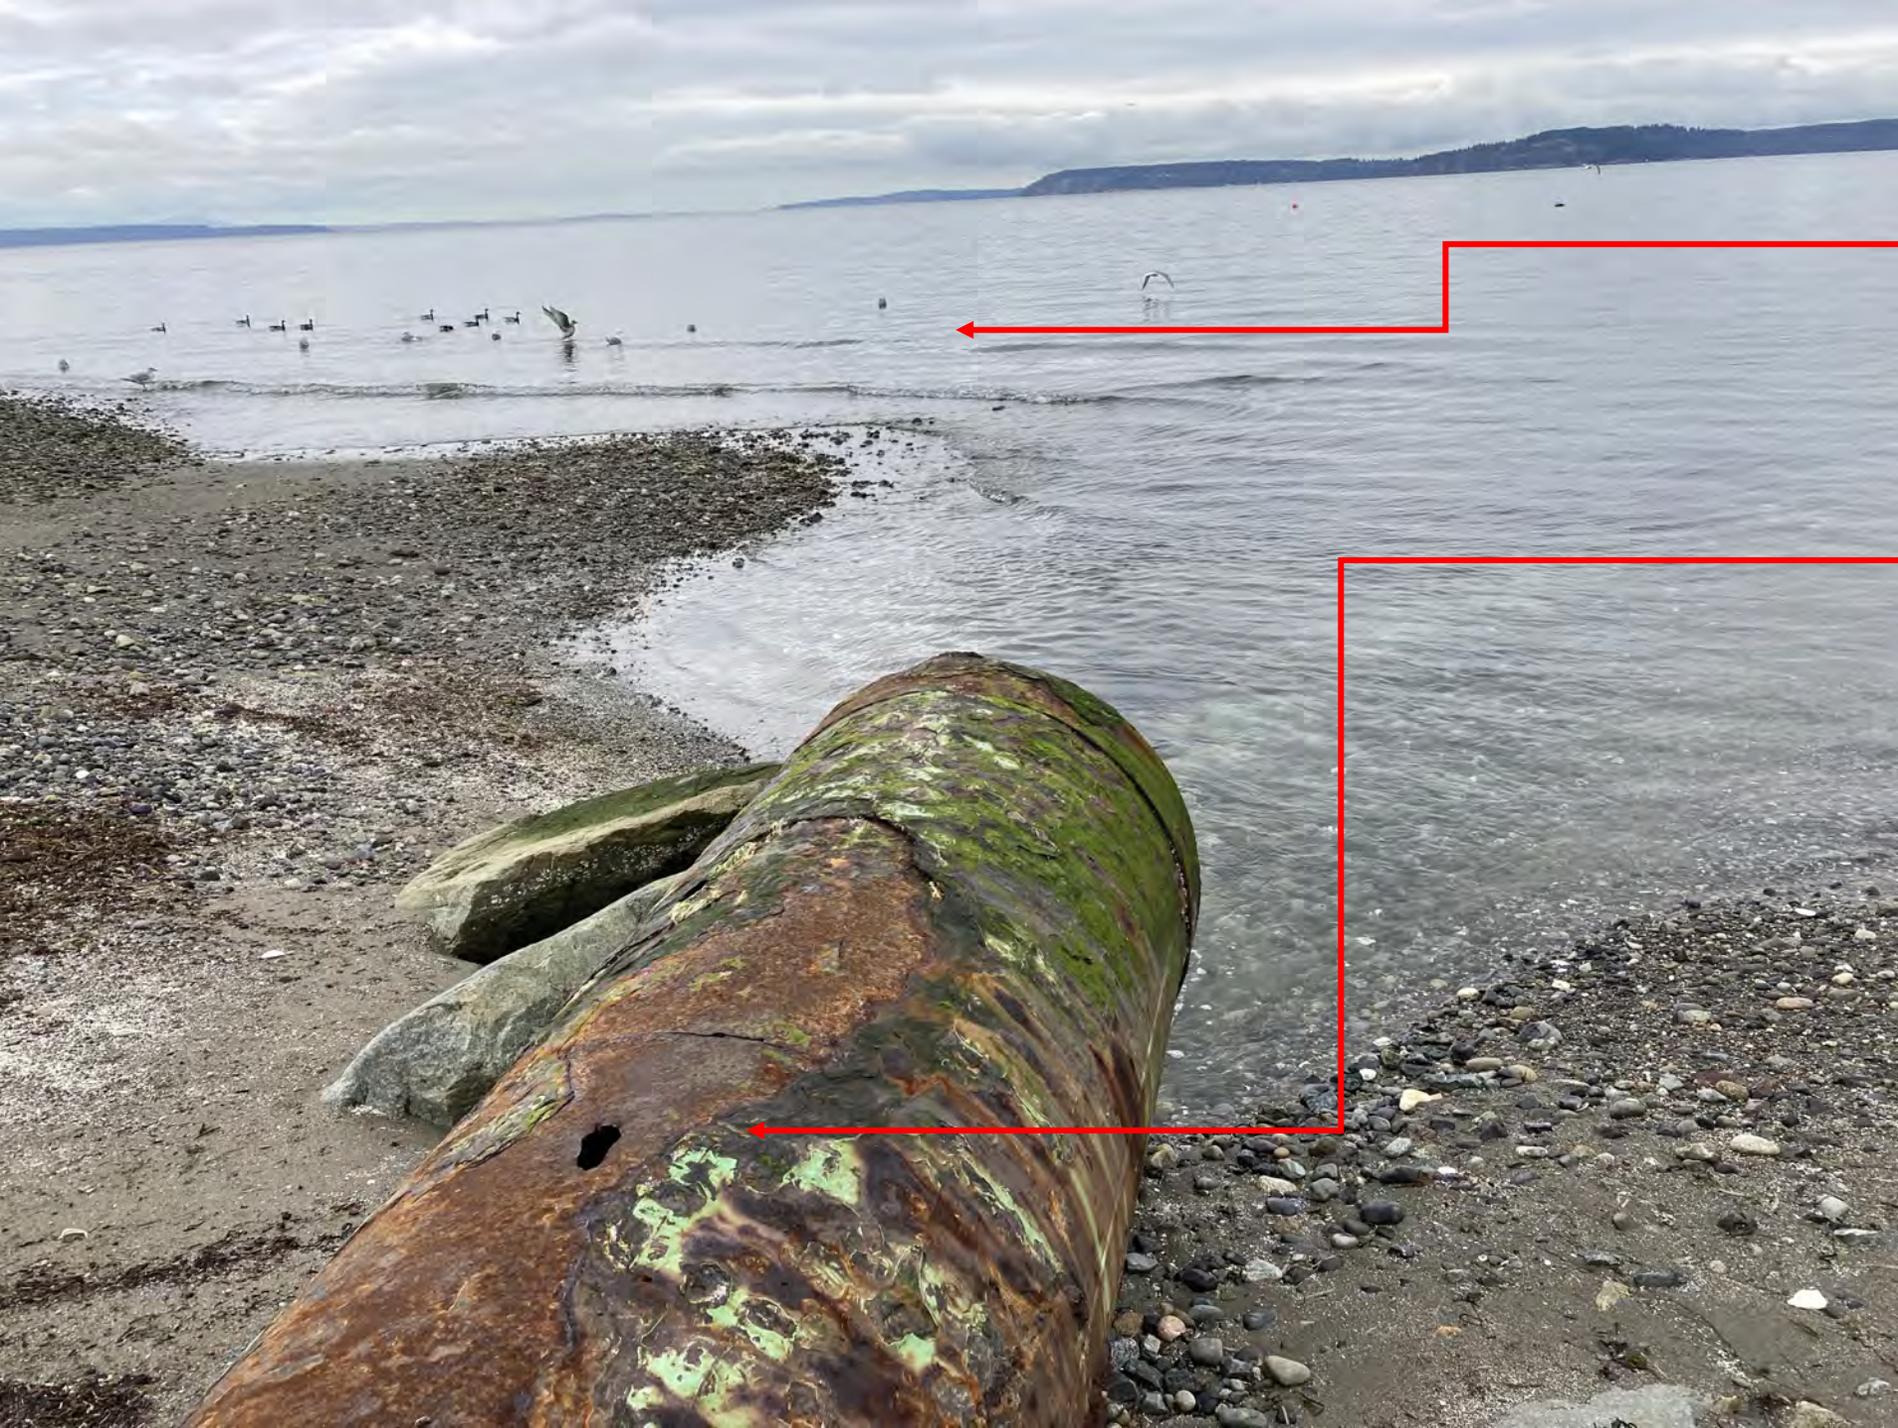
10-years later, delaminated
pipe steel has completely
rusted through, with a visible
transverse crack in the pipe.

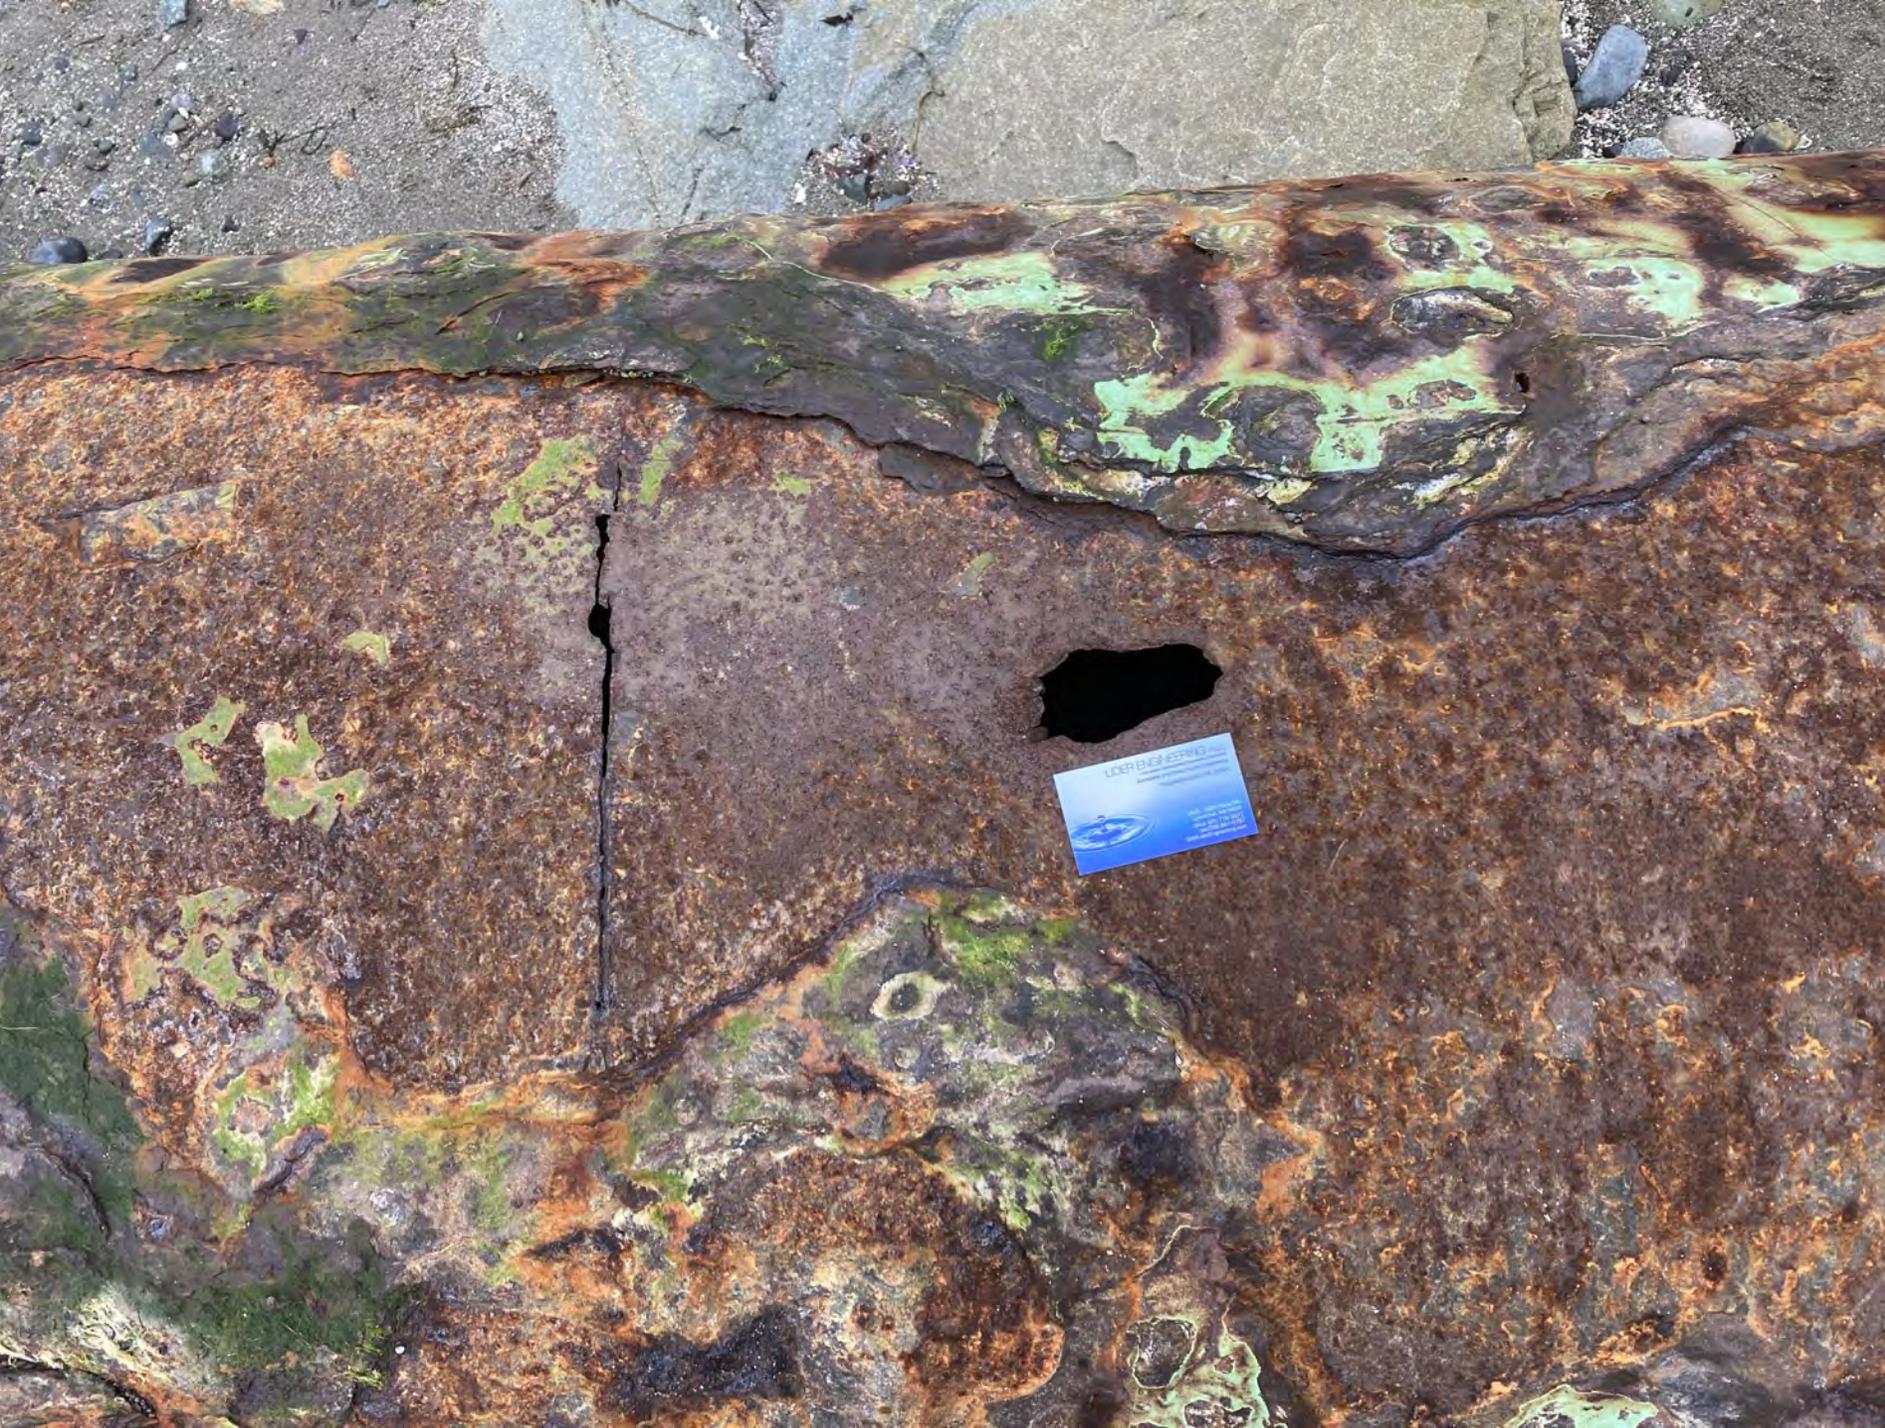
A hole the size of a business card has opened up in the 42" DIP.

A transverse crack has opened in the DIP.

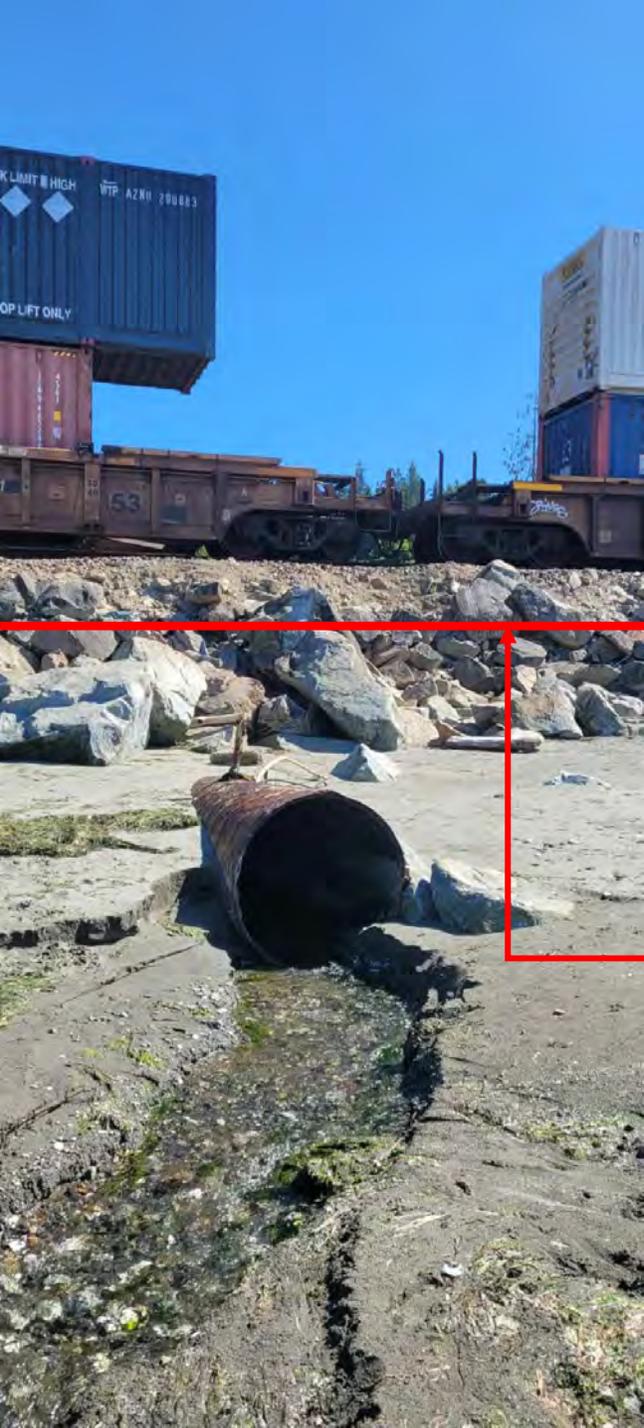
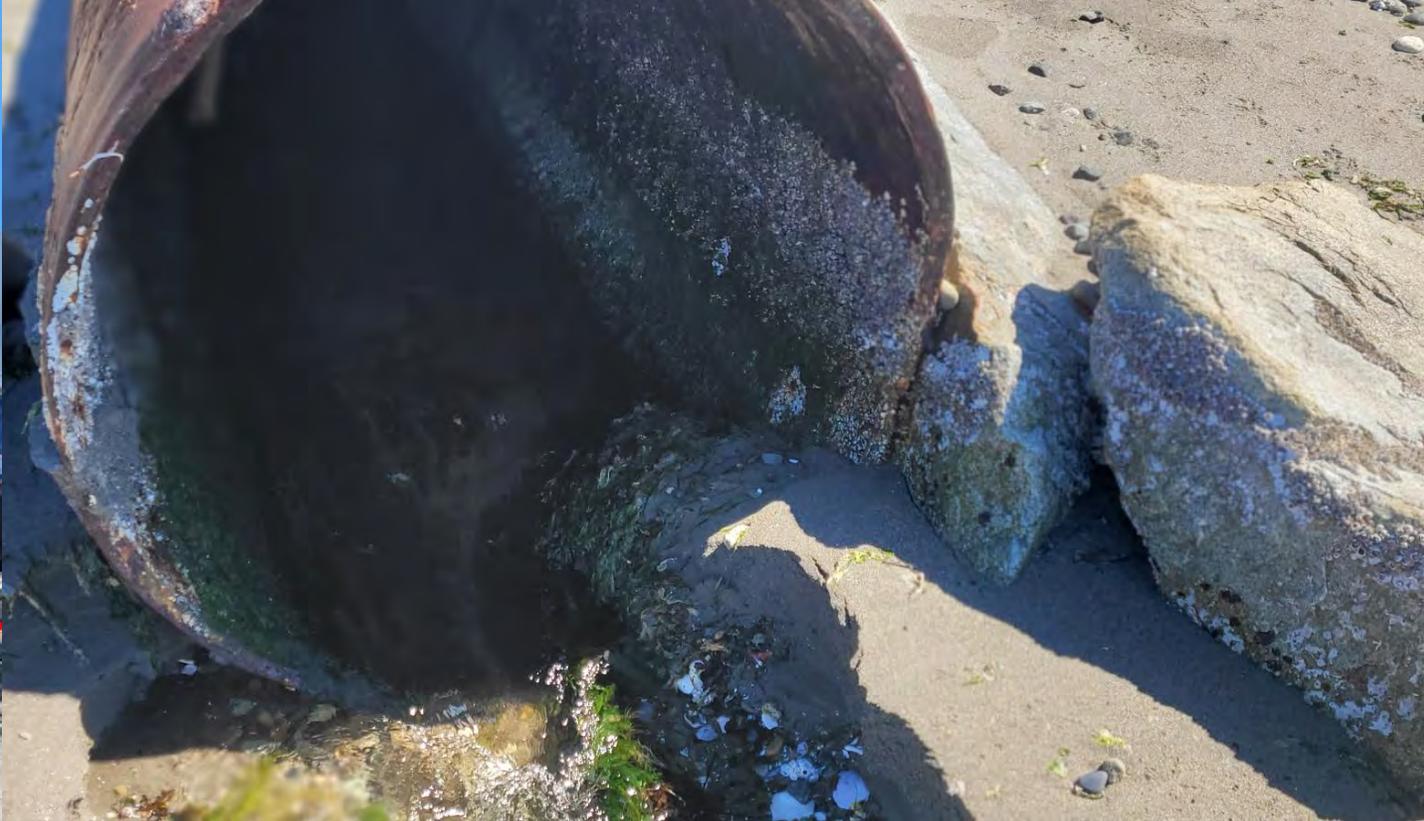
Current photos of 42" DIP. Note barnacles up to about the spring line of the pipe. Barnacles do not grow above elev. 11+/- MLLW, which is the Army Corps permit limit.

→ Approx. Extreme High Tide Elev. Significant vibration occurs in the track bed approx. 9-feet above the DIP. It is not unusual for two freight trains carrying hazardous cargo to cross over the DIP.

Barnacle growth. Pipe is regularly submerged in tidal saltwater accelerating corrosion and increases surface roughness.

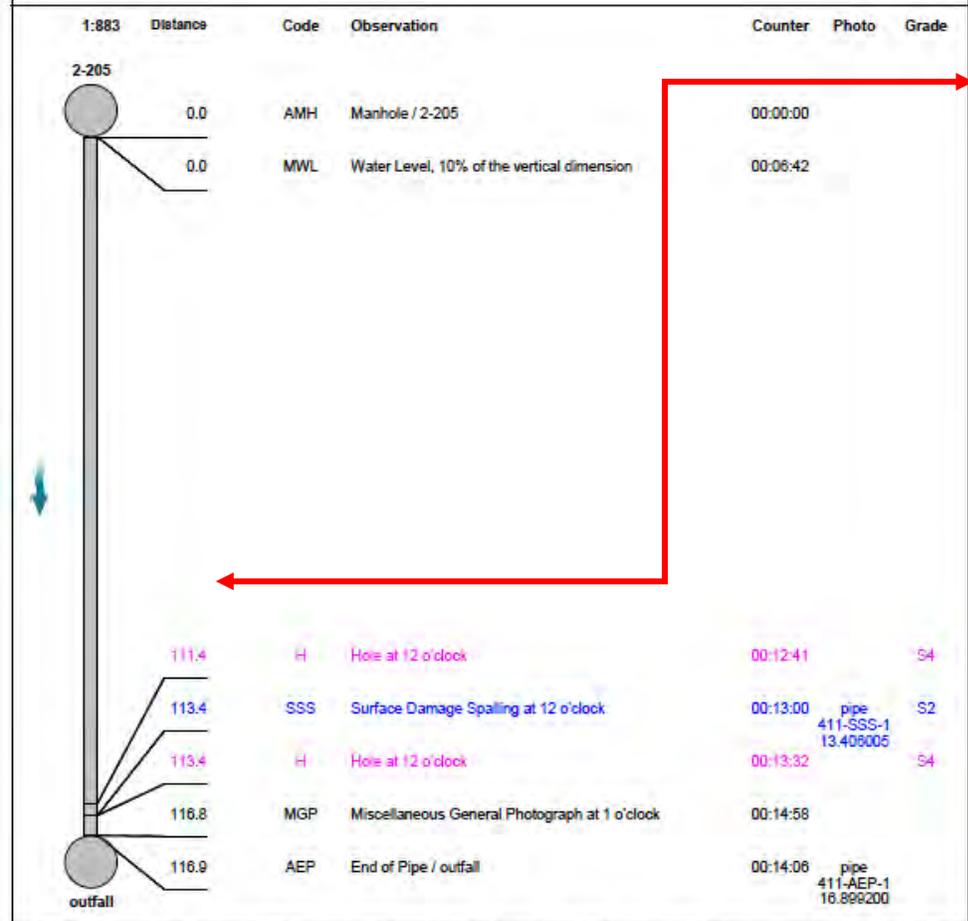
No mention of railroad ballast entering the pipe at 93-feet west of MH 2-205.

Public Works never responded to inquires as to why this significant structural deficiency was never identified.

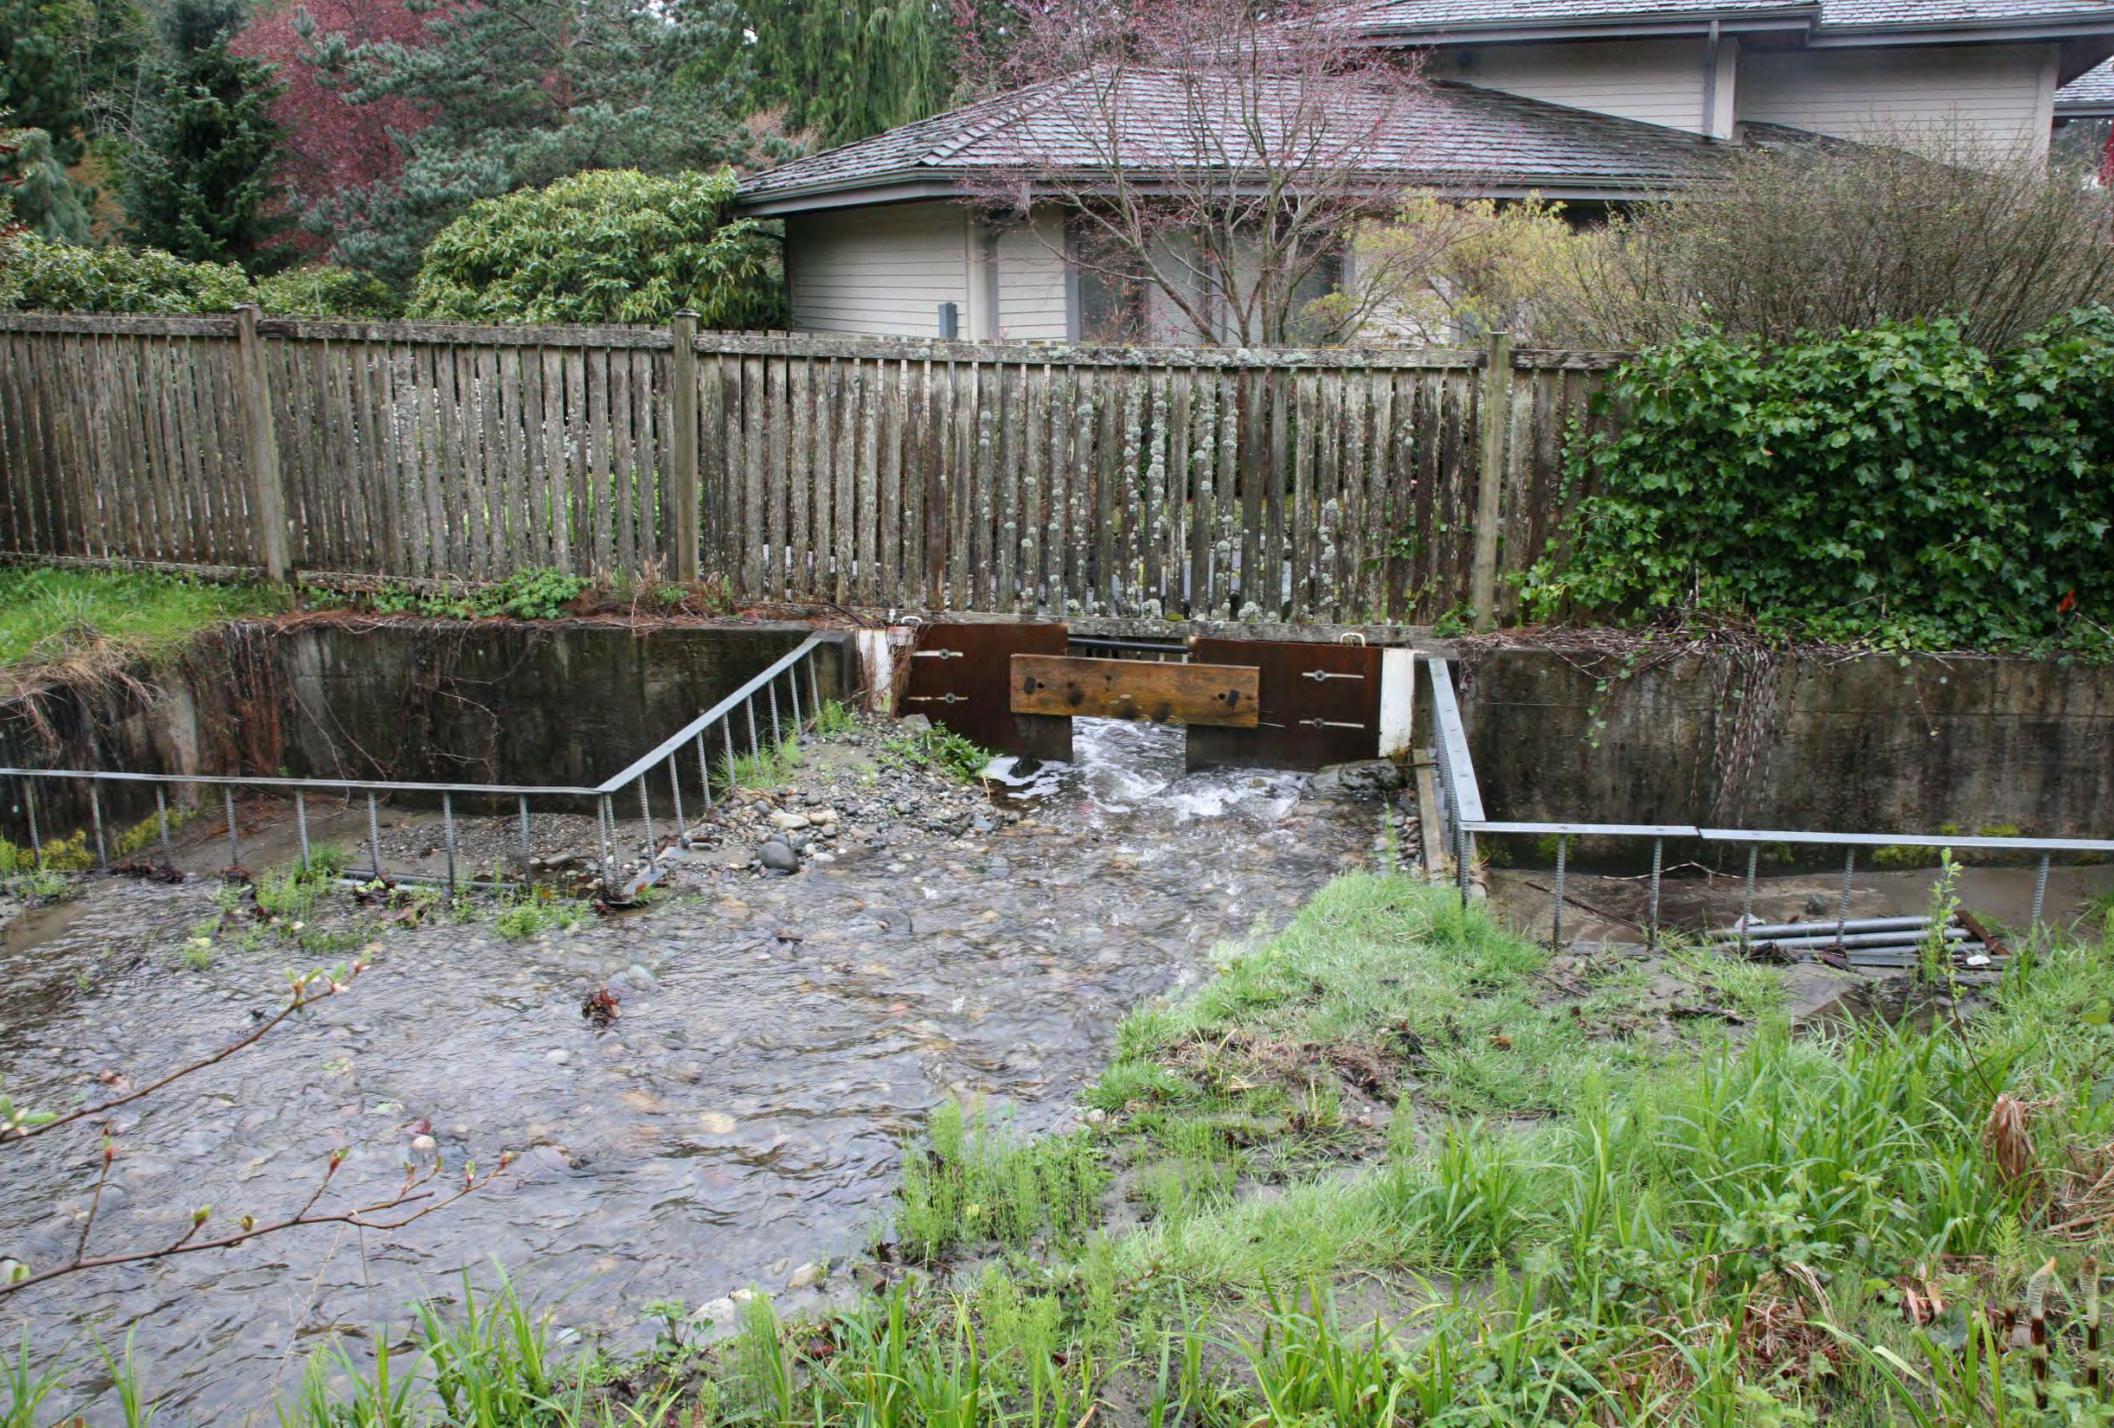
Flow Splitter & Weir look south at 8235 Talbot Road property, installed circa 1998.

Installed in an AE *high risk* zoned floodplain to prevent flooding from homes constructed in a high danger flood area, approved by the City of Edmonds.

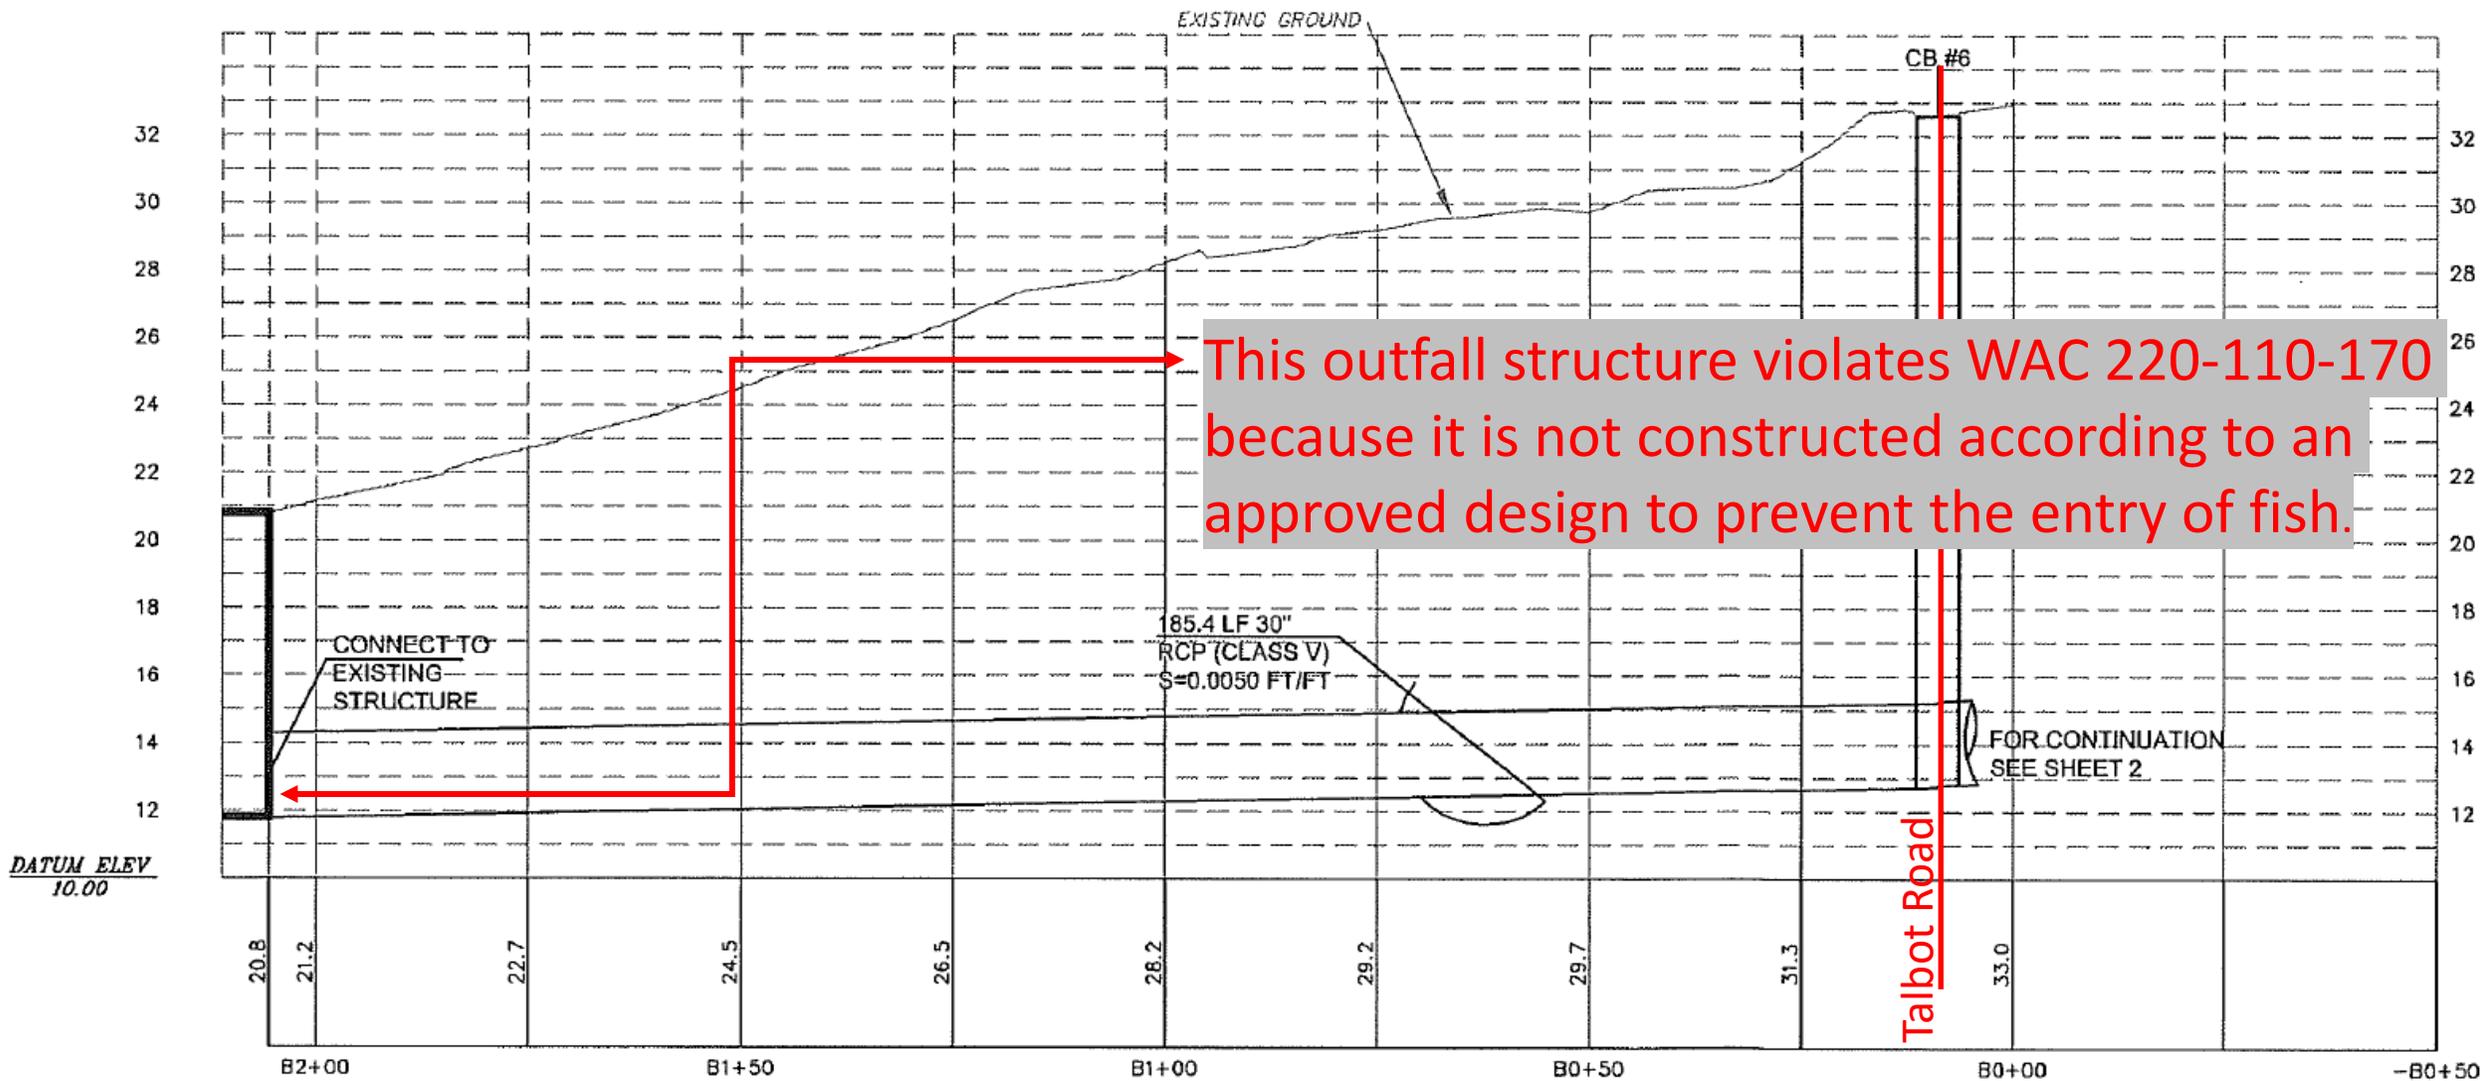
This outfall structure violates WAC 220-110-170 because it is not constructed according to an approved design to prevent the entry of fish.

In 2012, the City installed a 30-inch pipe from Talbot Road to the flow splitter, diverting even more flow under the BNSF tracks. The basin study or hydraulic calculations produced were inadequate and did not show that the pipes under the BNSF tracks could accommodate this additional flow or prevent fish entry.

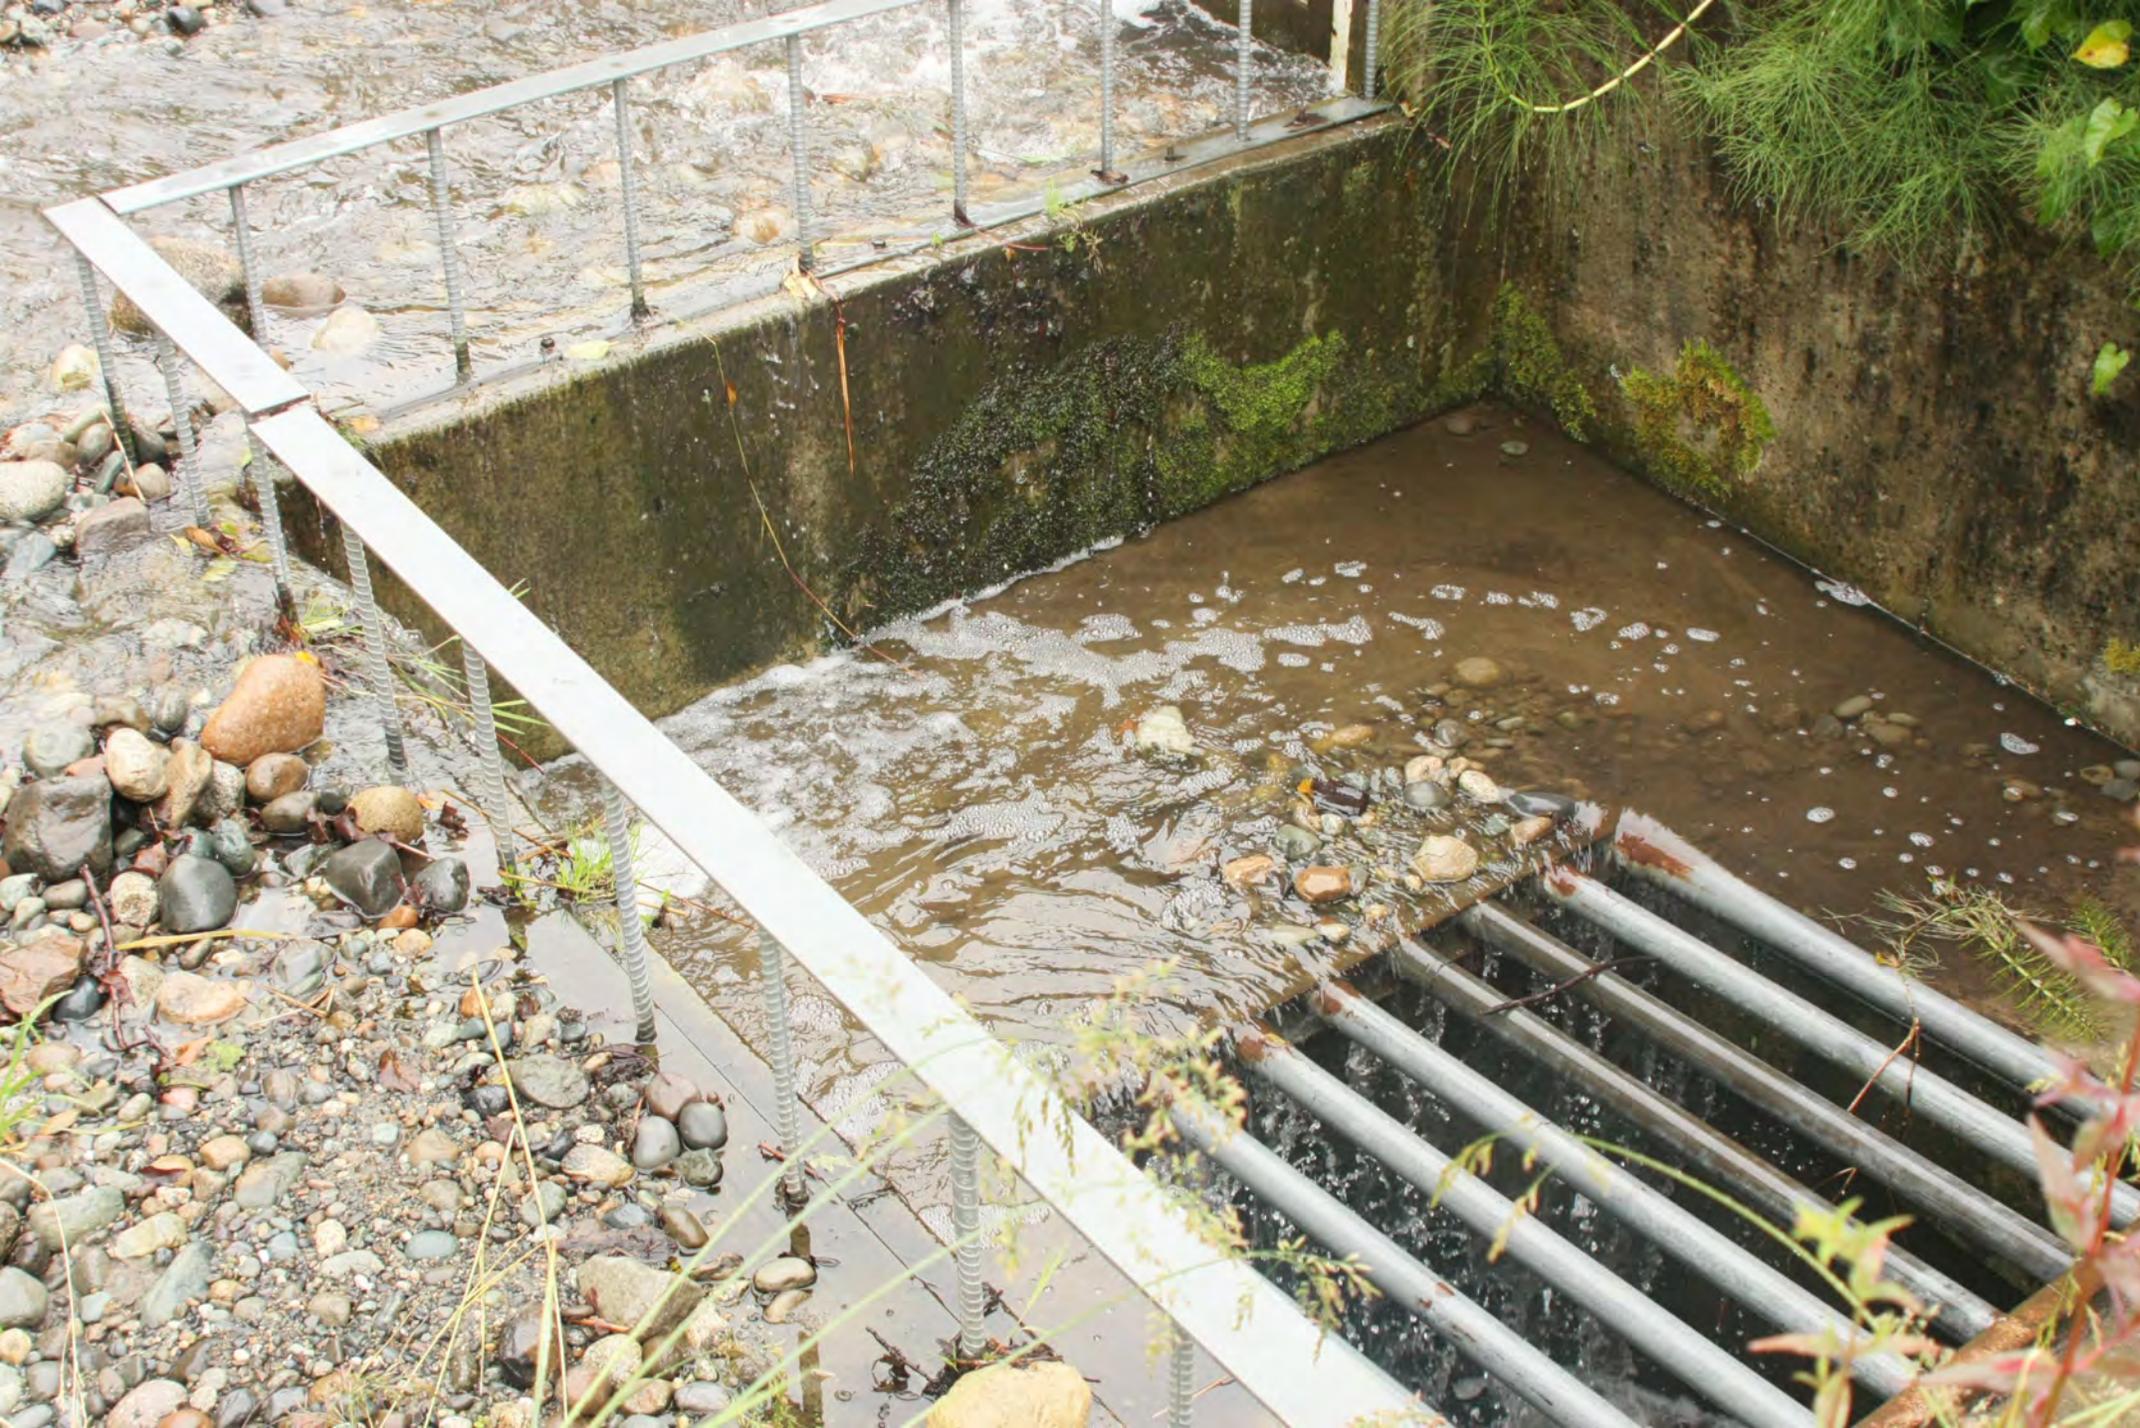
Grate in Flow Splitter diverts flow to 30" culvert below.

Flow splitter is a fish barrier.

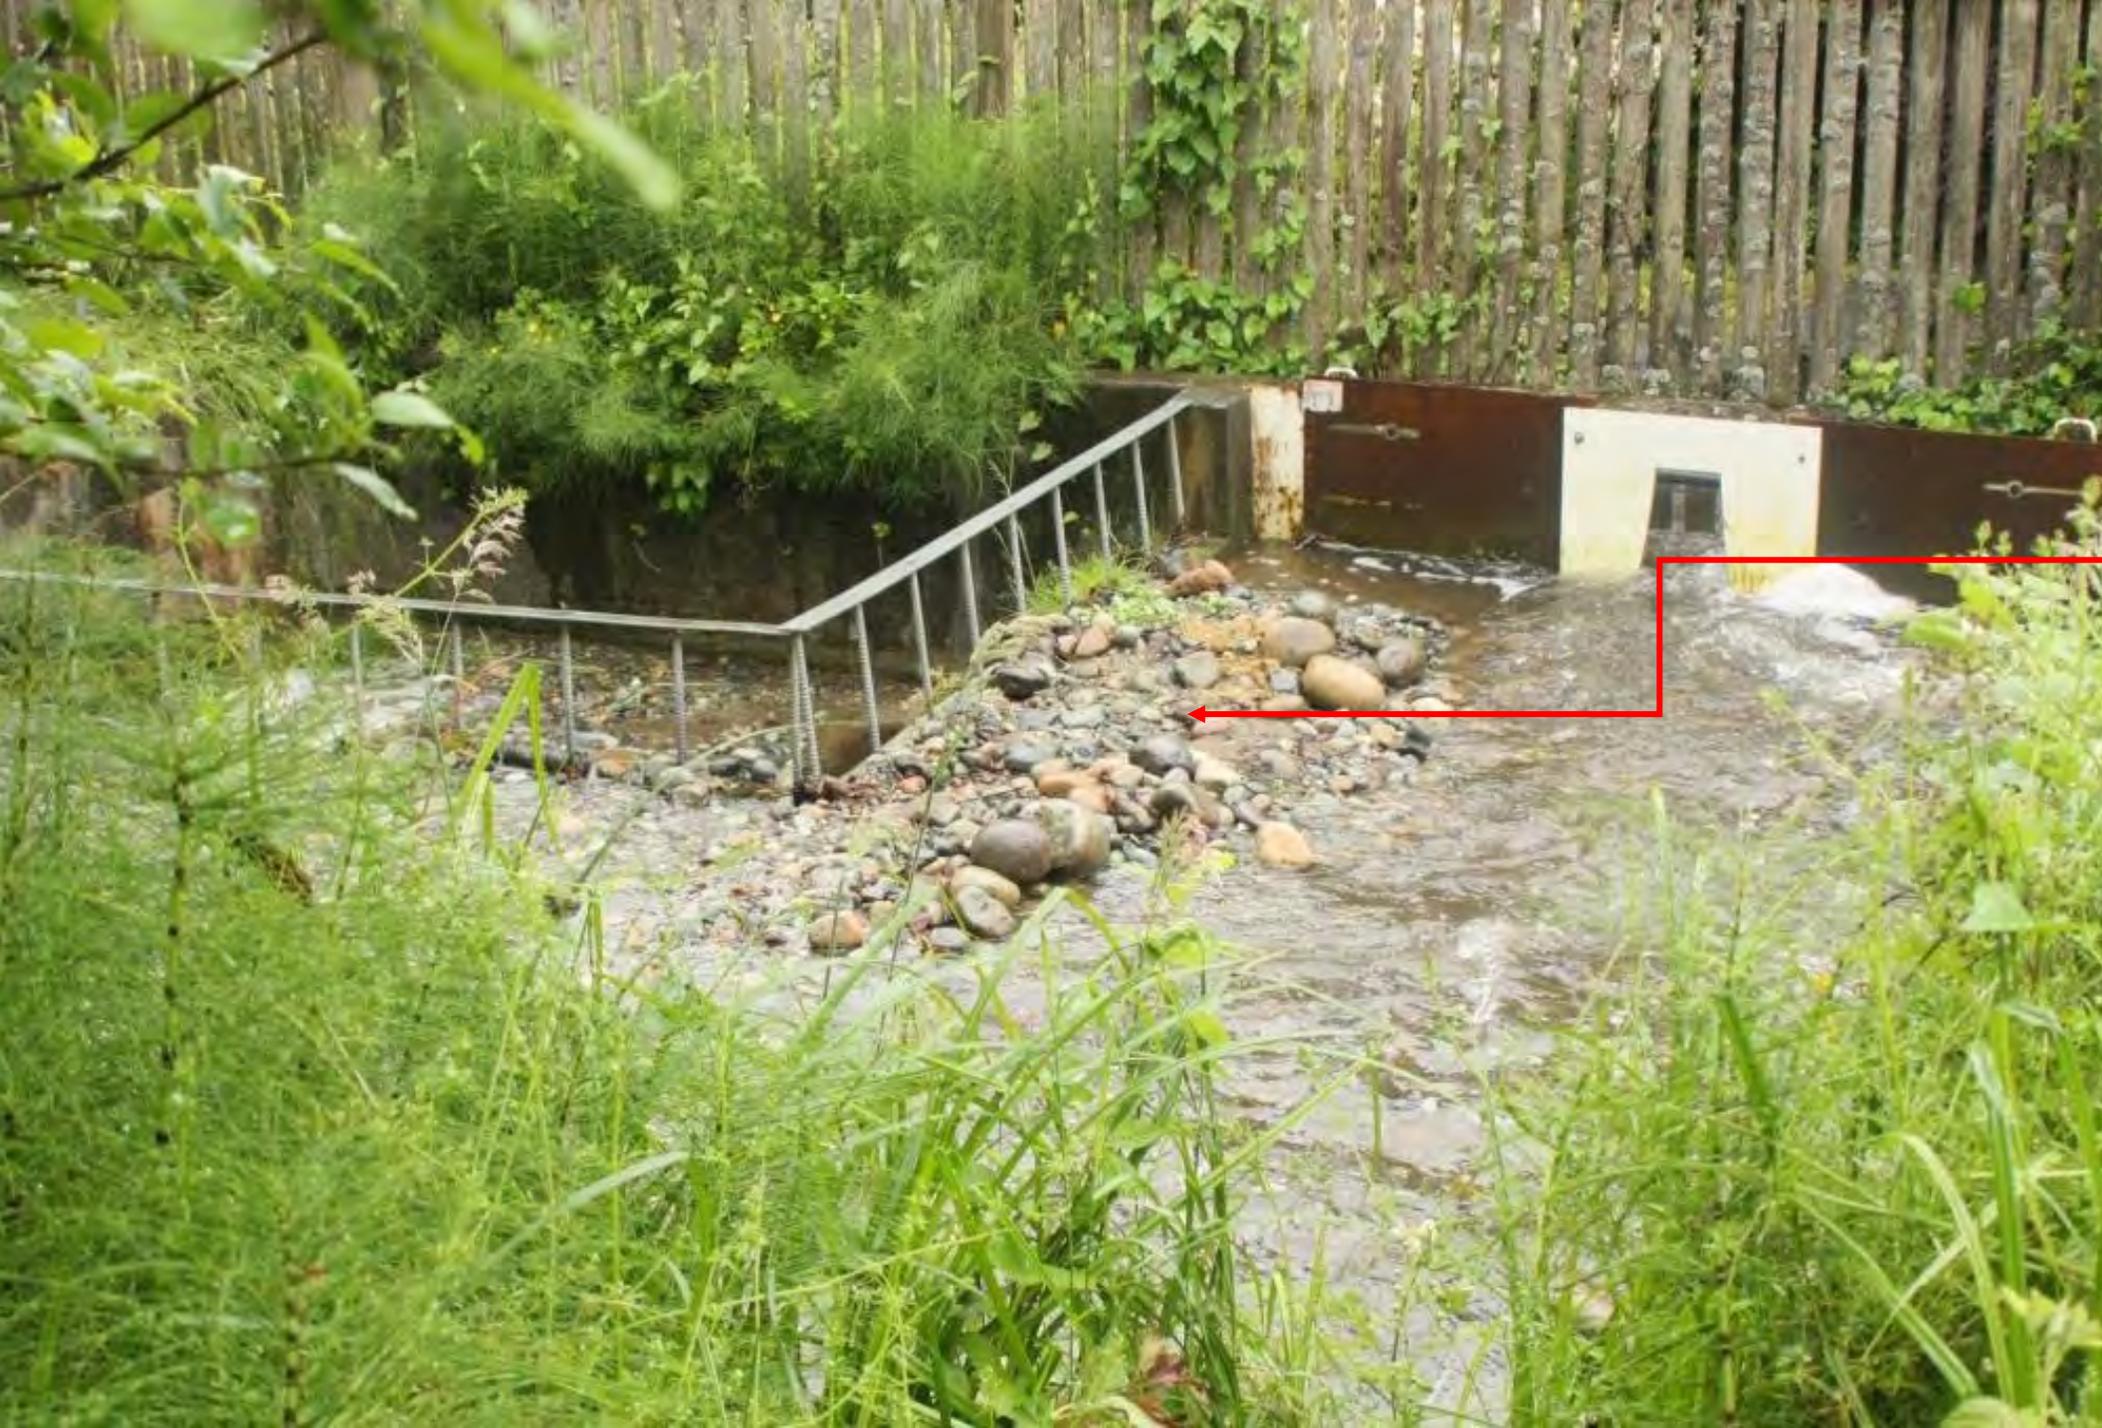
Sutro Weir has been installed.

Note rock/sediment accumulation.

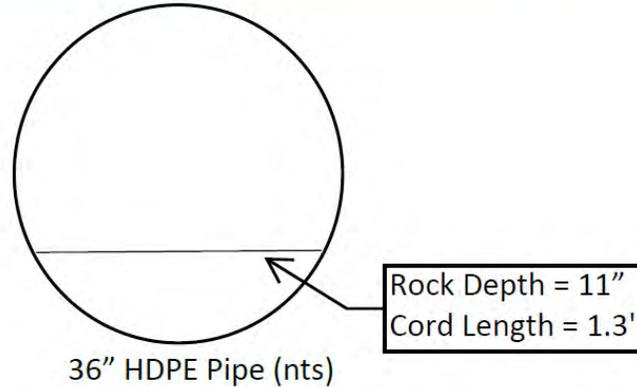
Per Lider Engineering calculations, the partially clogged culvert can only convey approx. 33.3-cubic feet per second. These calculations were furnished to the City on September 27, 2023, but have been subsequently ignored.

This is just sufficient to convey the 30.5 cfs, 100-year flow added by the City in 2012.
