SUBJECT: Notice of Appeal, DNS decision dated May 14, 2024
8229 – Talbot Road, Edmonds, WA
Continued Maintenance of Fish-Killing Flow Splitter
File No.: PLN2024-0020

Dithering = Disaster

Perrinville Creek
Failed Culverts and Flow
Splitter threaten BNSF Rail
Tracks,
Puget Sound
Edmonds, WA

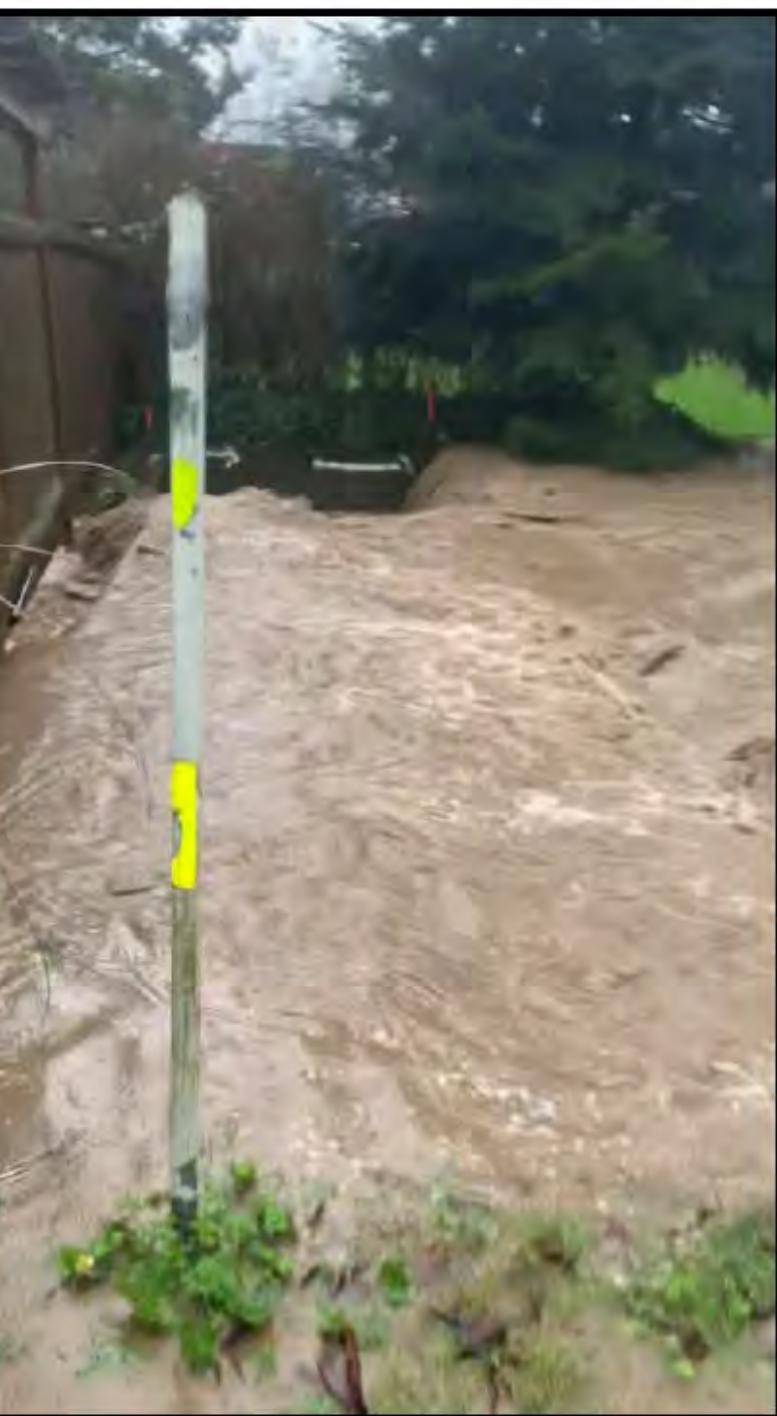
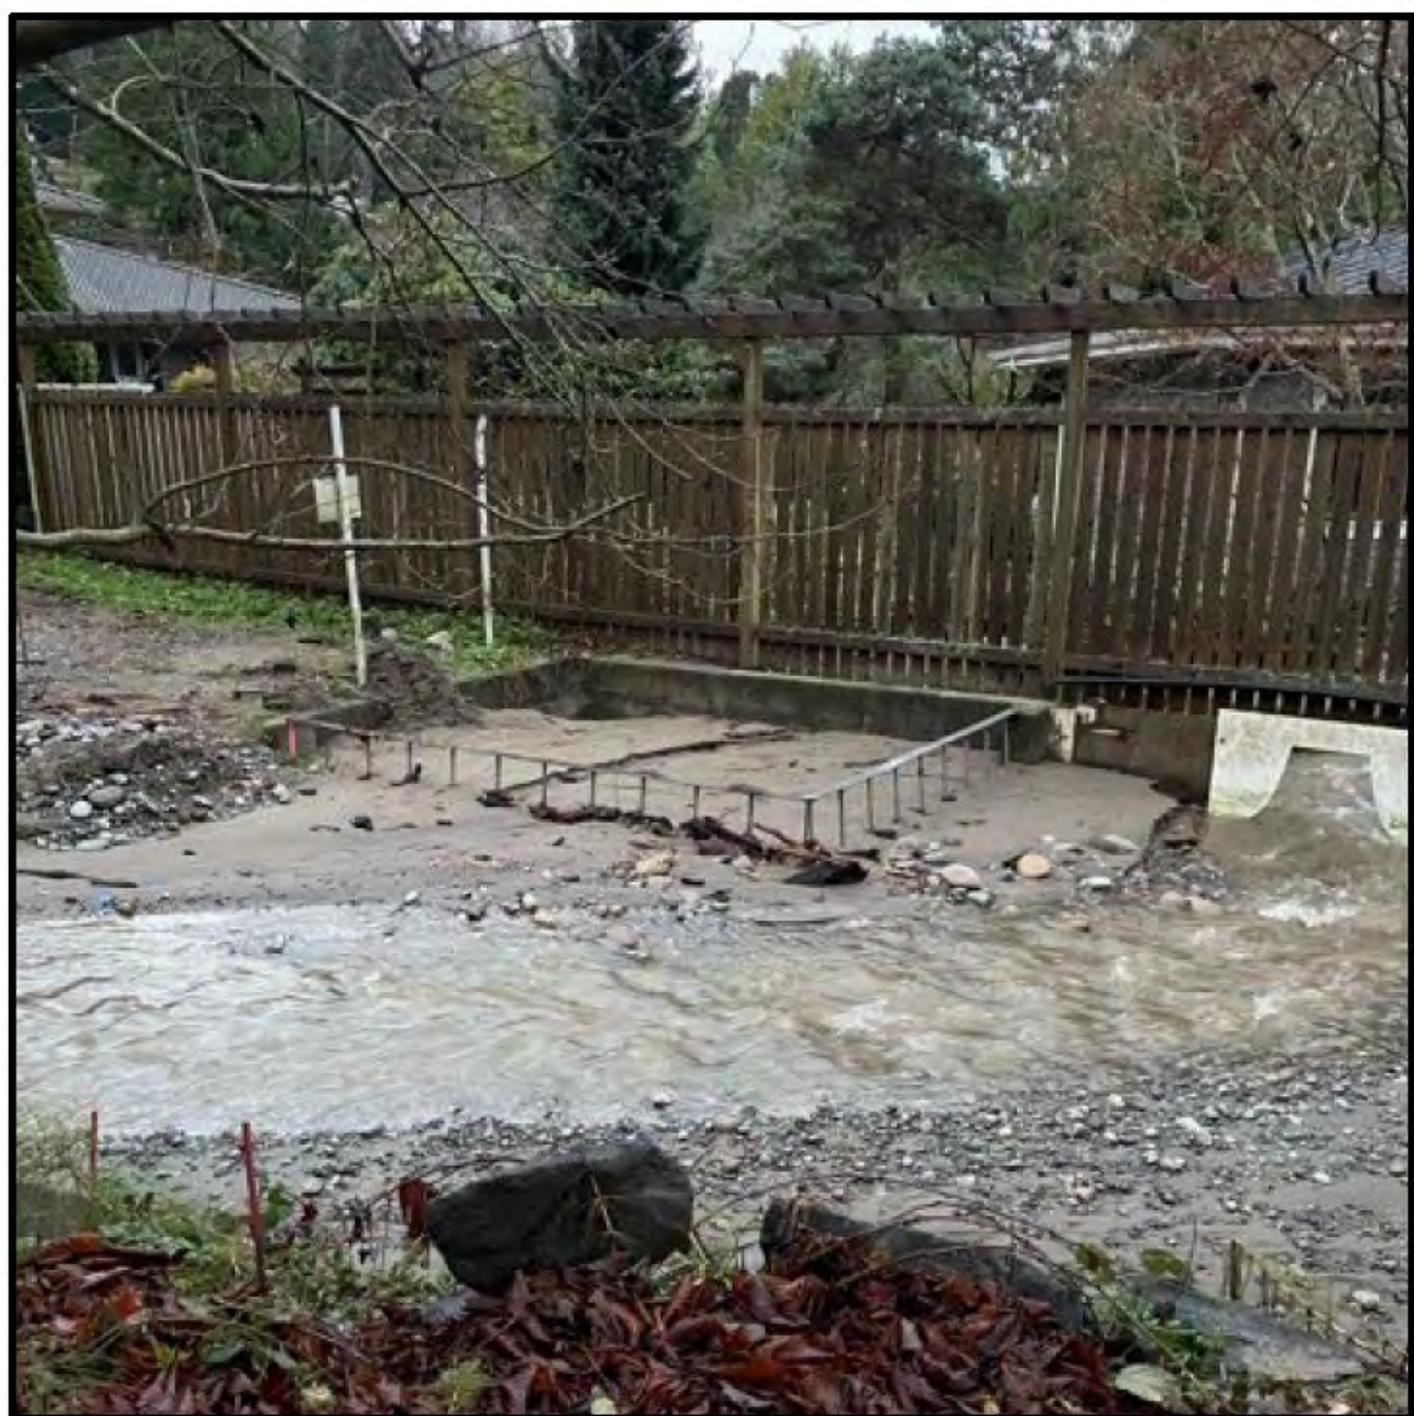
Dec. 2020
Storm: Flow
Splitter
clogged with
mud.

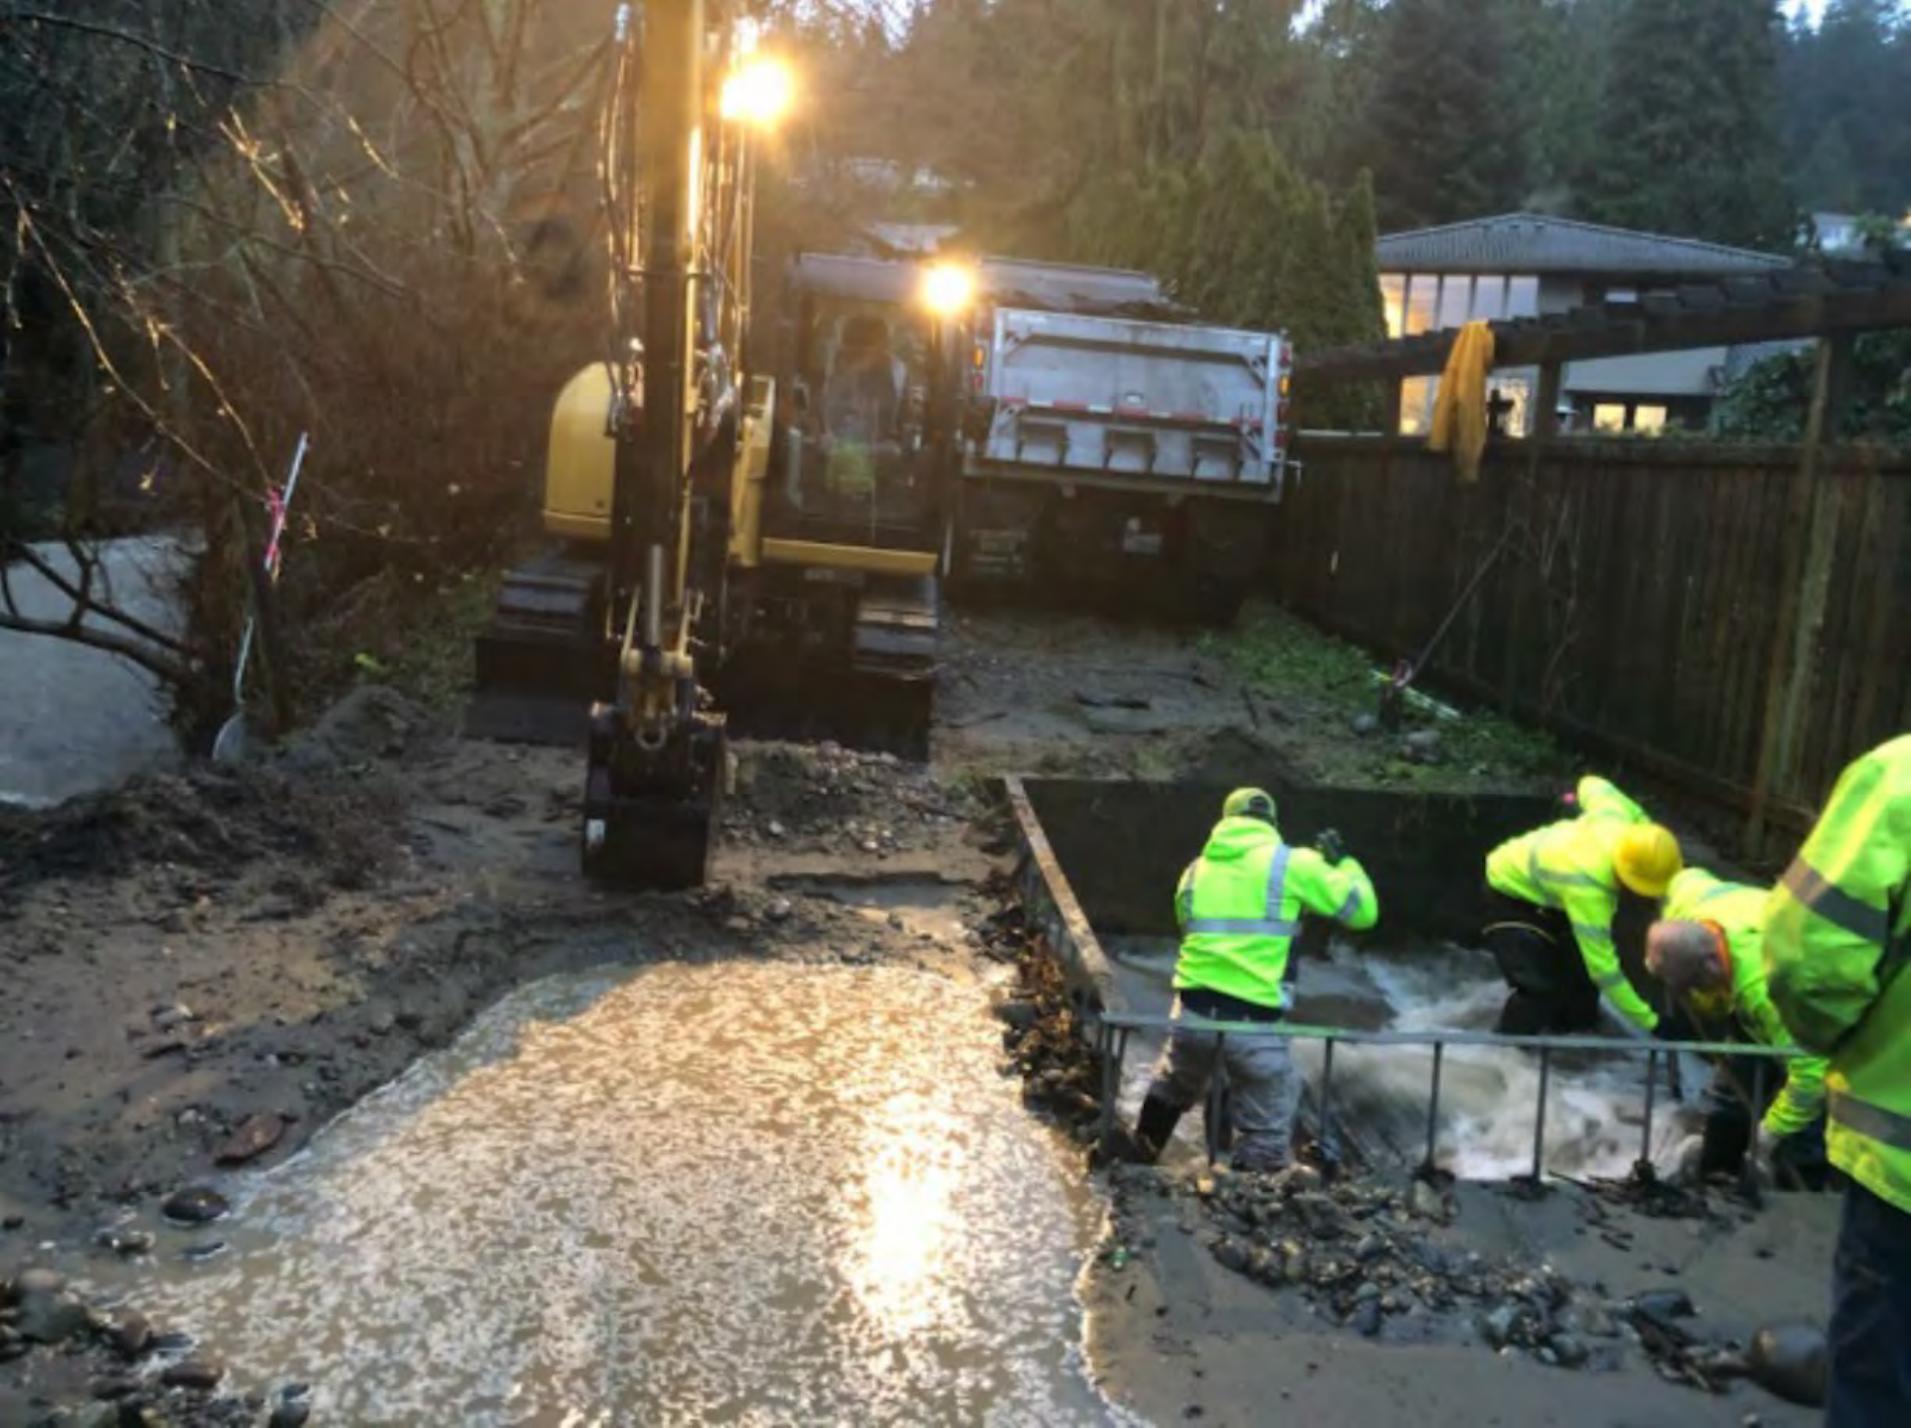
City of Edmonds
Maintenance crews
December 21, 2020,
working through the night
to clean rock from the flow
splitter to prevent a track
washout.

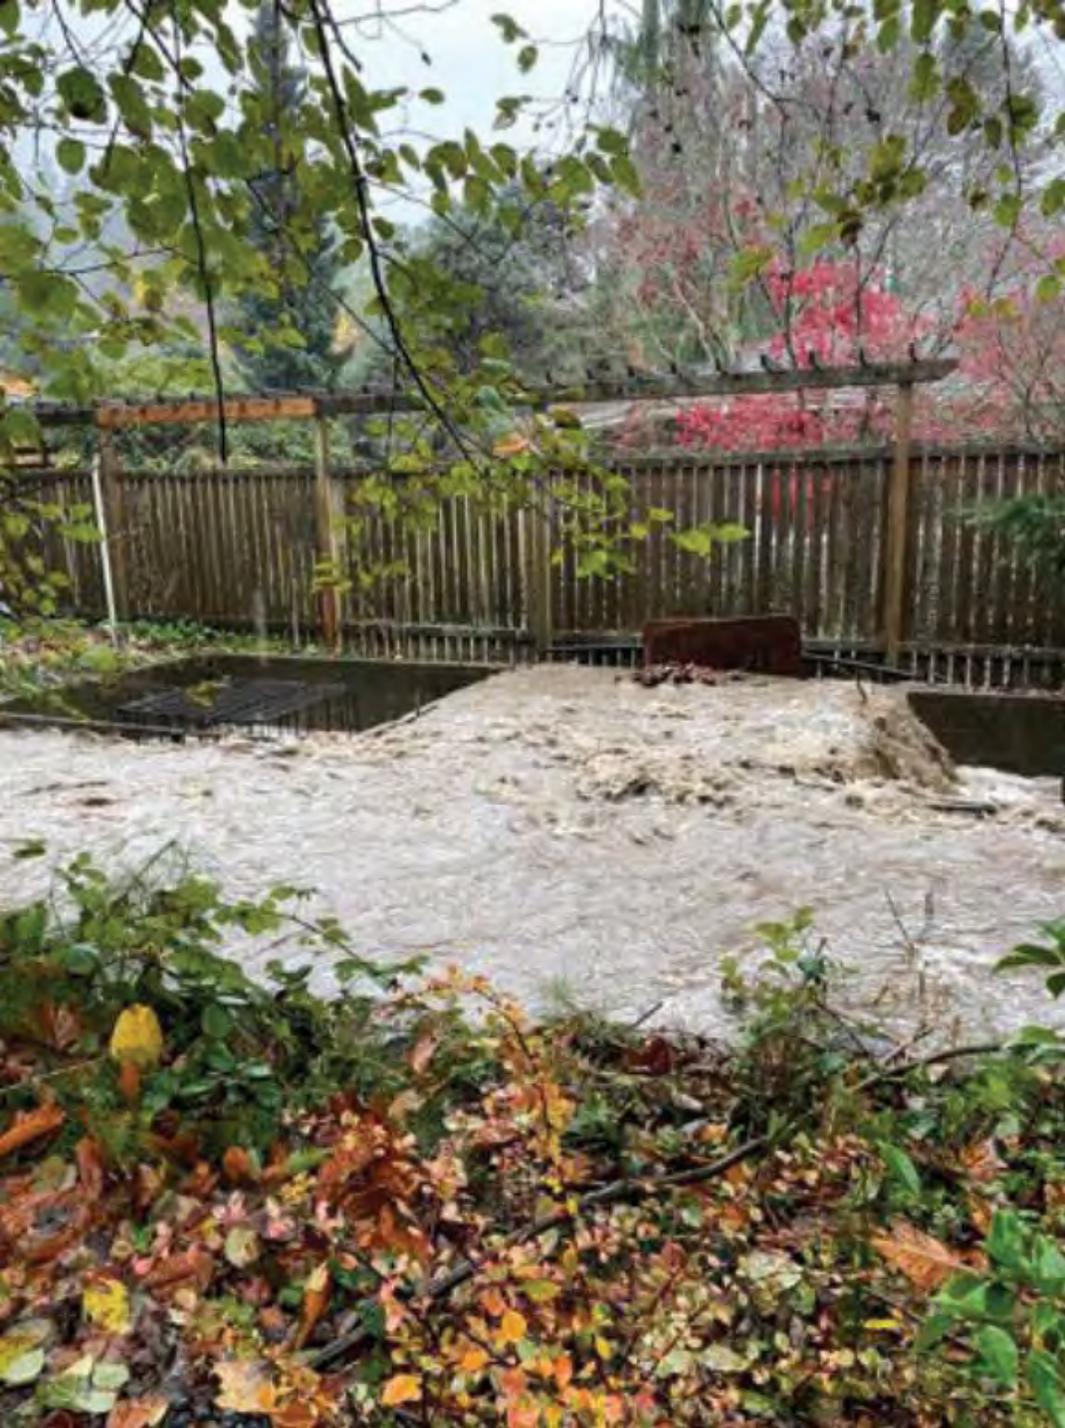
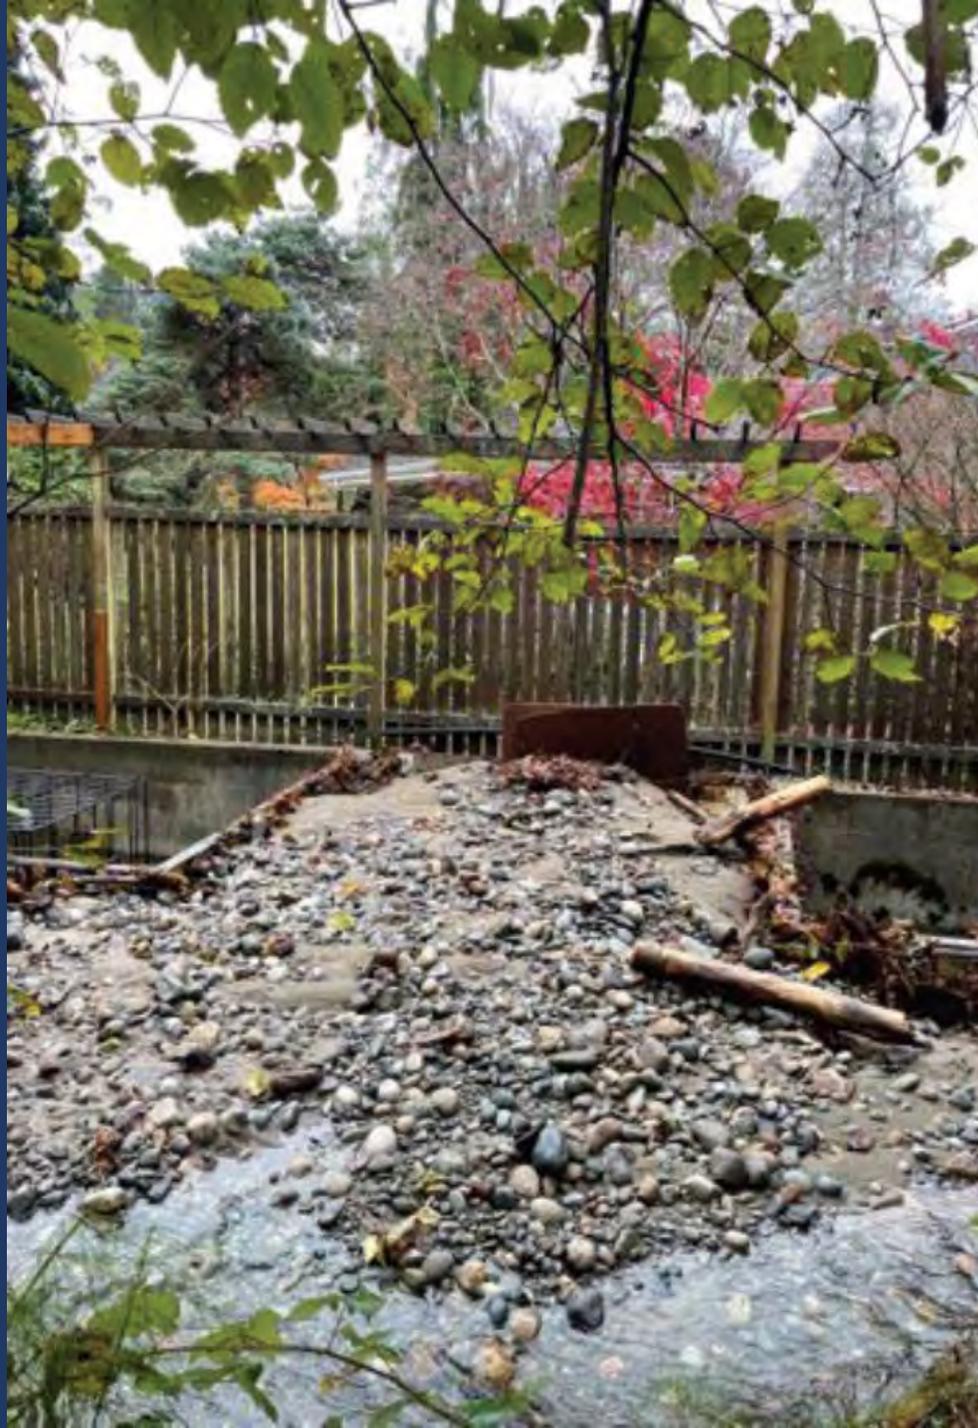
November 2021, with approx. 1-inch of rain, or a 6-month storm.

Flooding continues due to the City's fish killing flow splitter and undersized culverts.

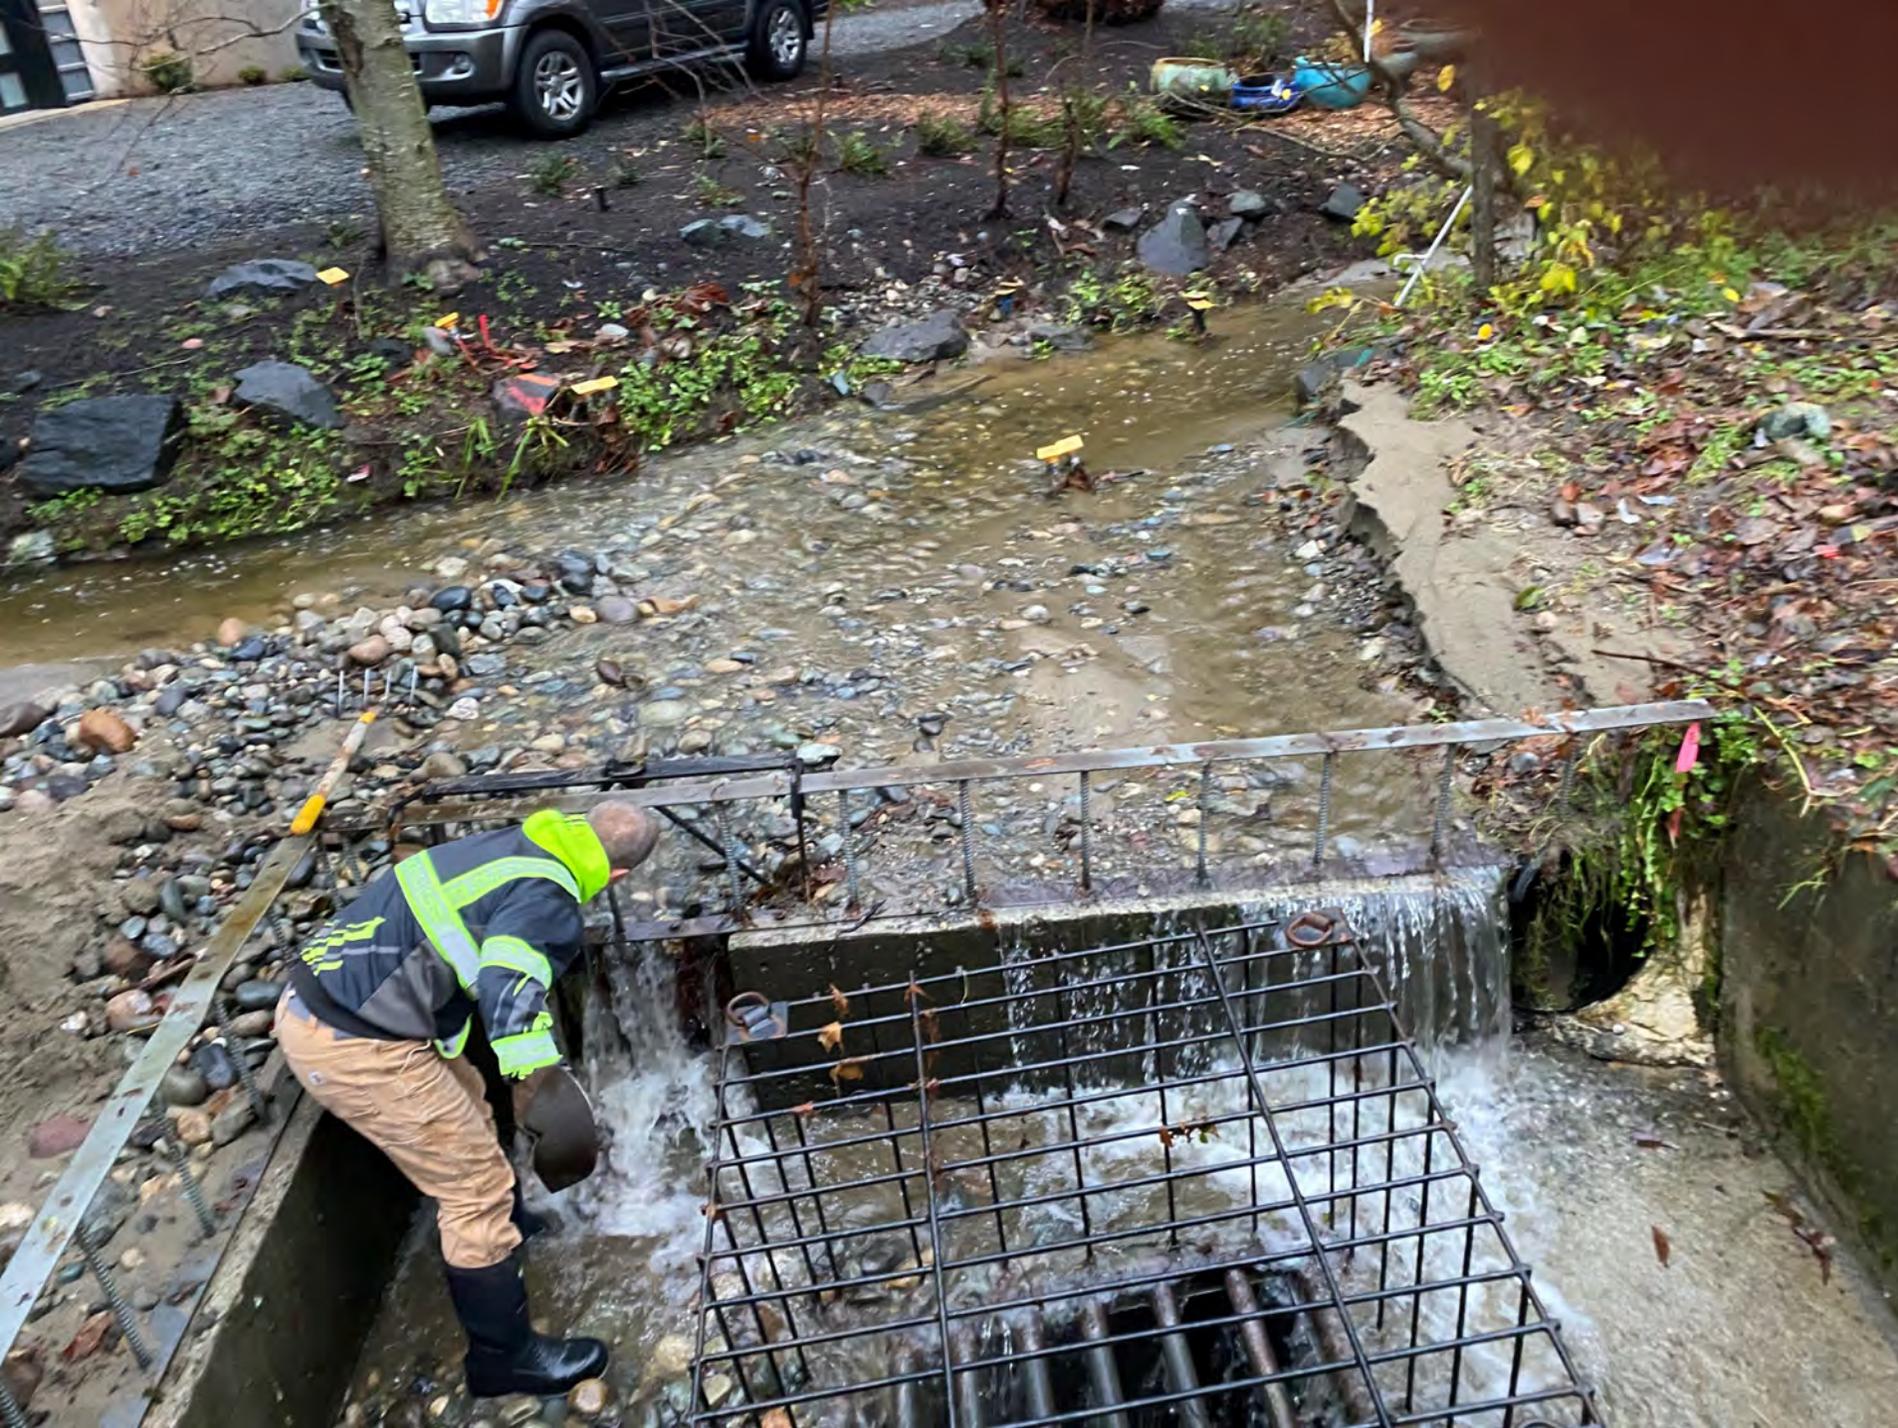
City of Edmonds Maintenance worker removing rock and sediment from fish killing flow splitter, December 6, 2023

This work is now illegal, as of Feb. 14, 2024, without an HPA.

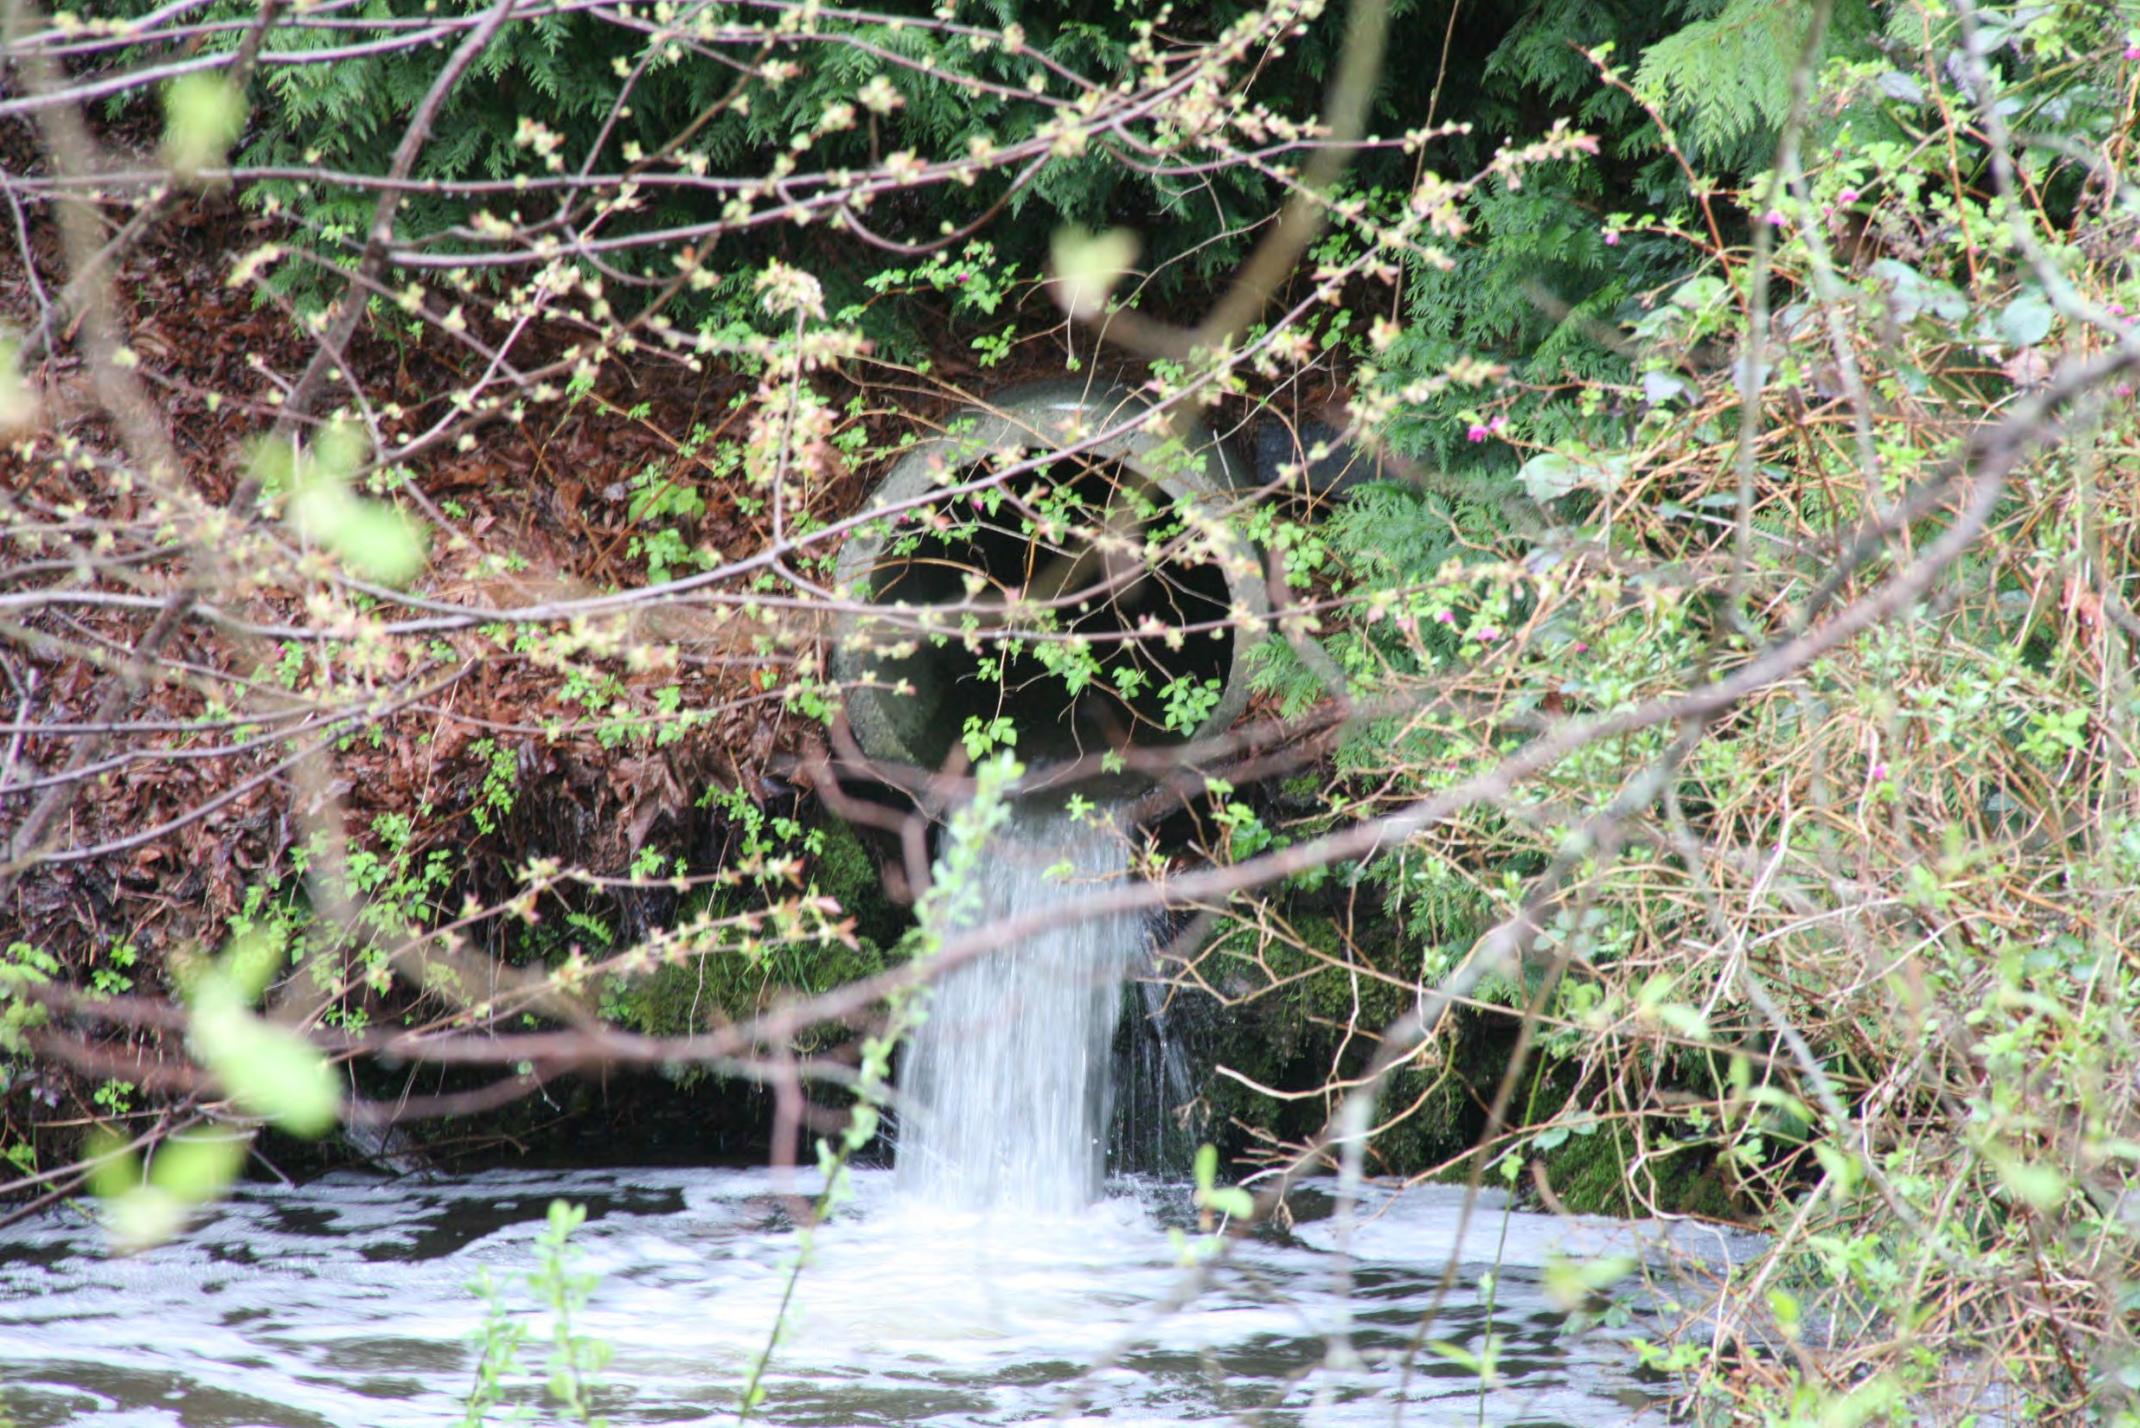
The outfall from Talbot Road culvert, Perrinville Creek is a barrier to fish passage.

Fish passage can be restored by removing the culvert and constructing a bridge to span Perrinville Creek.

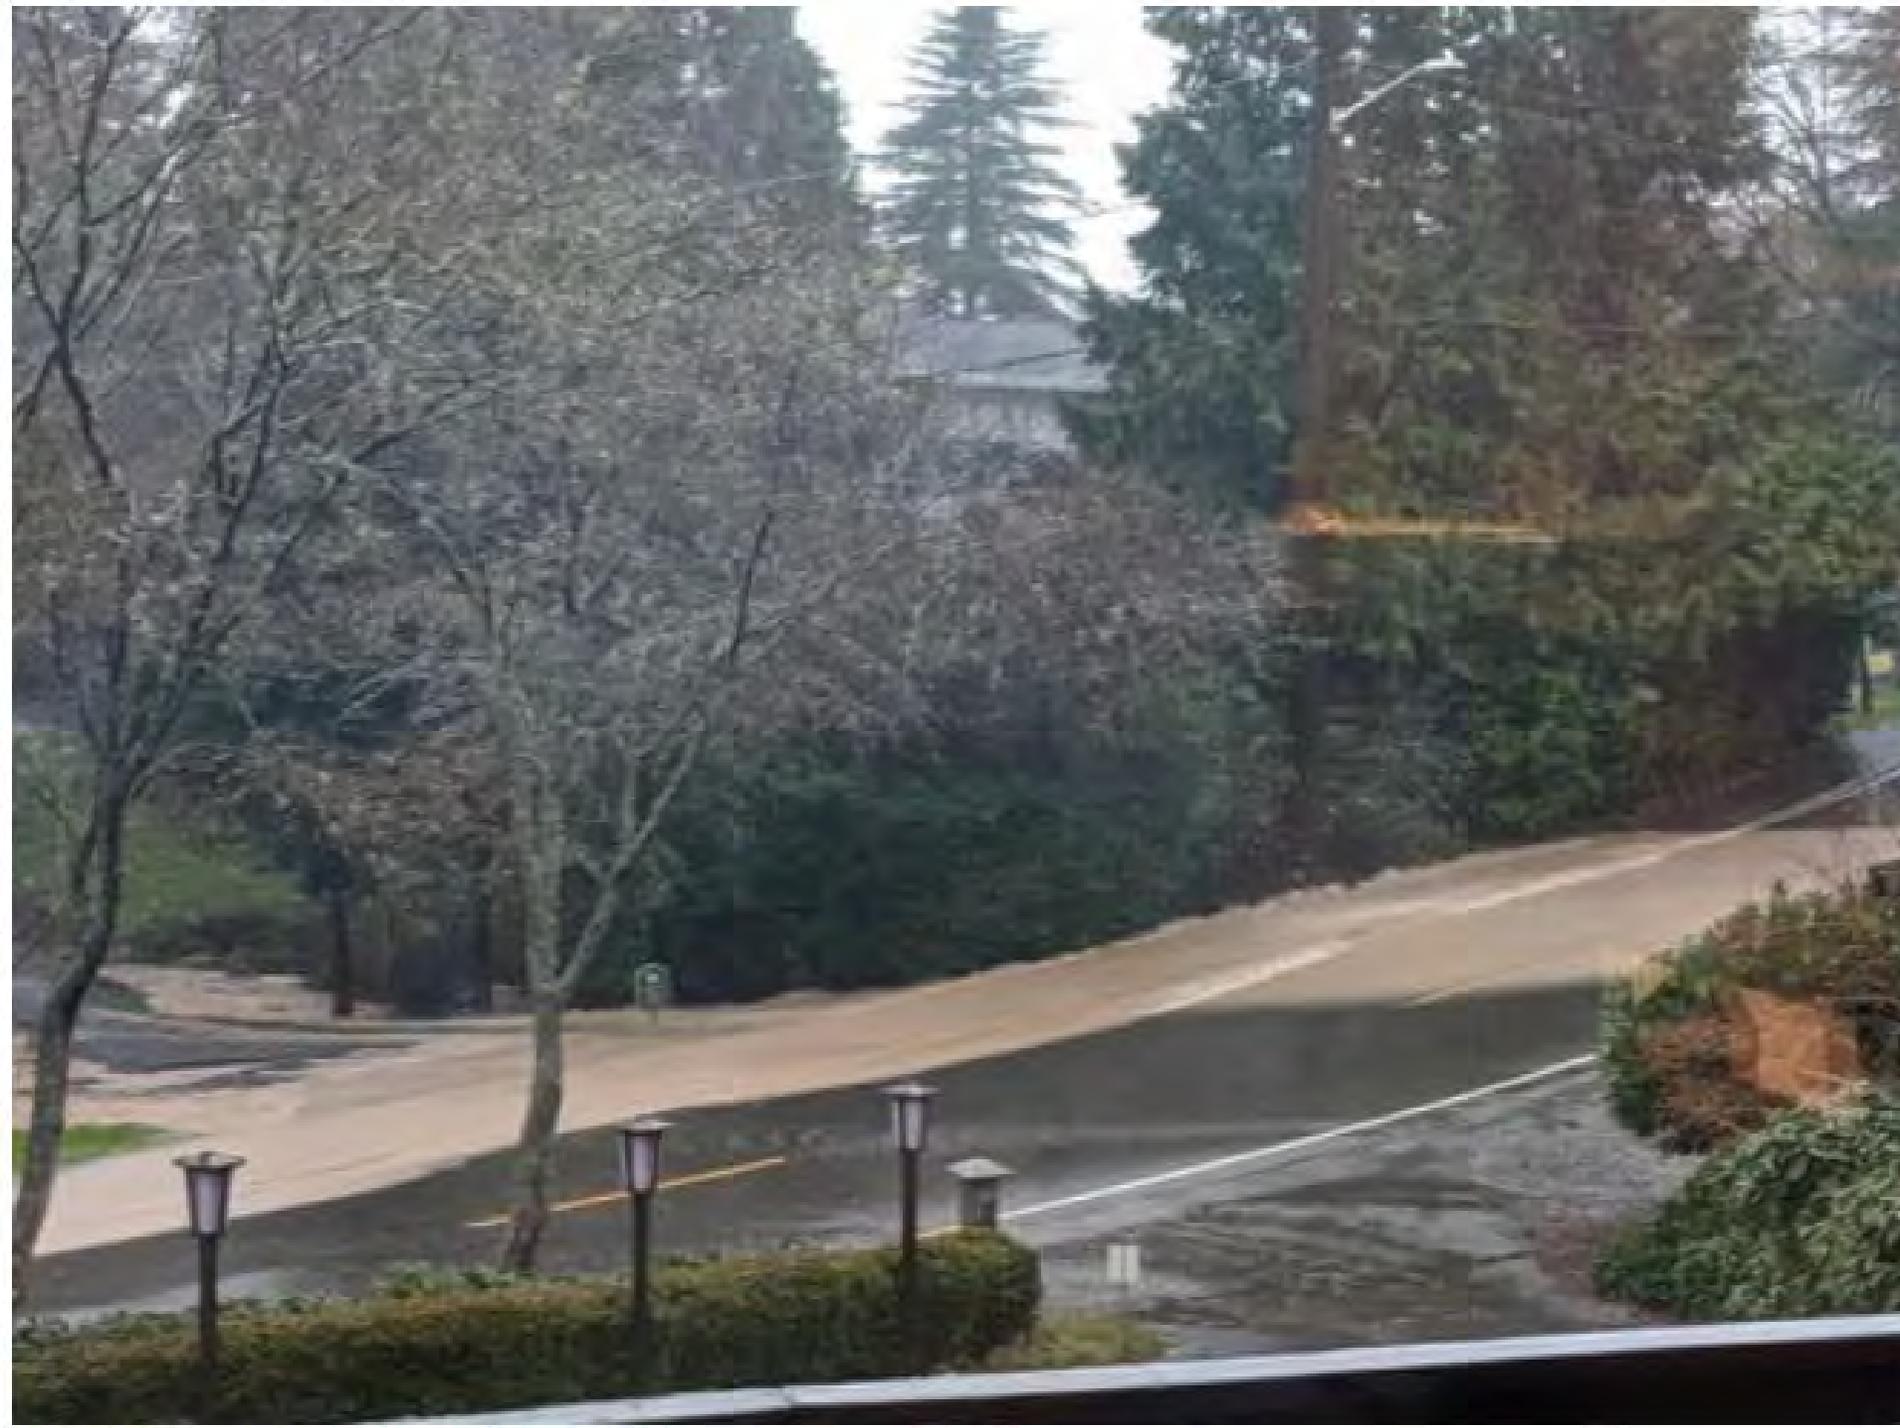
UNDERSIZED TALBOT ROAD CULVERT

Talbot Road culvert overtopped by Perrinville Creek flow, December 21, 2020 with 1.98-inches of rainfall.
