SUBJECT: Notice of Appeal, DNS decision dated May 14, 2024
8229 – Talbot Road, Edmonds, WA
Continued Maintenance of Fish-Killing Flow Splitter
File No.: PLN2024-0020

Dithering = Disaster

Perrinville Creek
Failed Culverts and Flow
Splitter threaten BNSF Rail
Tracks,
Puget Sound
Edmonds, WA

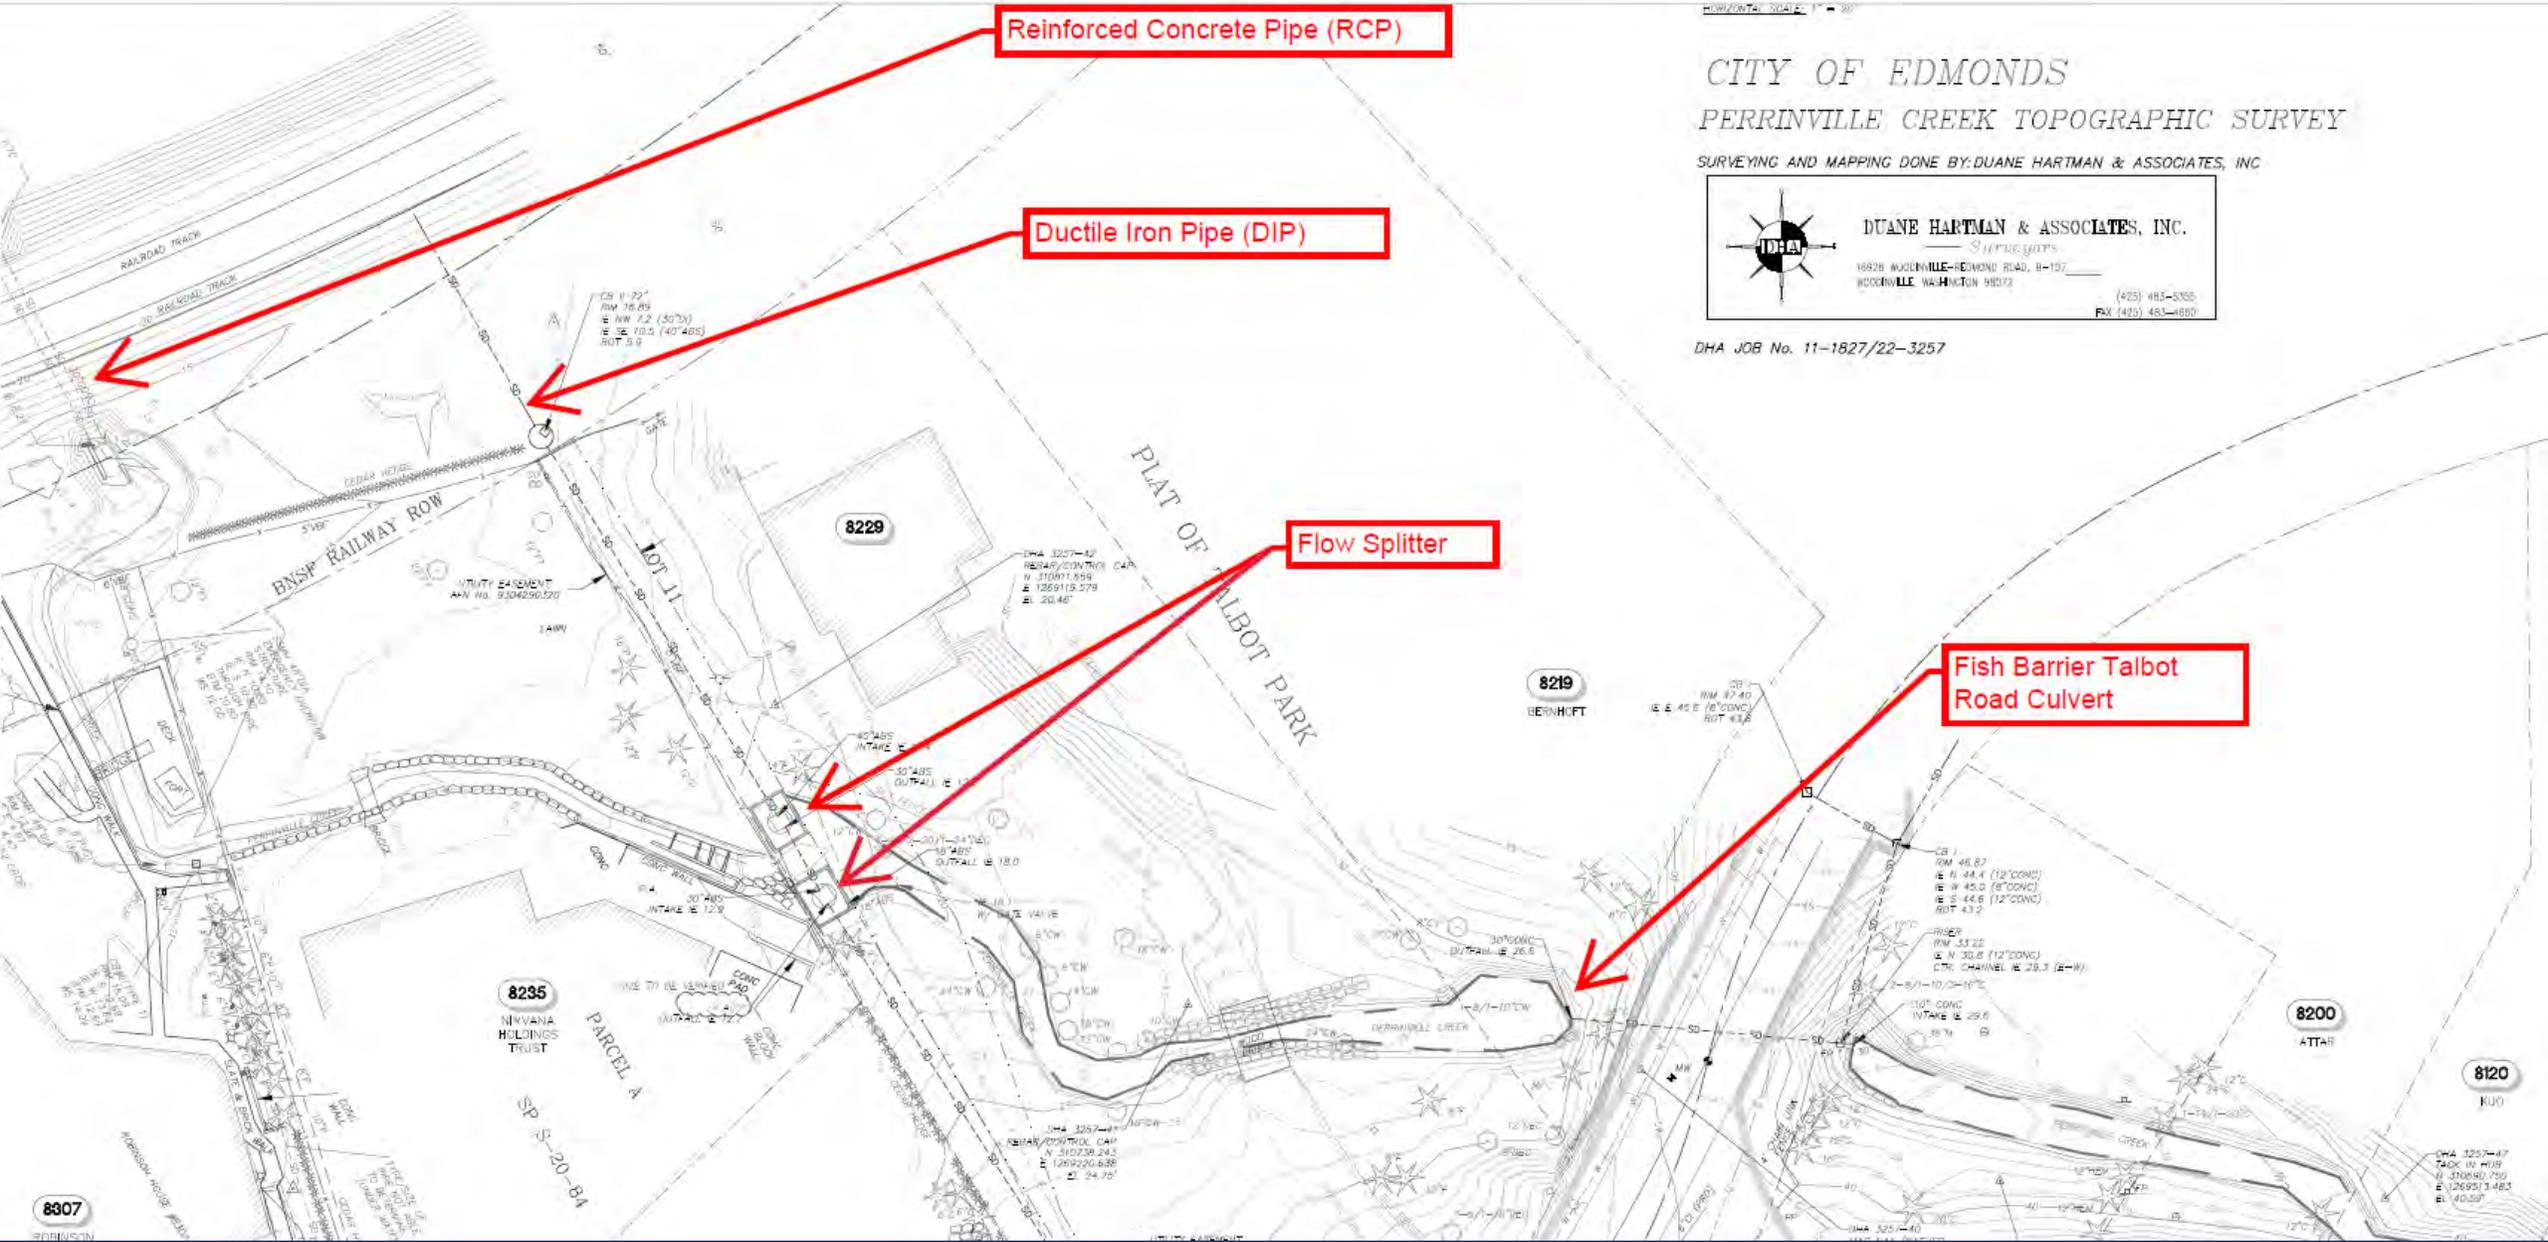
This *draft* Utility Topography Map, unsealed, undated, and with errors is the only plan produced by the Edmonds Public Works after nearly 2-years and \$900,000 approved by the Edmonds City Council

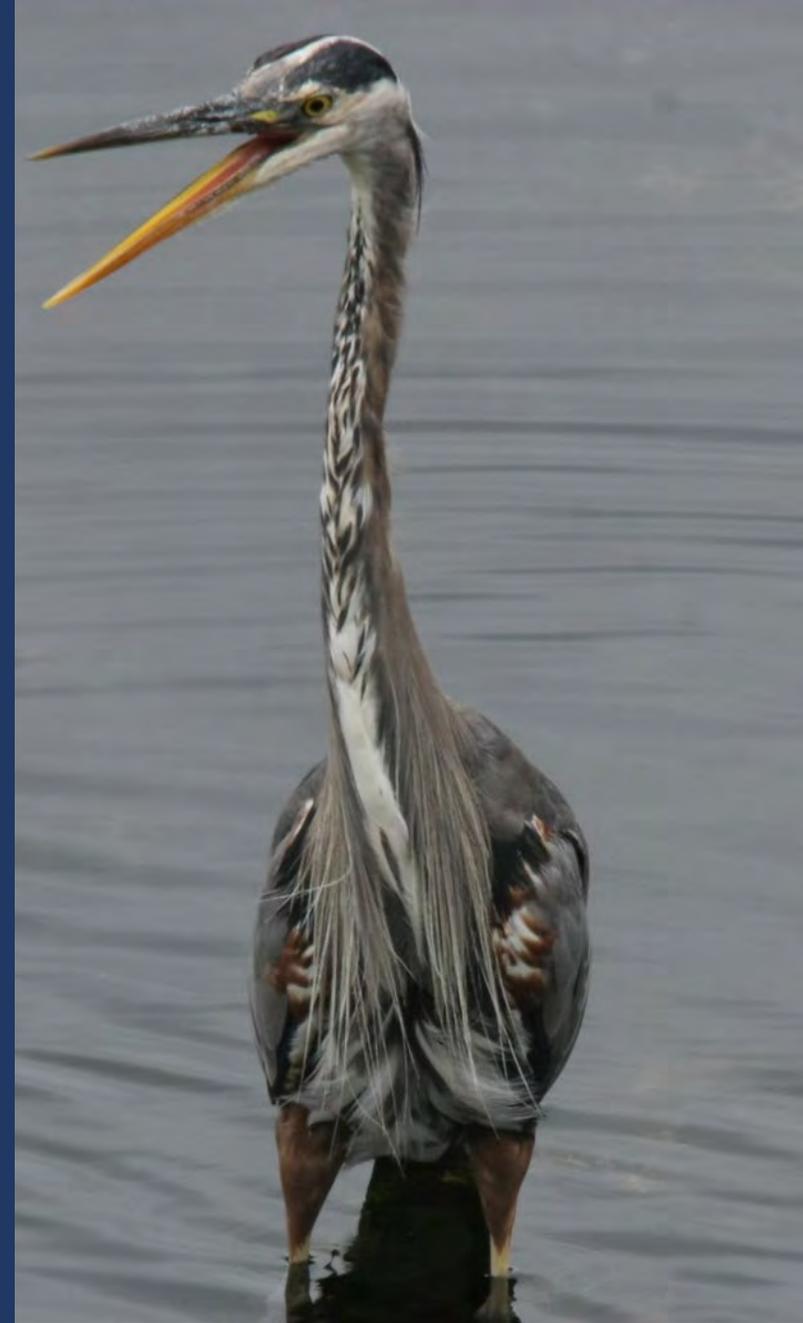
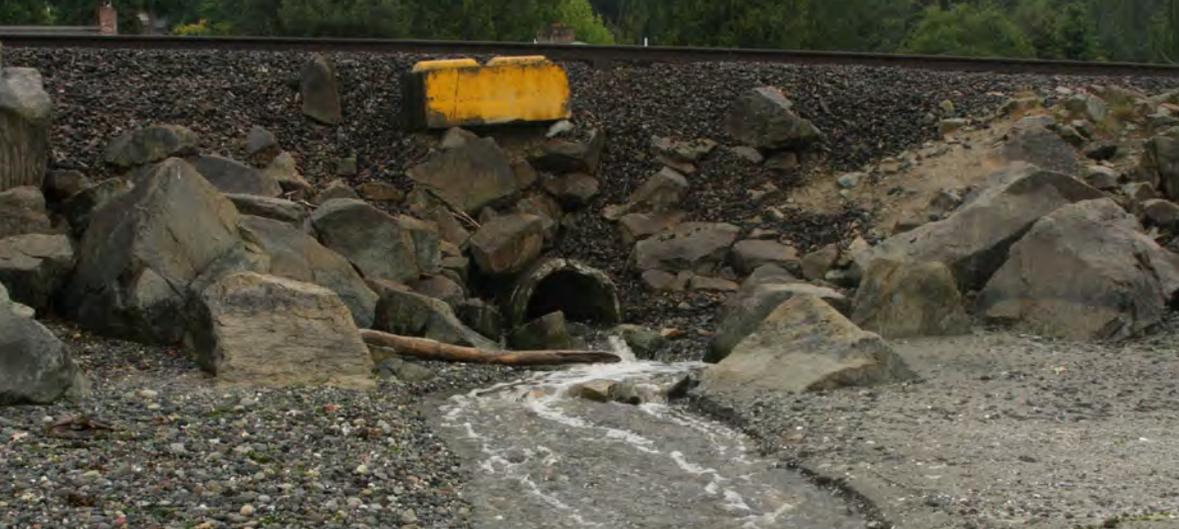
ISSUE 1: BNSF 30-INCH CONCRETE CULVERT

30" BNSF Culvert outfall
to Puget Sound over a
decade ago.

Culvert flowing half-full
in June is not a good
sign!

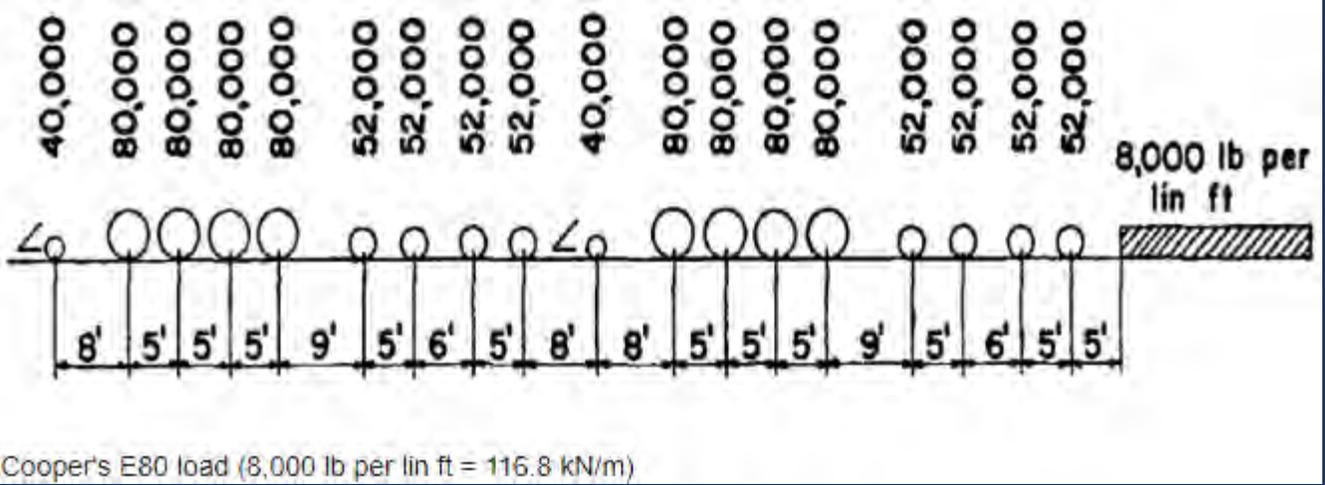
Proper pipe bedding is critical to distribute loads around the pipe. Pipe bedding is even more critical with railroad loads.

Railroad ballast rock is angular rock about the size of your fist and will put point loads on the pipe causing it to crack.

Cracking exposes pipe rebar to saltwater.

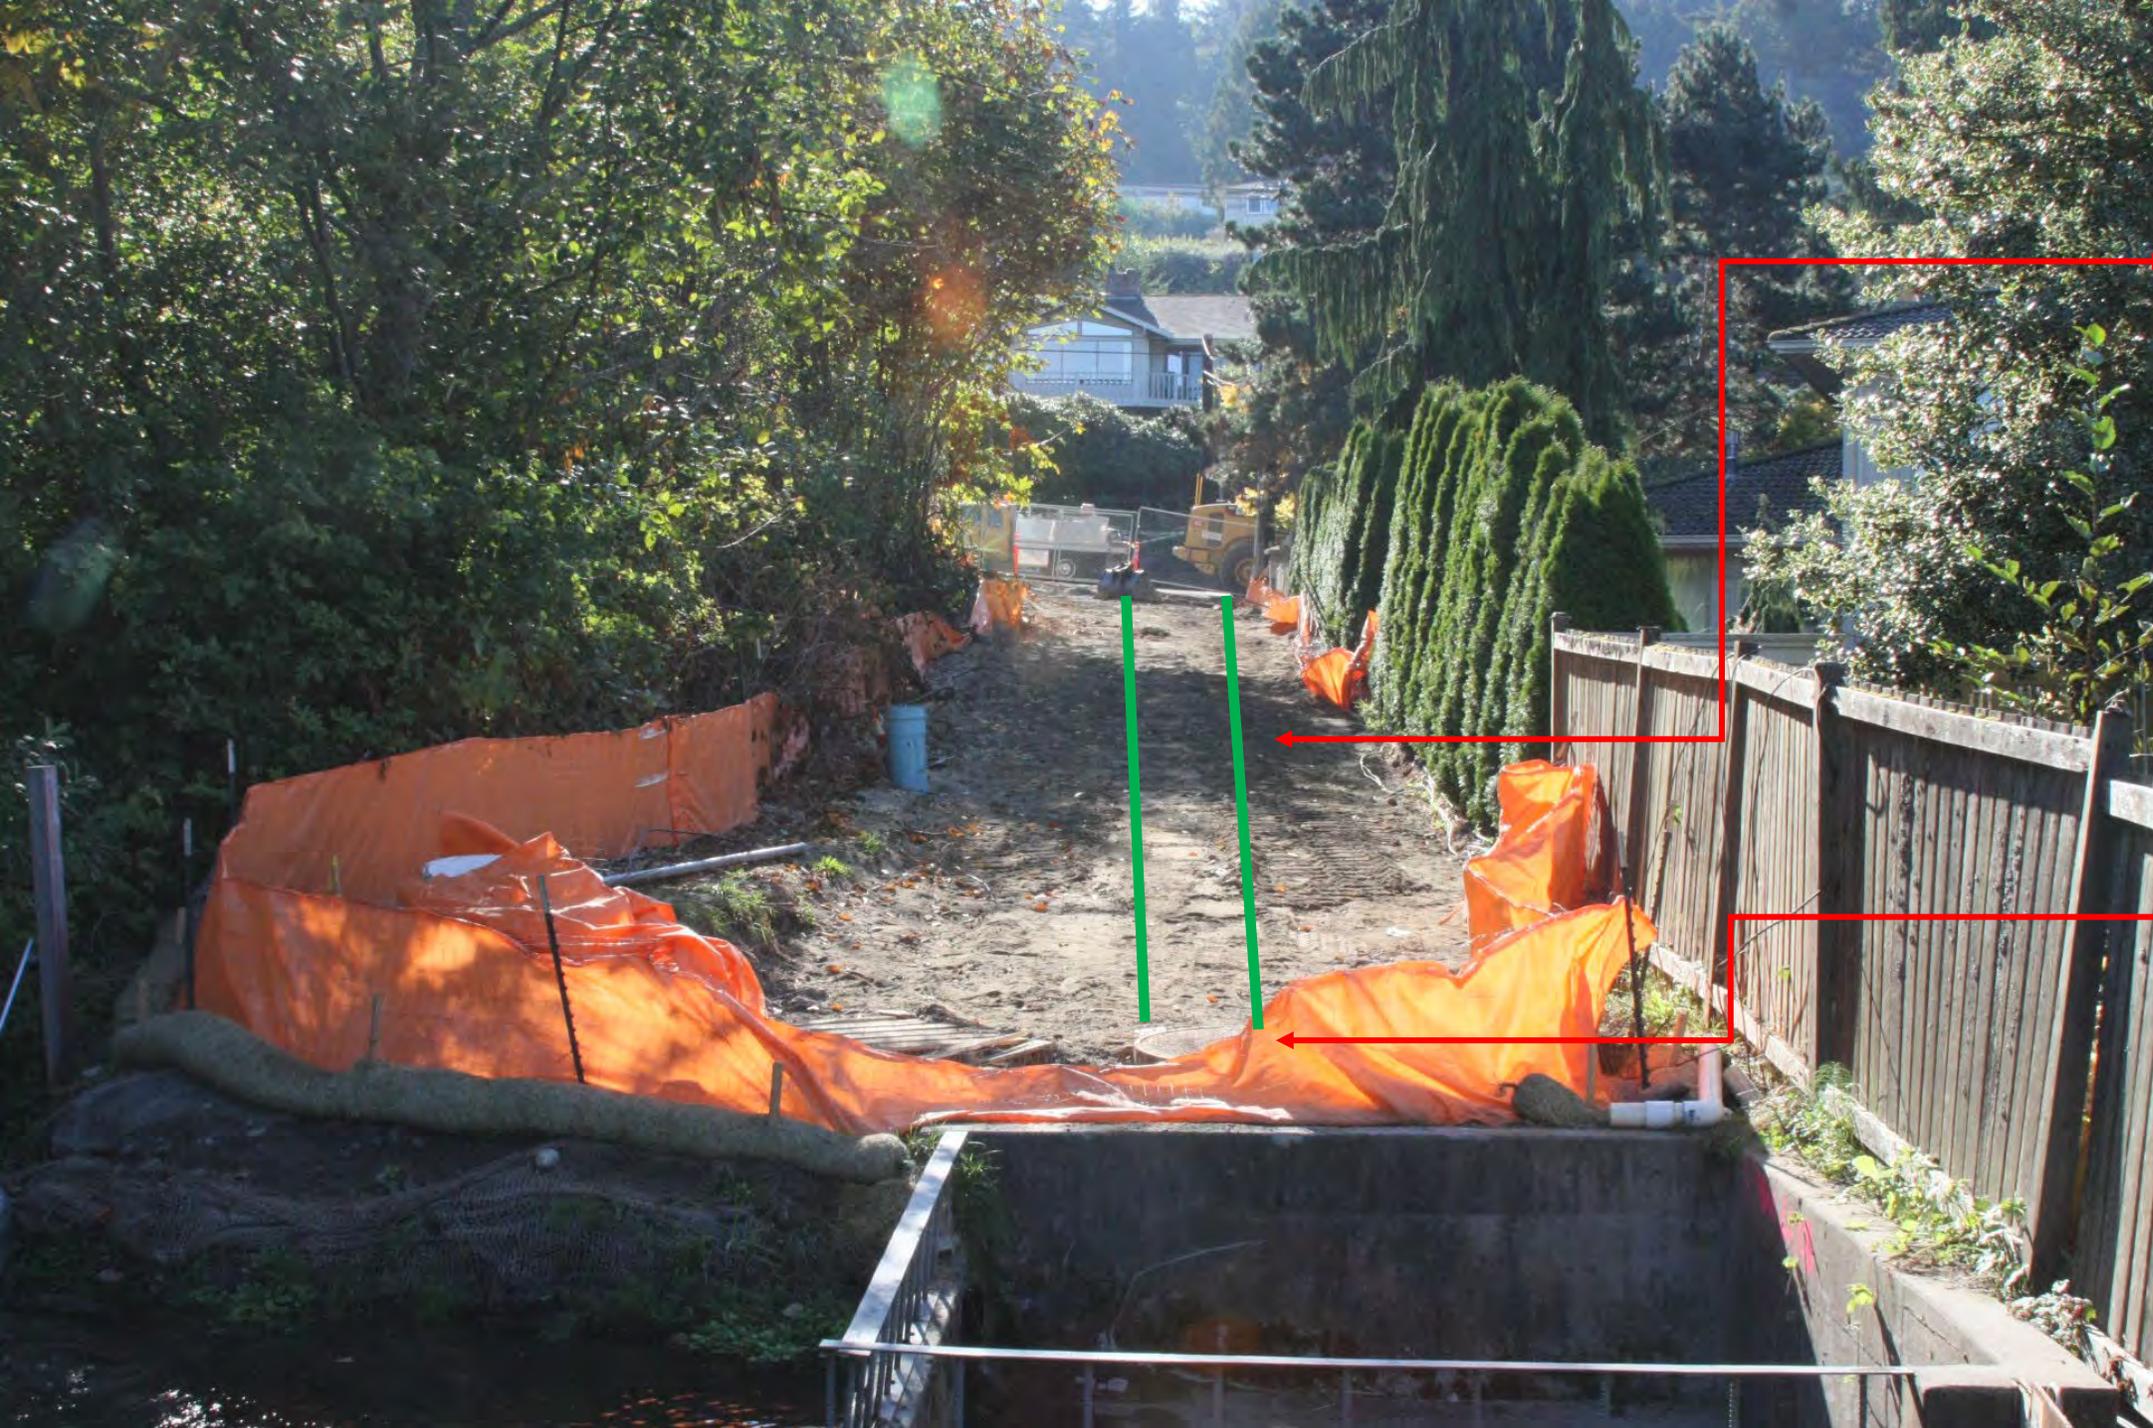
Looking East
towards Talbot Rd
from flow splitter

30" RCP
Installed by
Edmonds Public
Works in 2012,
shortly after
backfill.

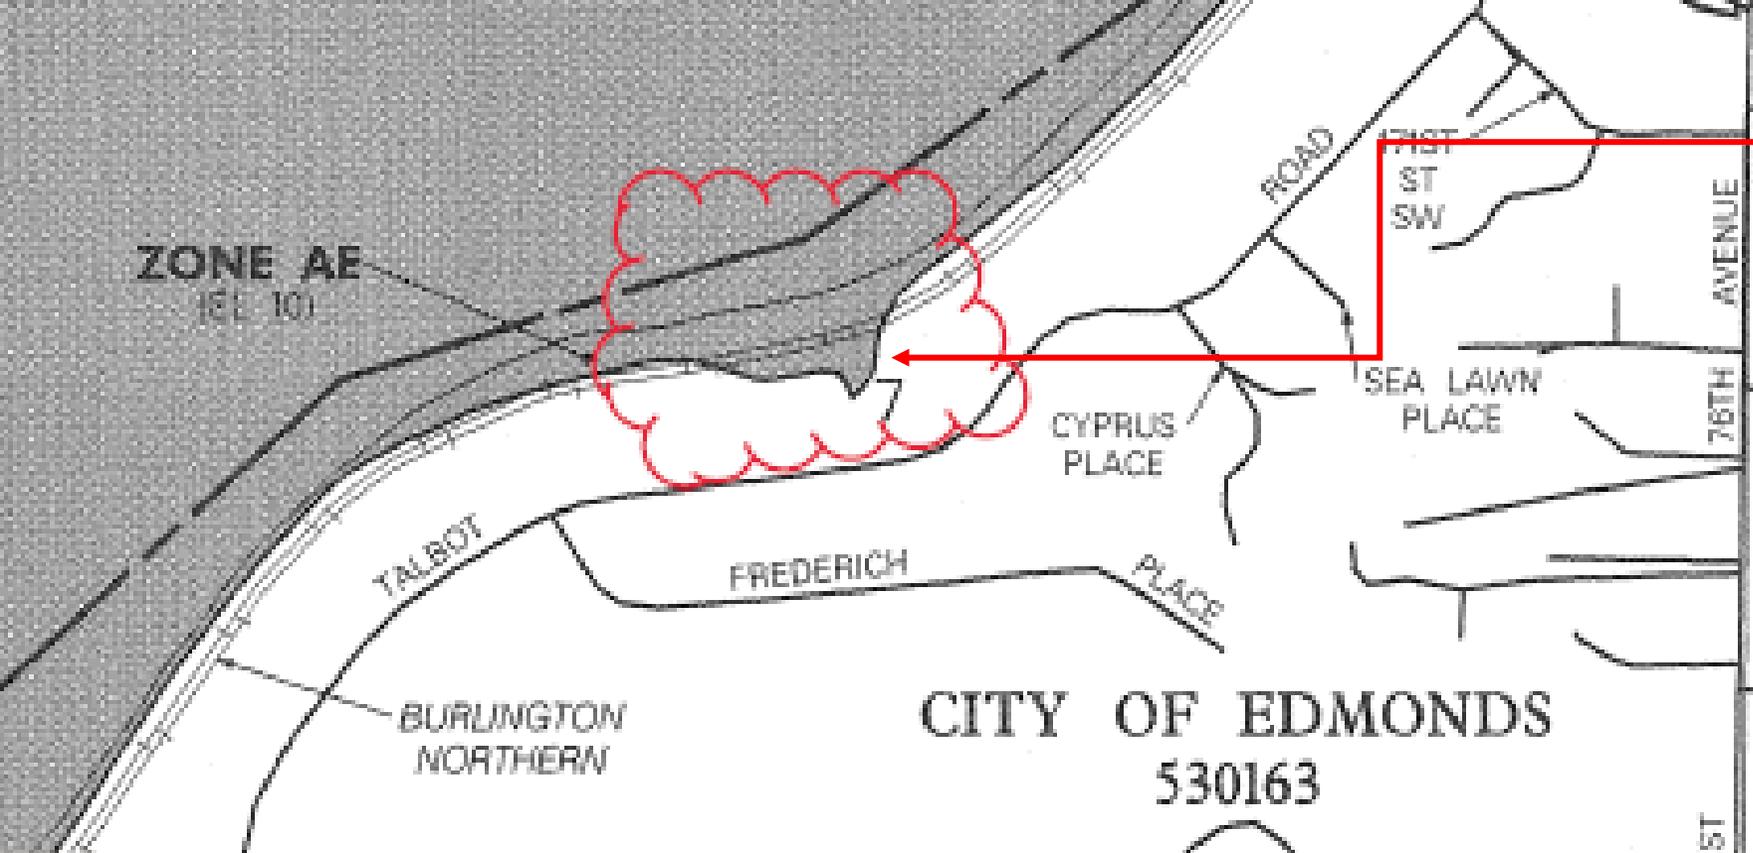
Backyard of house
8235 & 8307 Talbot
Road

This beautiful
backyard
w/fertilized lawn
down to stream
was built in a
Zone AE
floodplain.

The City may need to use its eminent domain powers to take property to restore its mistakes of permitting construction in a flood plain.

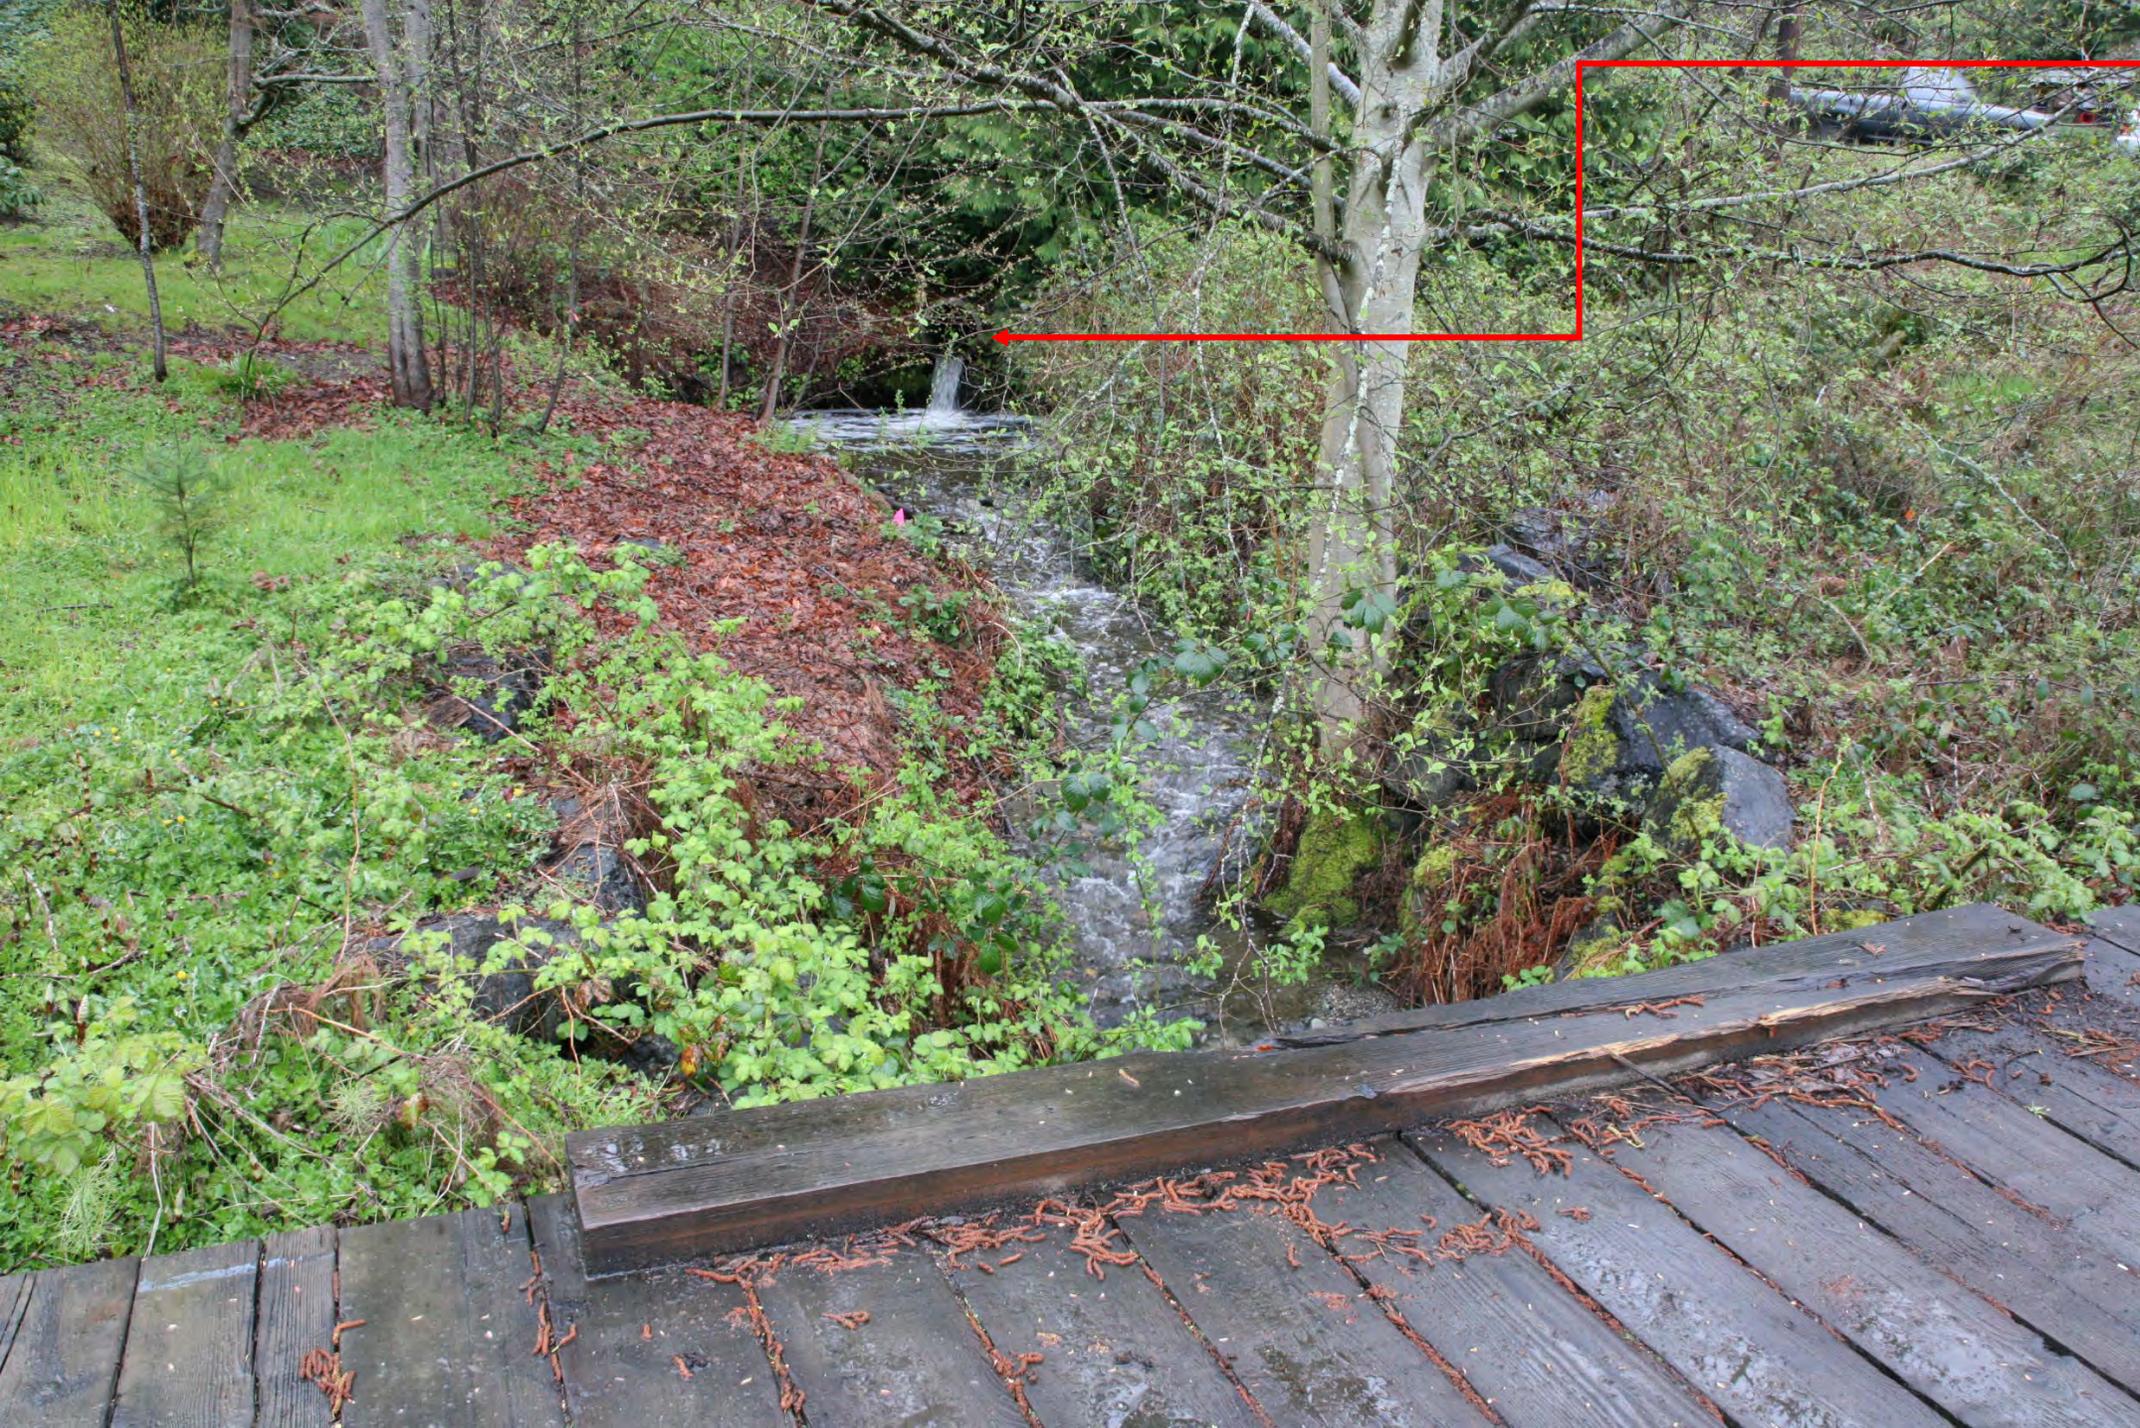
Looking northeast towards Talbot Rd, from bridge to house at 8229 to Talbot Road culvert outfall.
